Lahontan Regional Water Quality Control Board

**ADOPTION OF SETTLEMENT AGREEMENT AND STIPULATION FOR ENTRY OF
ADMINISTRATIVE CIVIL LIABILITY ORDER NO. R6T-2016-0063, ACTION
MOTORSPORTS OF TAHOE, INC., MEEKS BAY MARINA, EL DORADO COUNTY**

Figure 1. Site Map, From Page 18 of Meeks Bay Marina June 3, 2015 SWPPP

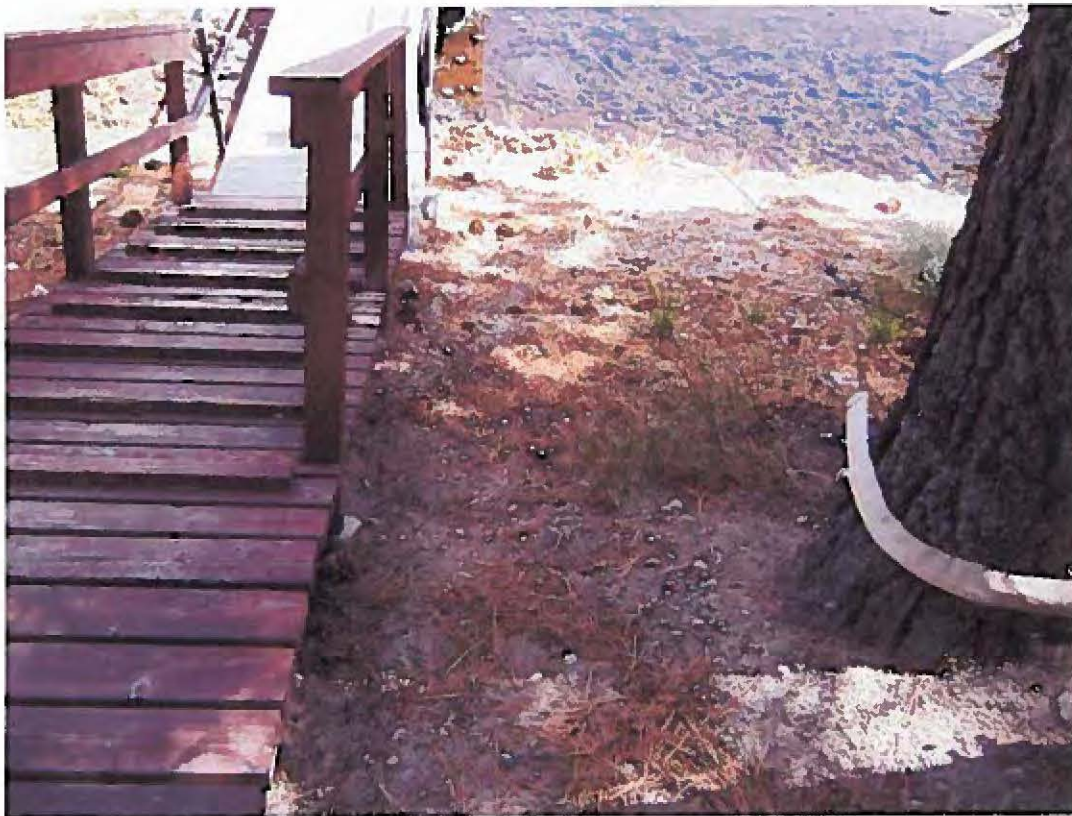
Photograph 24 - Close-up of the west side of the 4th walkway shown in Photograph No. 20. Evidence of erosion can be observed.

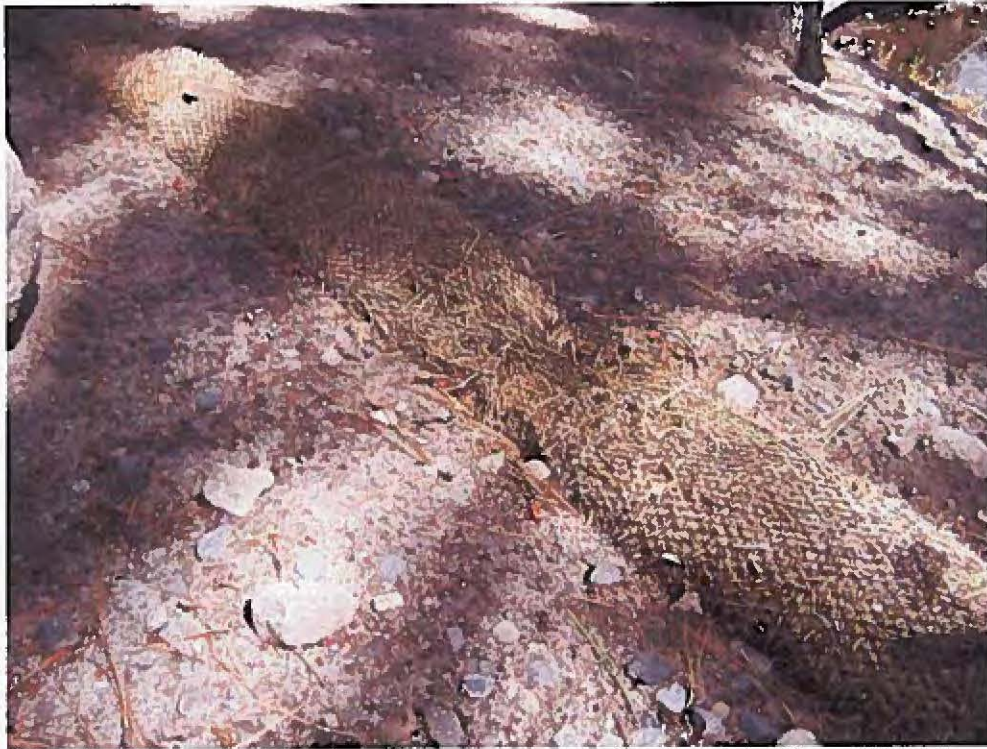
Photograph 25 - 10 feet west of the 4th walkway west of the office. The fiber roll has degraded.

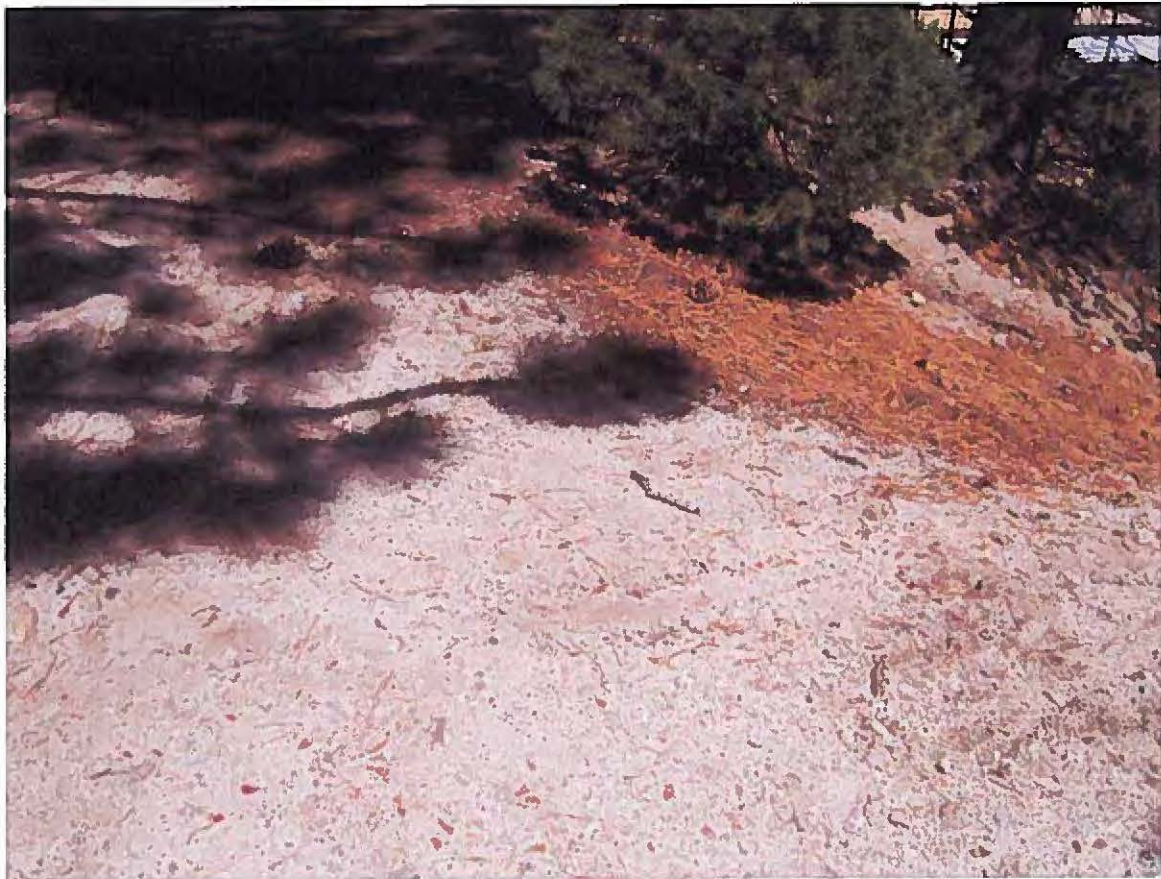
Photograph 26 - 20 feet west of 4th walkway ramp from office, facing east. No fiber roll has been installed, and a small gully erosion can be observed.

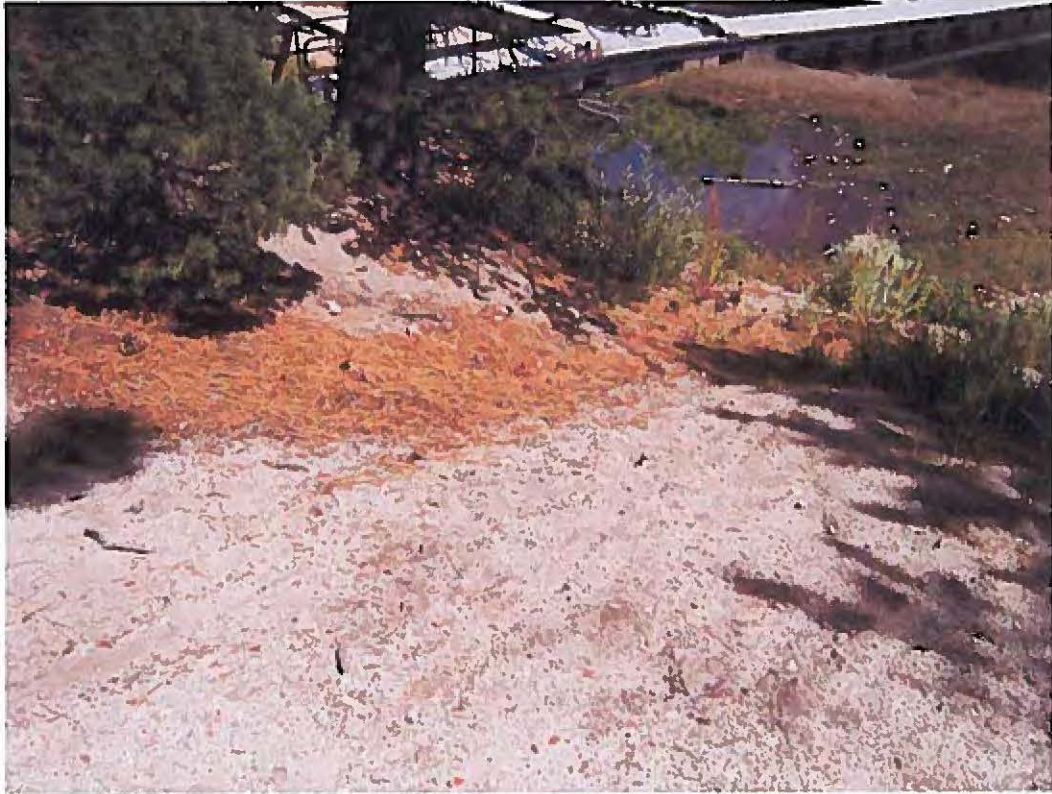
Photograph 27 – Same photo point as Photograph No. 26, panning toward the southeast.

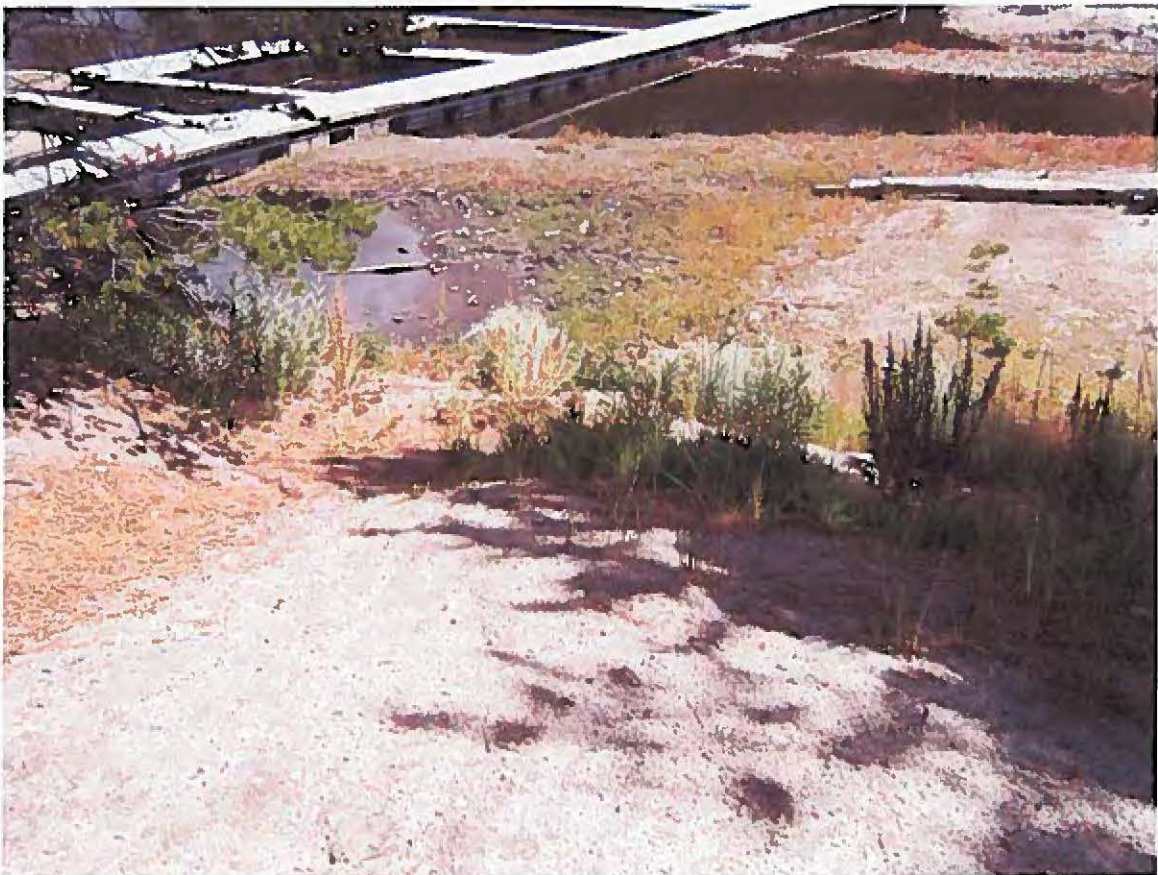
Photograph 28 - Same photo point as Photograph No. 26 and 27, panning toward the south.

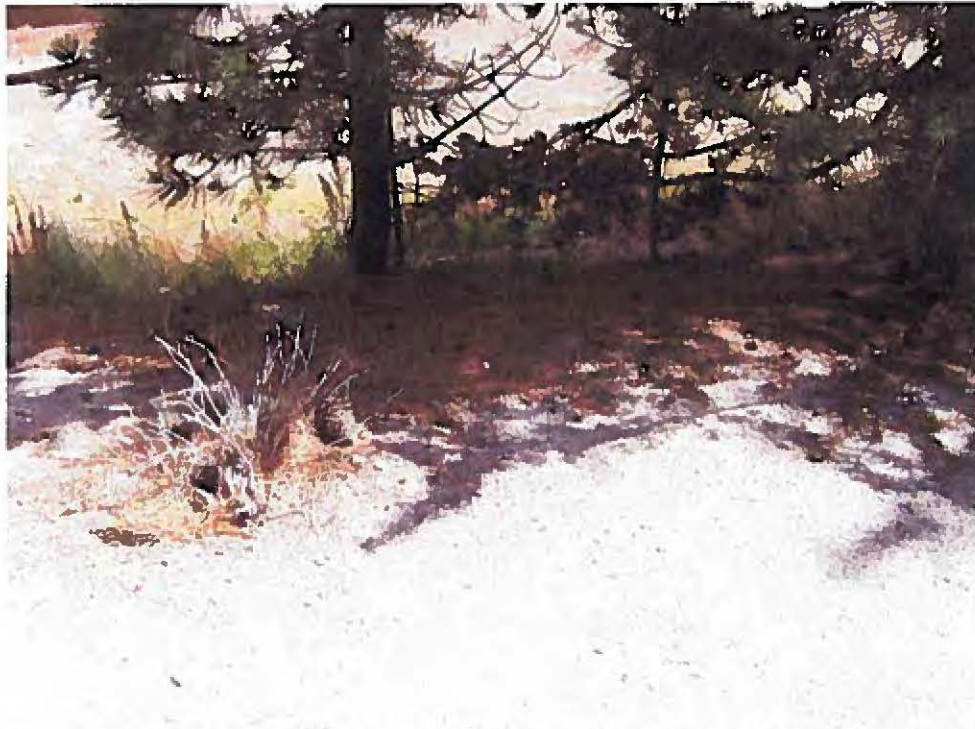
Photograph 29 - Standing at photo point 28, looking southwest. Fiber rolls have not been placed to collect potential stormwater runoff from the unpaved parking area.

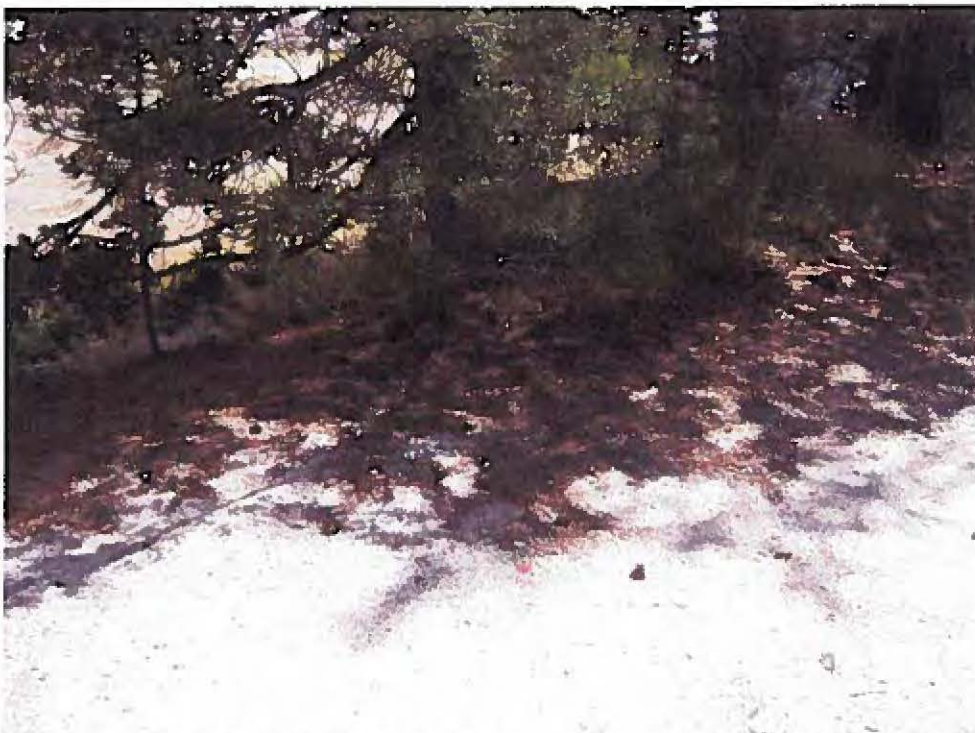
Photograph 30 - Standing at photo point 28, panning west from photo point 29, looking southwest-west. Fiber rolls have not been placed to collect potential stormwater runoff from the unpaved parking area.

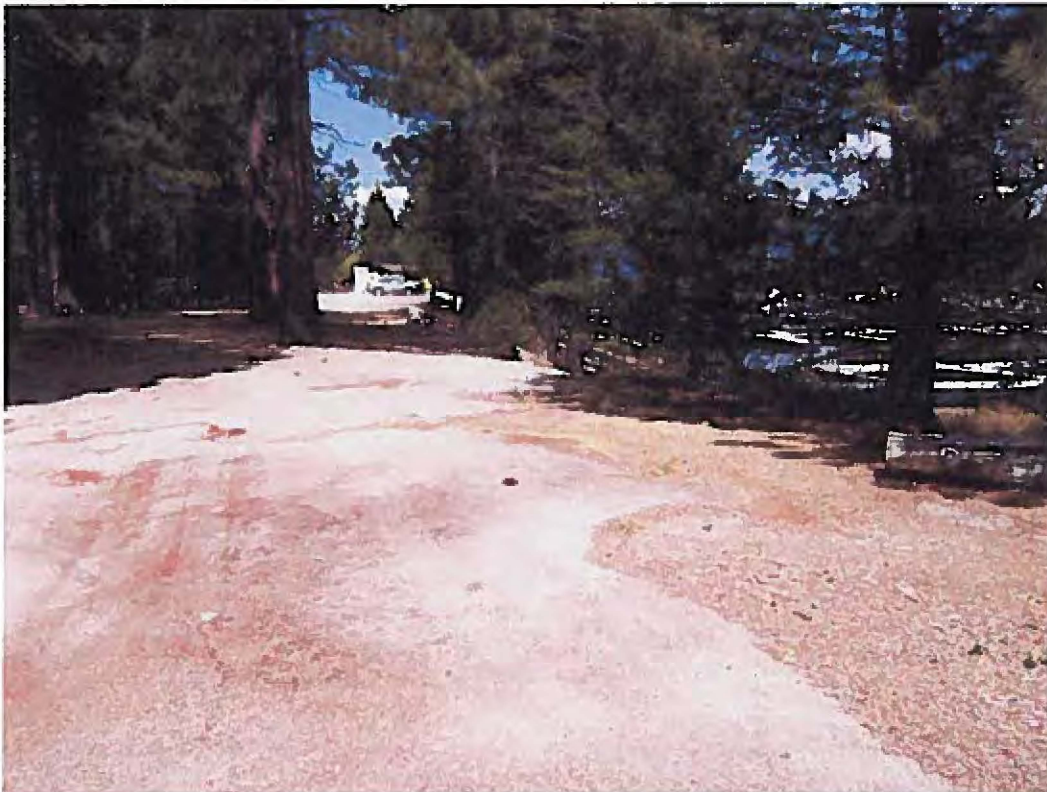
Photograph 32 - At west end of the marina boundary in the boat trailer parking area looking east. Fiber rolls were not installed at trailer parking area. Note the evidence of ponded water in the middle of the photograph, indicating fiber rolls may not be necessary in this area.

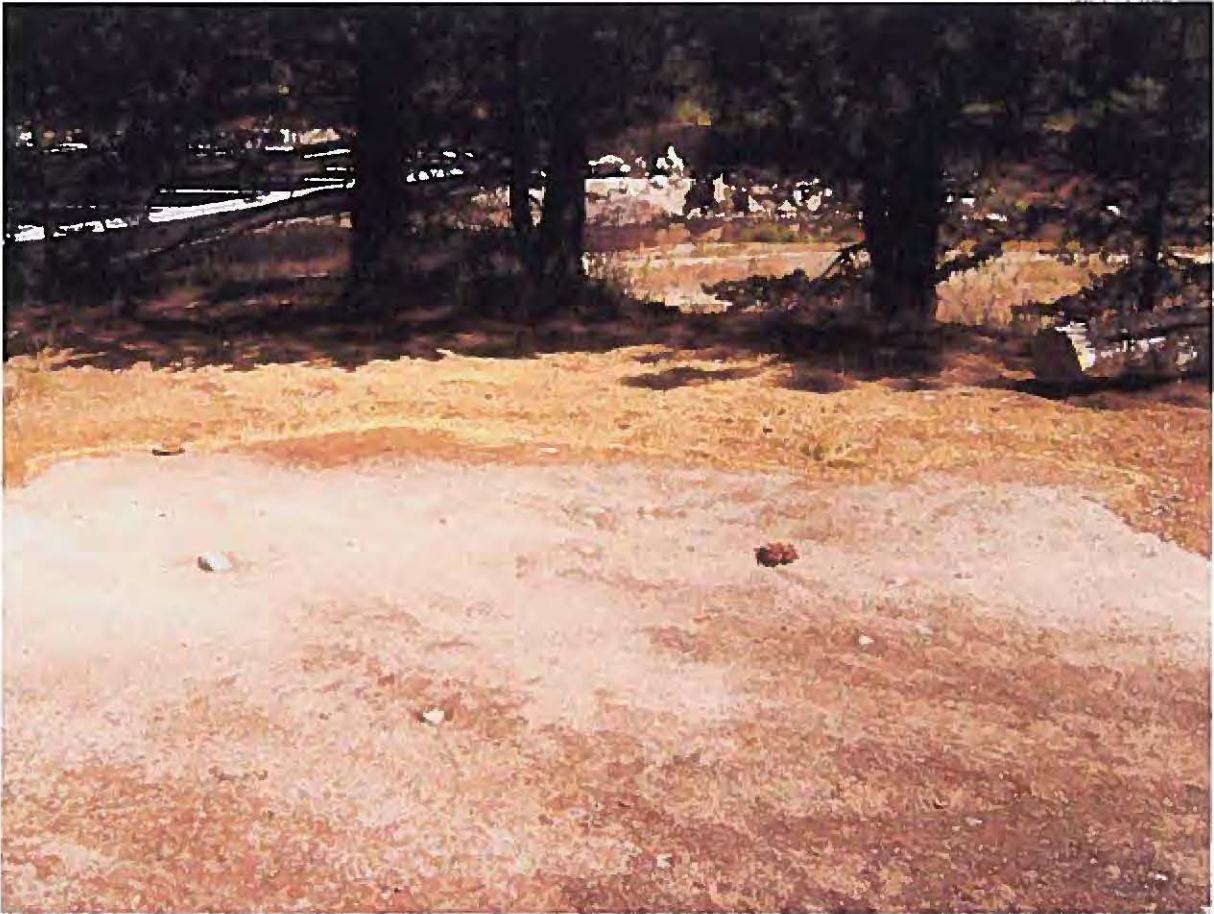
Photograph No. 33 – Close-up of storm water ponding line noted in Photograph No. 32. While there isn't evidence that stormwater runoff discharged over the bank in this area, it is likely that storm water flowed eastward toward the discharge point noted in Photographs No. 26-28.
