Trout Creek Restoration Monitoring: Changing Benthic Invertebrate Indicators in a Reconstructed Channel

September 2009

David B. Herbst
Sierra Nevada Aquatic Research Laboratory - University of California
HCR 79, Box 198
Mammoth Lakes, CA 93546
herbst@lifesci.ucsb.edu
760.935.4380

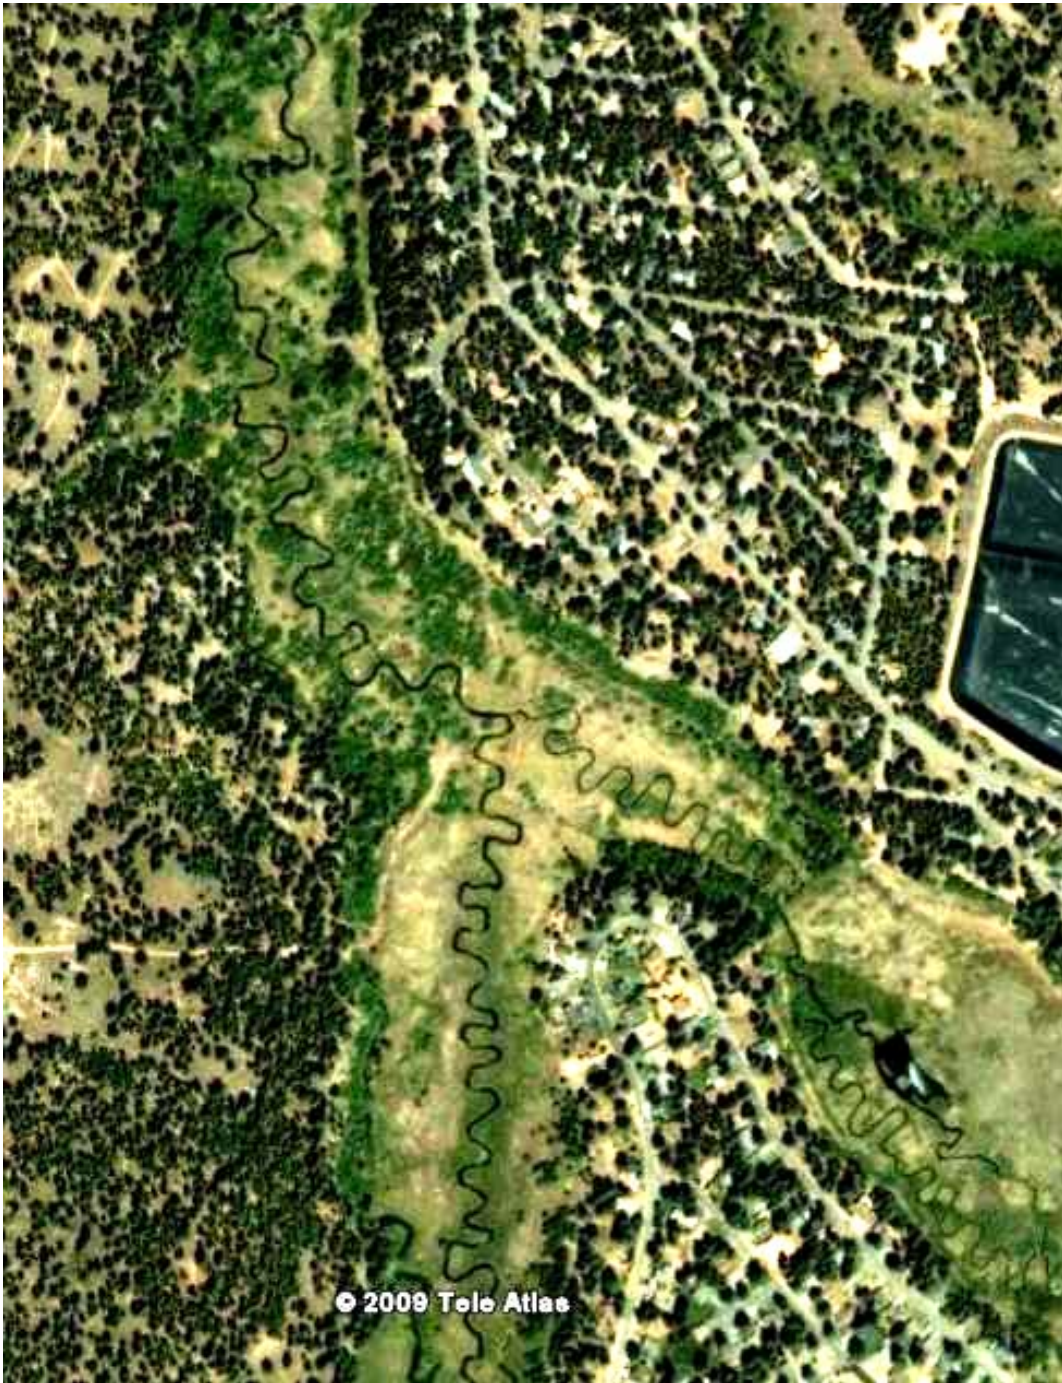
Figure 2. Restoration reaches on Trout Creek above and below the confluence of Cold Creek (coming in from the right side of the aerial photo).

In each of the three study reaches (upper project above Cold Creek, lower project below Cold Creek, and above project upstream of Pioneer Trail; Figures 1 and 2 aerial photos) five benthic invertebrate samples were collected, each in separate riffle segments separated from one another by 2-3 riffle-pool sequences. Each sample consisted of a composite collection from three square-foot locations across the channel in the shallow erosional riffle habitats. Samples were collected using a standard D-frame net of 250-

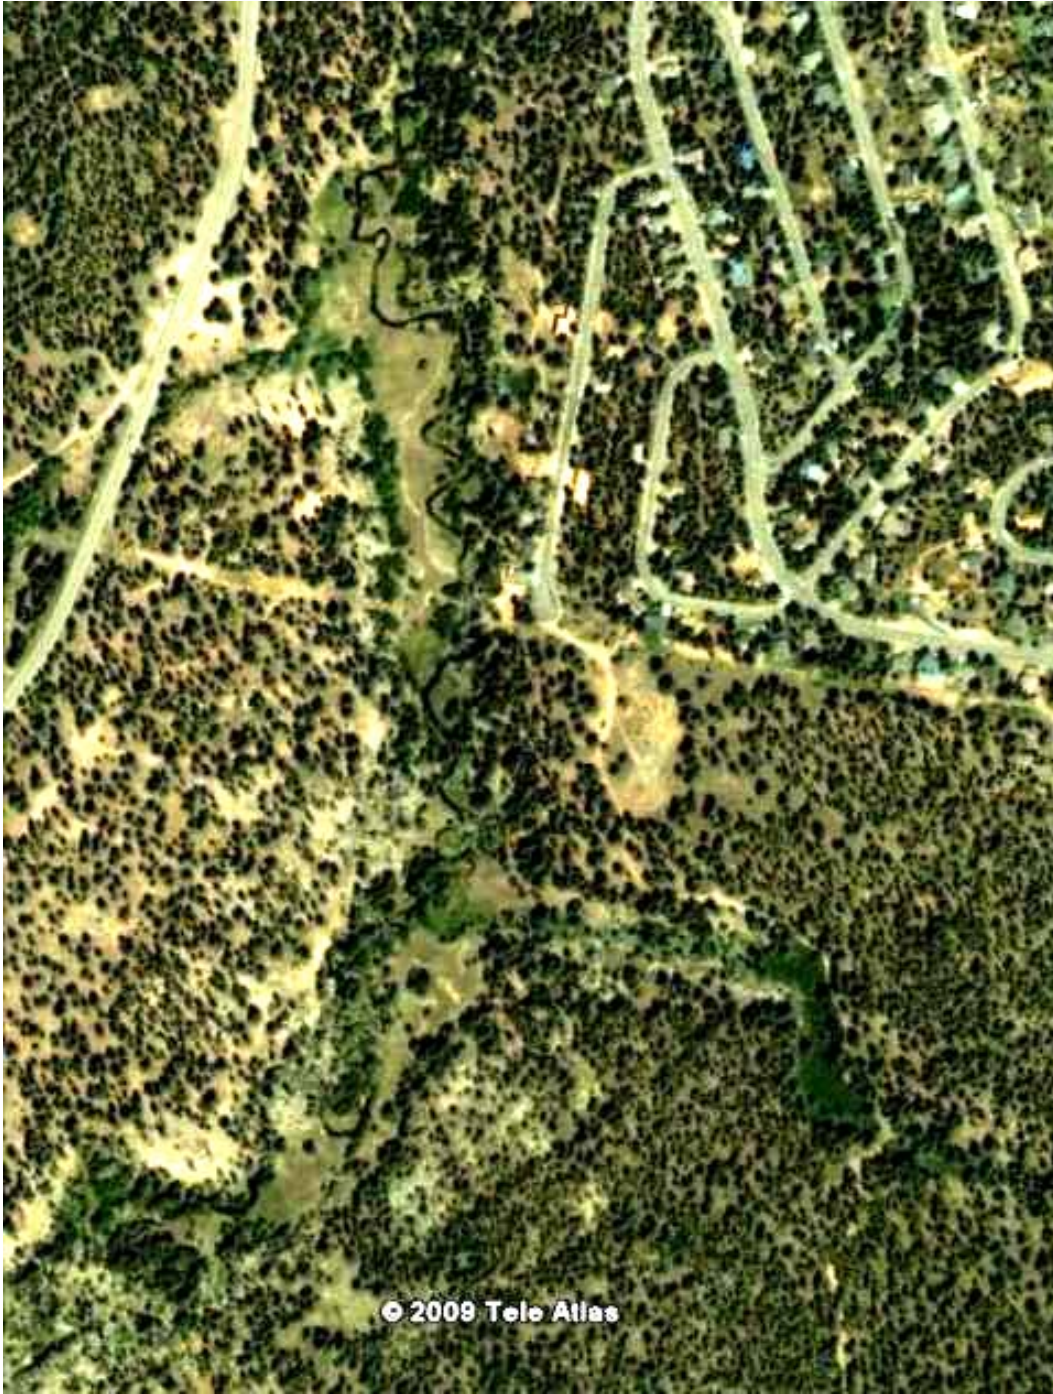
Figure 3. Upstream control reach (above crossing of Pioneer Trail Road) on Trout Creek, sampled during post-project phase.

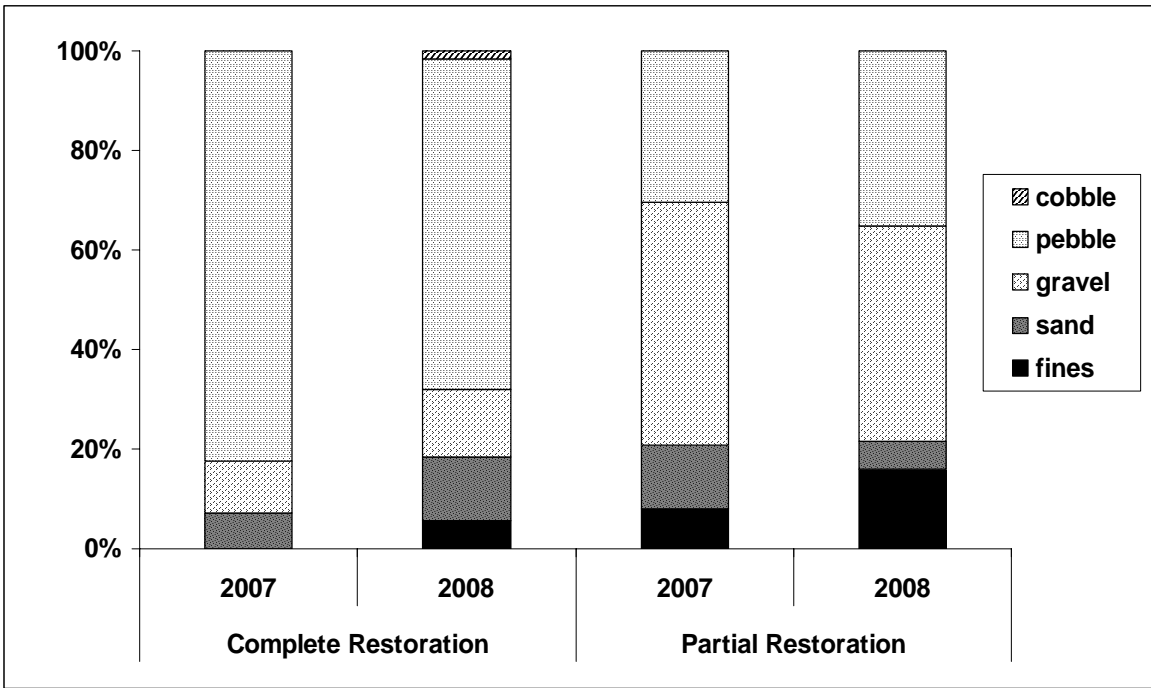
Figure 4. Substrate composition in riffles of reconstructed reaches of Trout Creek.

The streambed in both partial and complete reconstructed channels retained a substantial fraction of gravel to cobble size substrate in 2007-2008, but over the intervening years since project completion, the riffle habitats that had been covered with gravel-pebble-cobble substrates now contain about 20% fines and sand composition (Figure 4). Though overall geomorphic integrity of the channel appears to be retained,

The biological integrity improvements observed in the first two years following channel reconstruction do not appear to have been entirely sustained after an additional four to five years. While gravel and pebble rock substrates remain in riffles, more sand and fines have become deposited on the bed (Figure 4). Rock substrates form the habitat that support the most invertebrate diversity and larger body sizes, whether examined before or after habitat restoration (Figures 6 through 14). As this habitat varies, so does the benthic invertebrate community. Rock substrates support the growth of algal periphyton, and trap organic matter in the form of leaves and wood that accumulates in crevices. Algae and decomposing organic matter form the food base to aquatic invertebrates, so bed substrate composition is an important determinant of both habitat and food resources availability. These substrates are also more stable under higher flows, providing attachment and refuge not afforded by sand.

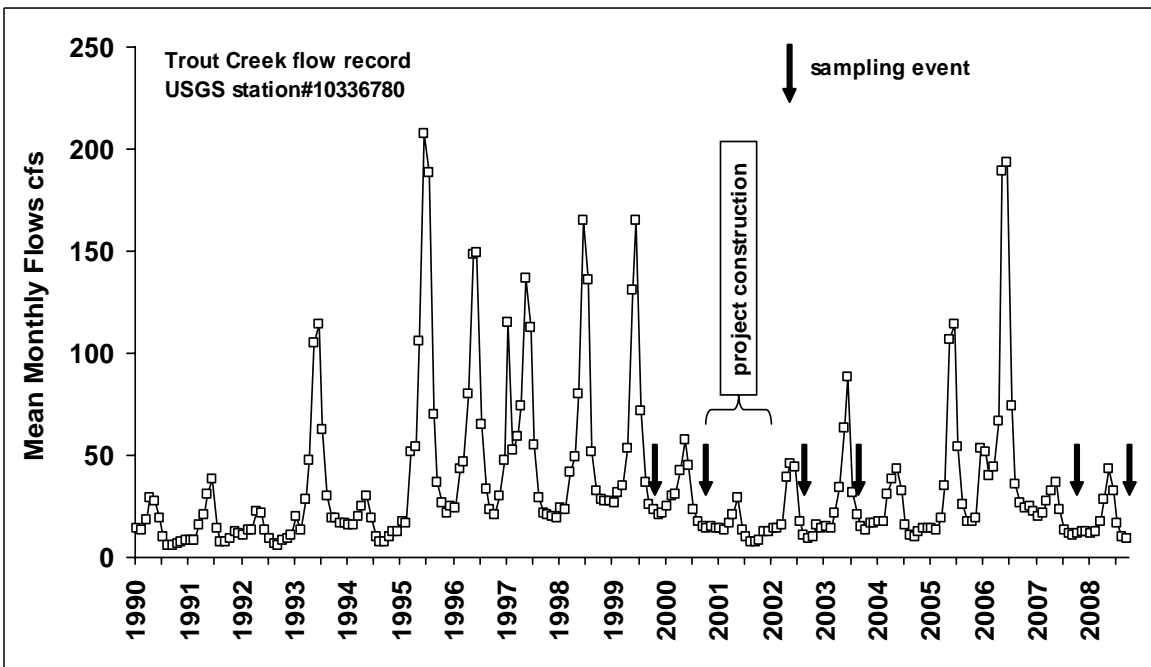
Figure 5. Record of monthly hydrograph from Trout Creek from 1990 into the fall of 2008. Peak flows typically occur in May-June, sampling occurred in late September of each year (at arrows). Gauge is located at Martin Avenue, below the project area (top of Figure 1).

Sampling was conducted under late summer baseflow conditions in all years (late September), though peak flows in May and June varied between years (Figure 3). In 2006, between the initial post-project surveys and the 2007-2008 repeats, flows were very high, providing conditions for suspended and bedload transport that would test the persistence of the gravel and cobble substrates added during habitat reconstruction. During pre-project sampling, collection locations were not restricted to the dominant streambed substrate at the time (sand), but were selected to represent the range of patch-scale variation that could be found, including localized gravel deposits. The pre-project habitat in the channelized stream consisted mostly of shifting sand and silt substrates, while the new stream channels created during restoration consisted mainly of mixed gravel and cobble-sized rocks within the riffle habitat sections.

there has been bank sloughing observed at some of the meander bends of the new channel, and some of the pools show signs of incision, deepening, and deposition of fines and sand. It is possible that some of these changes occurred during high flows in 2006 that could have carried suspended and bed load sand (Figure 5).

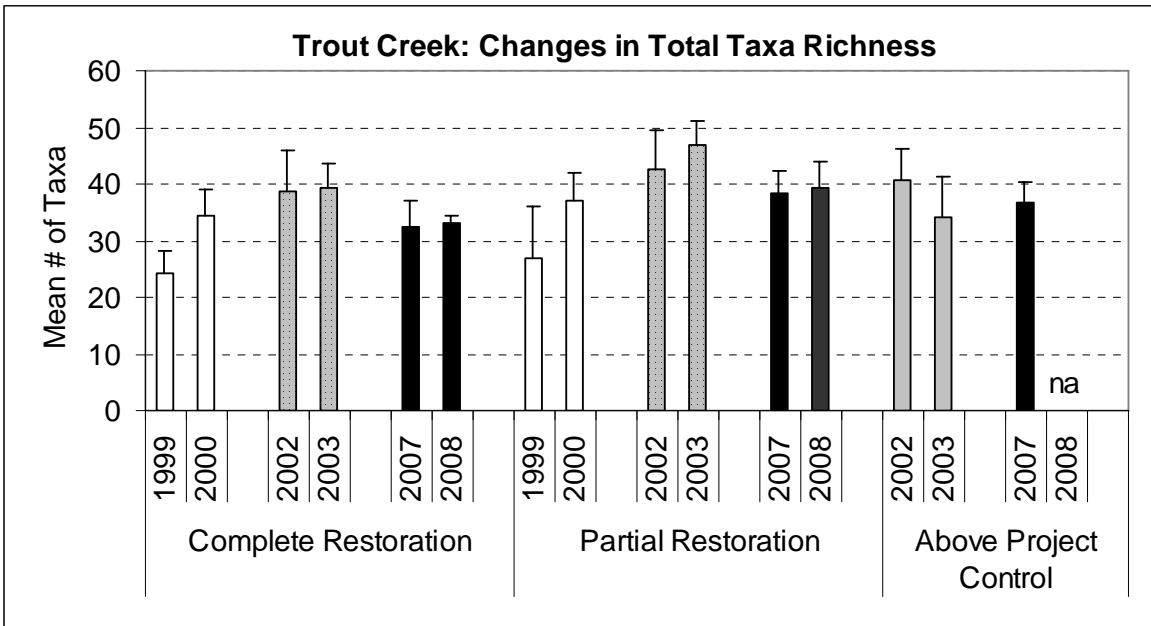
Figure 6. Total taxa richness diversity before restoration (open bars), initial post-restoration (grey bars), and after >5 years since project completion (black bars), for study sites on Trout Creek.

Invertebrate bioassessment responses show that despite the retention of much of the rock substrate introduced during restoration, the indicators have returned to levels near the former stream condition. The initial post-restoration gains in richness diversity for all taxa and among the EPT taxa were reduced in 2007-2008 to levels within the range of the unrestored stream (Figures 6 and 7). The density of invertebrates greater than 5 mm in size was also reduced below the range found in 2002-2003 in the complete restoration reach, but was more varied in the partial restoration reach. Dominance by a single taxon in the restored reaches also increased after having declined from pre-restoration conditions, but this was also seen at the control site. For diversity measures and size, the control reach maintained indicator levels.

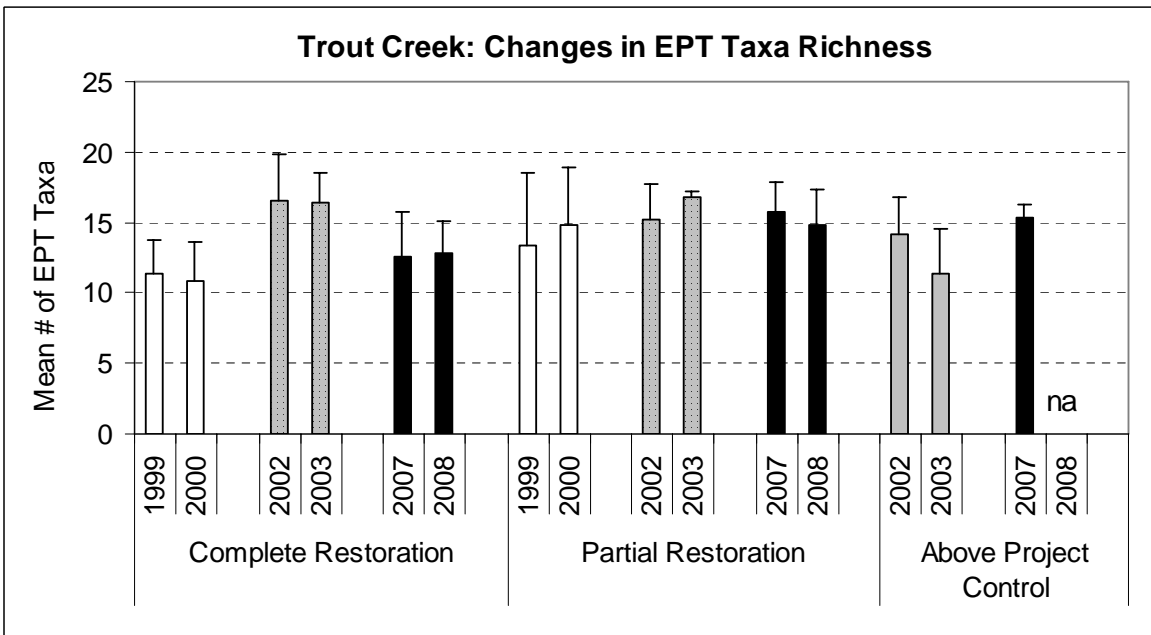
Figure 7. EPT taxa richness diversity before restoration (open bars), initial post-restoration (grey bars), and after >5 years since project completion (black bars), for study sites on Trout Creek.

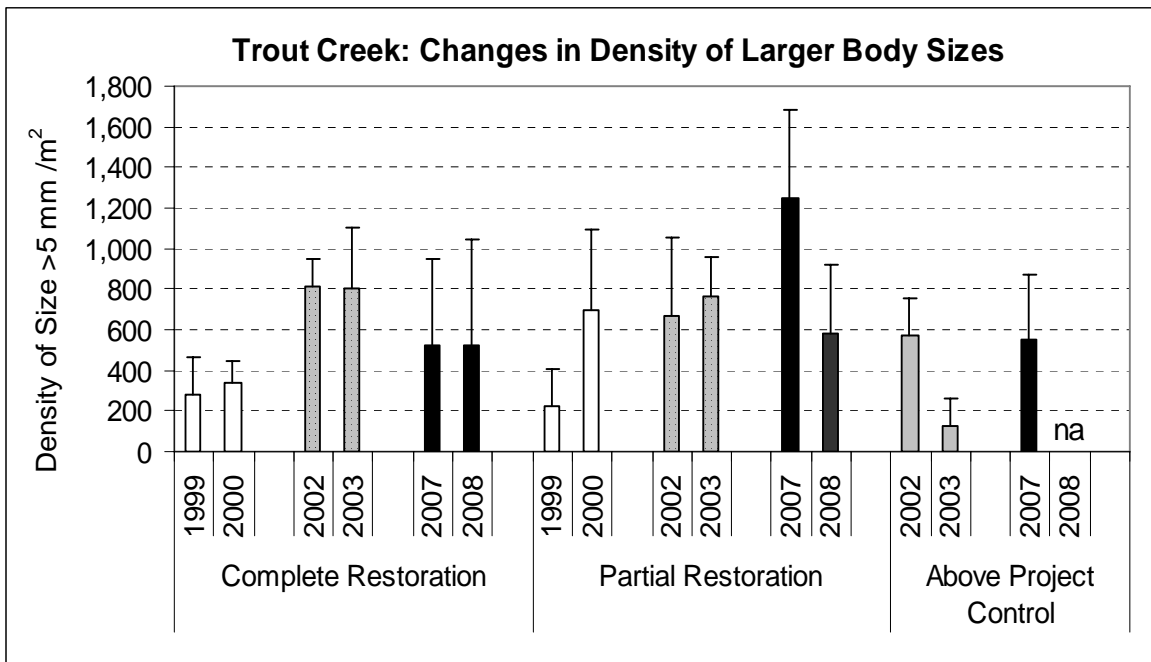
Figure 8. Density of larger benthic invertebrates (>5 mm) before restoration (open bars), initial post-restoration (grey bars), and after >5 years since project completion (black bars), for study sites on Trout Creek.

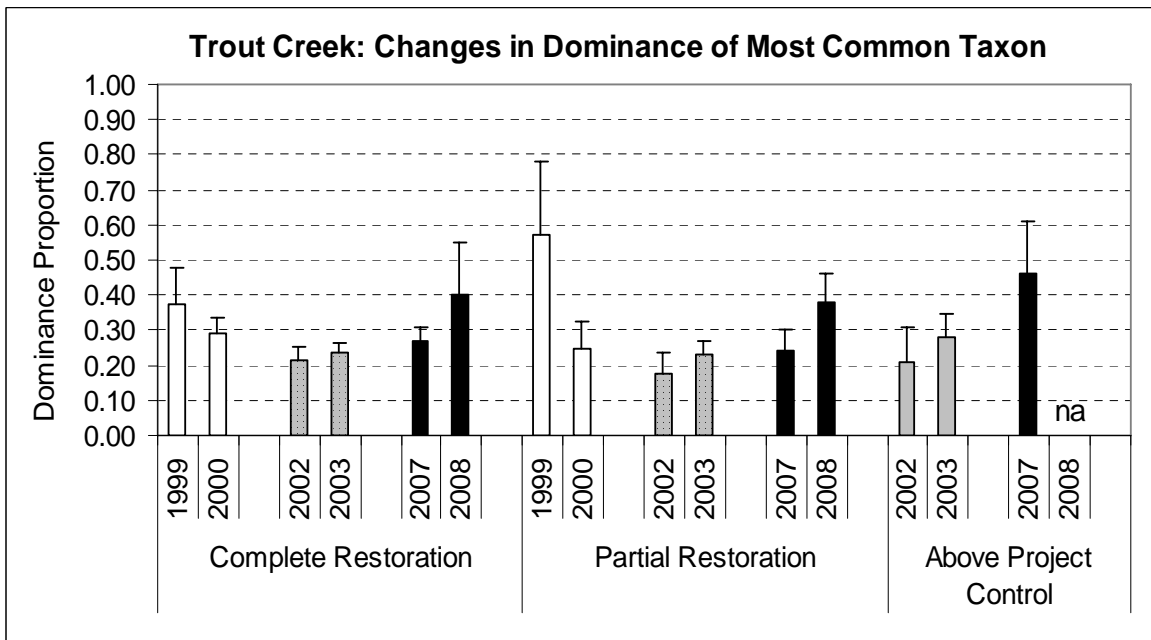
Figure 9. Dominance or proportion of total community comprised of a single taxon before restoration (open bars), initial post-restoration (grey bars), and after >5 years since project completion (black bars), for study sites on Trout Creek.

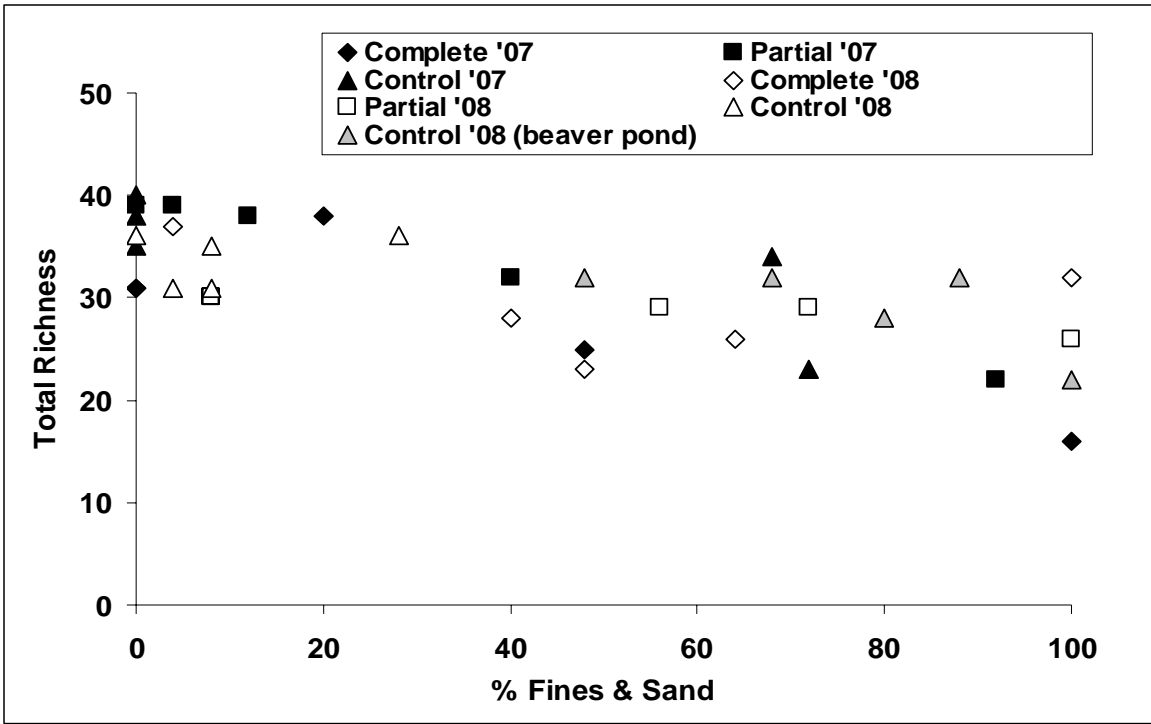
Figure 10. Richness diversity of total taxa from quadrat samples with grid-frame counts of FS cover. Samples taken from a range of conditions in all reaches in 2007 and 2008.

The quadrat samples demonstrate that FS cover has an important influence on the diversity and composition of the invertebrate community. As FS cover increased, the total and EPT taxa richness levels declined (Figures 10 and 11), with all samples below 30% FS having more than 30 total taxa and 10 EPT present, while over 60% of samples above 40% FS had less than 30 total taxa, and almost 90% had 10 or fewer EPT. The percent of EPT in quadrats declined substantially as FS cover increased (Figure 12), though even at low levels of FS, quadrats from the complete restoration area had reduced %EPT. In the samples taken from the beaver-pond flooded control reach of 2008, the

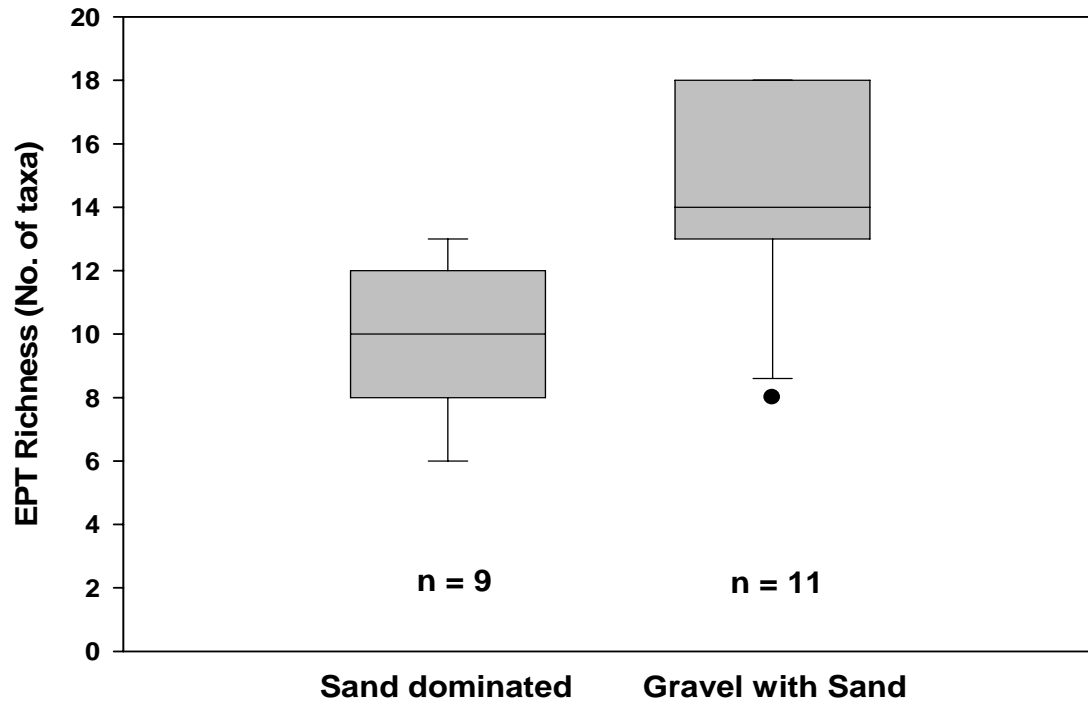
EPT Richness by Substrate for 1999 & 2000

Figure 14. Richness diversity of EPT taxa on different substrate types sampled in the pre-project channelized stream segments (above and below Cold Creek) in 1999 and 2000 shown in box (25th-75th percentiles, median line) and whisker plots.

Although quadrat samples of FS substrate cover were collected only in 2007 and 2008, substrate classes recorded for pre-project samples permitted contrast of sand-only substrates with those having mixed gravel content. These samples also showed also that the presence of some gravel enhanced EPT diversity (Figure 14).

Less fine and sand cover within the matrix of larger substrates (gravel, pebble, cobble) yields more diverse invertebrate communities, supporting the assumption that reduced sedimentation is an important driver of sustained ecological recovery. This association was demonstrated in the quadrat grid-frame samples where improved response measures were usually found at lower levels of fine and sand cover (Figures 10-13). An exception to this was apparent within the quadrats collected in the complete restoration area where even though low FS cover promoted diversity, the percent EPT was lower than found at other sites. With entirely replaced channel and streambed in this area, the absence of local recolonization sources may limit abundance of these taxa. Where fines and sand were abundant in quadrats, as in the former channelized stream, lower diversity and smaller organisms persist. Even the earlier pre-project samples in areas with gravel substrates supported more diverse invertebrate communities but were present only in localized patches (Figure 14).
