**FIGURE S-5**  
**CHROMIUM GAS AND ELECTRIC COMPANY**  
**GROUNDWATER MONITORING AND DOMESTIC WELL**  
**SAMPLING AND MAXIMUM COMPOSITE PLUME**  
**OUTLINE IN UPPER AQUIFER**

SECOND QUARTER 2018 GROUNDWATER MONITORING REPORT AND DOMESTIC WELL RESULTS SITE-WIDE GROUNDWATER MONITORING PROGRAM

PACIFIC GAS AND ELECTRIC COMPANY  
HINKLEY COMPRESSOR STATION  
HINKLEY, CALIFORNIA

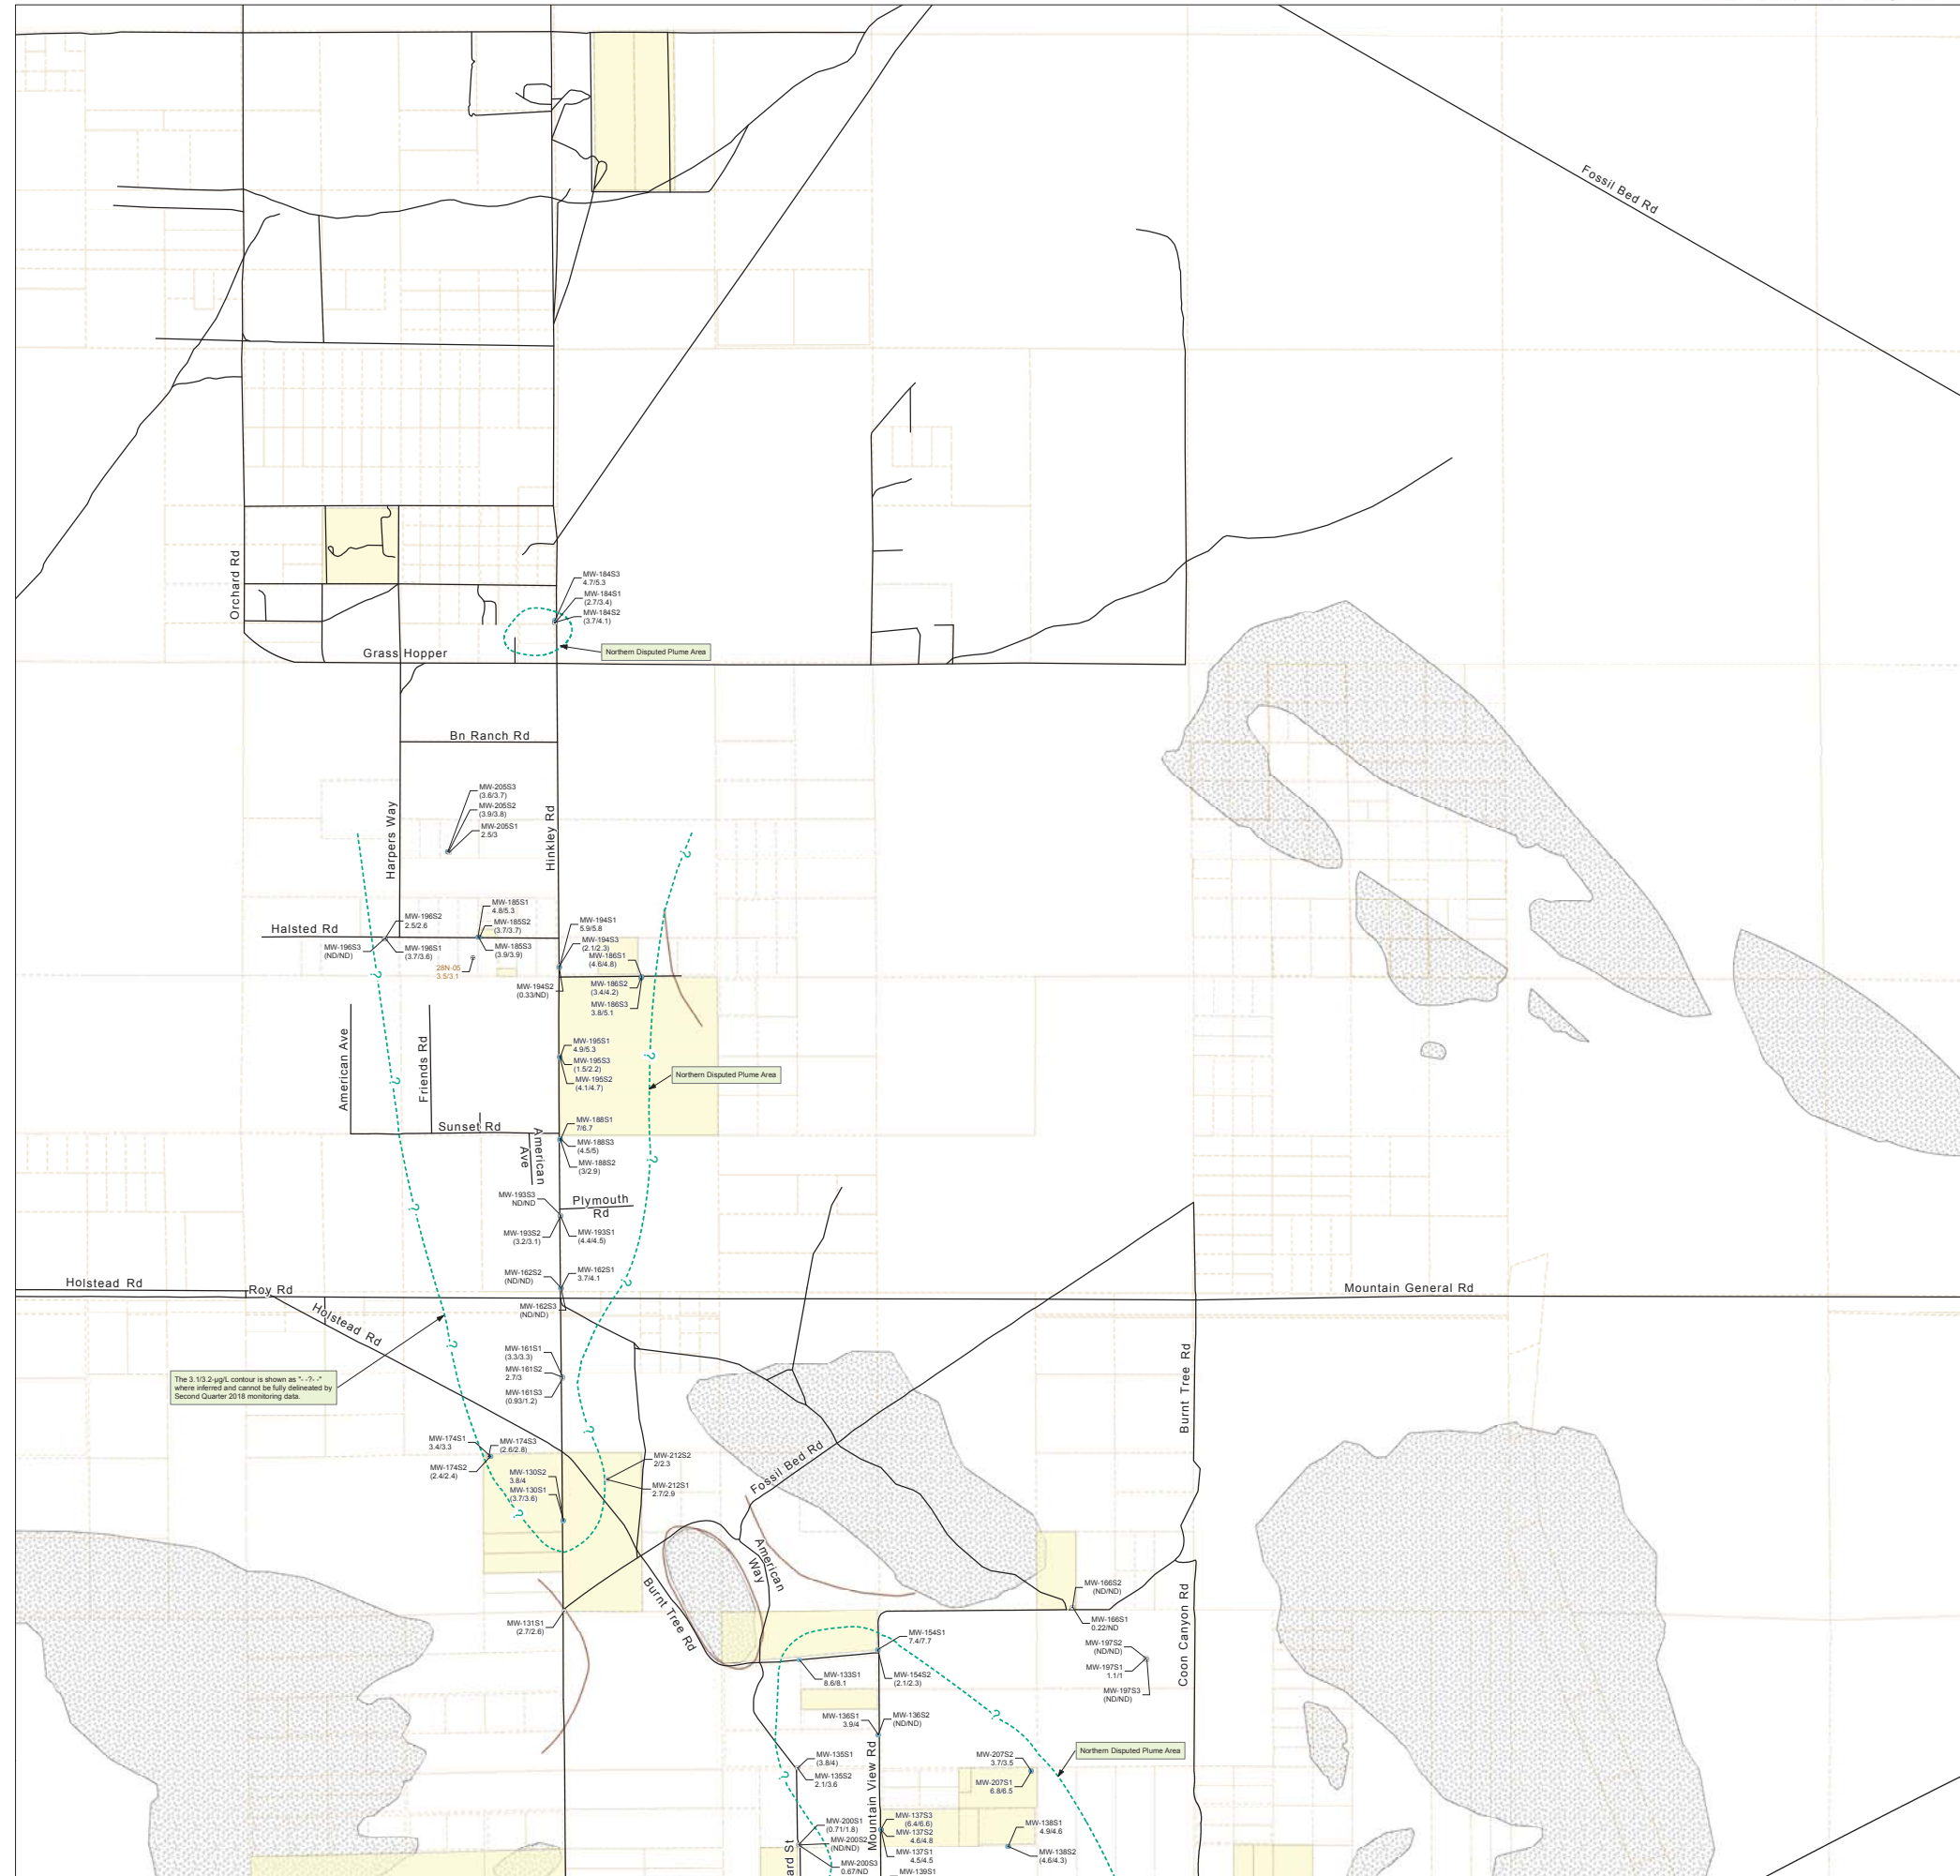
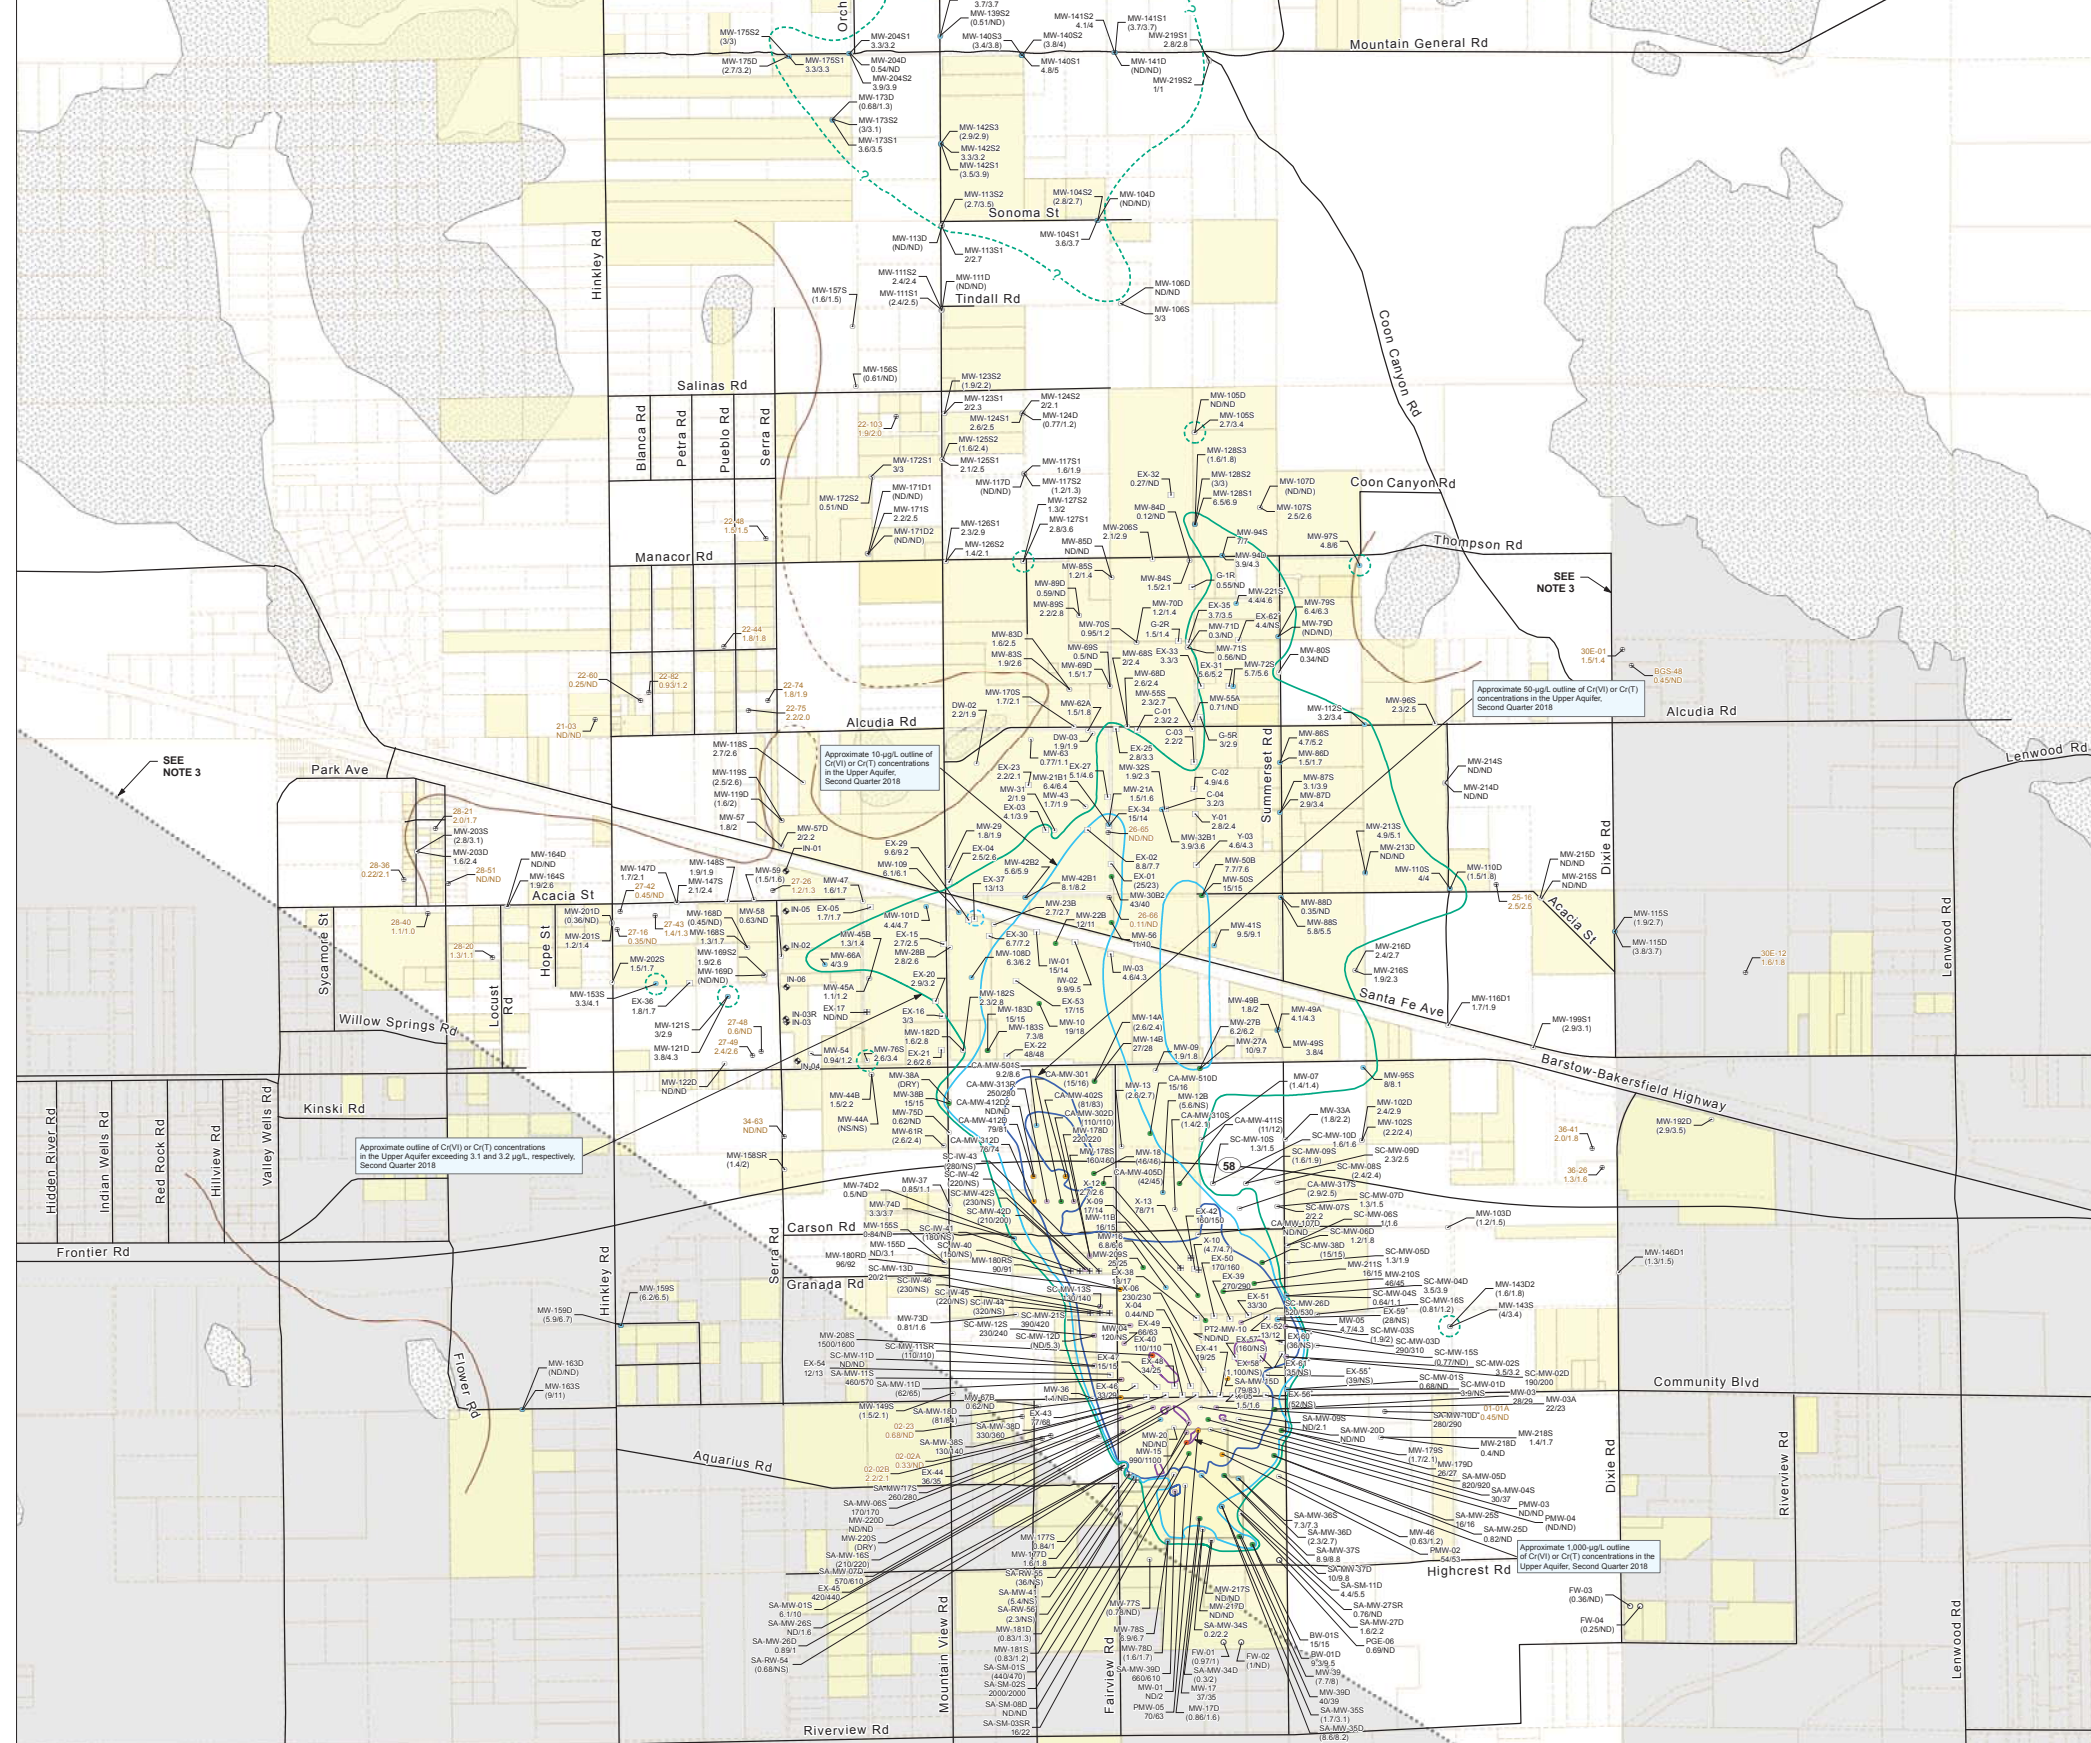
Cr(VI)/Cr(T) concentrations in µg/L; maximum of primary and duplicate samples during Second Quarter 2018 sampling. Data in parentheses are from previous reporting period. See Table E-1 for sample dates.

- Chromium results are shown for Site-wide Groundwater Monitoring Program and domestic wells sampled in the Second Quarter (April through June) 2018 monitoring period. For wells sampled multiple times during the reporting period, the most recent results are shown.

- The concentration outlines are based on Second Quarter 2018 chromium results for the groundwater monitoring and extraction wells that are completed in the shallow zone and deep zone of the Upper Aquifer as noted on Figures S-1 and S-2. Results for domestic wells (brown-colored plume areas) were not used for chromium plume contouring, except for those in the northern dispersed plume areas, pursuant to the Lahontan Regional Water Quality Control Board's Cleanup and Abatement Order dated November 4, 2015 (Water Board 2015).
