Mad River Watershed Assessment

Prepared for
Redwood Community Action Agency
904 G Street
Eureka, CA 95501

Prepared by
Stillwater Sciences
850 G Street, Suite K
Arcata, CA, 95521

June 2010

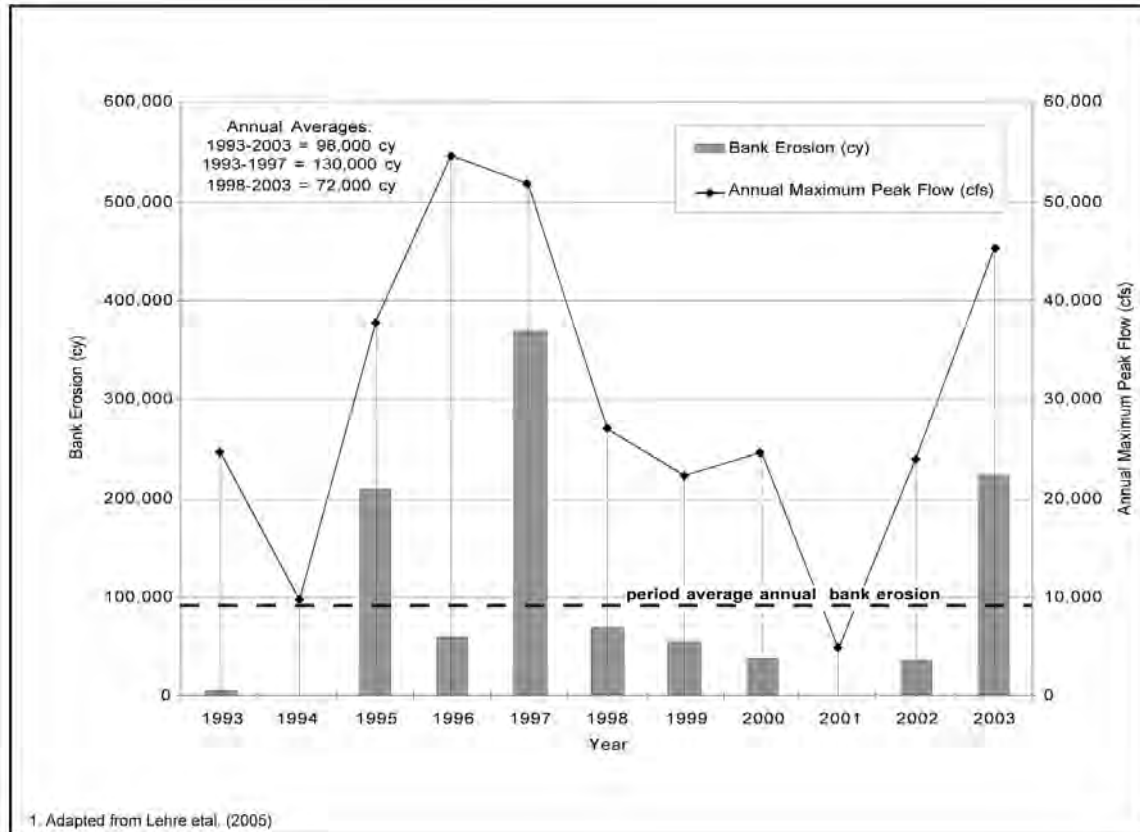
Figure 2. Bank erosion and peak discharges in the lower Mad River, 1993-2003.

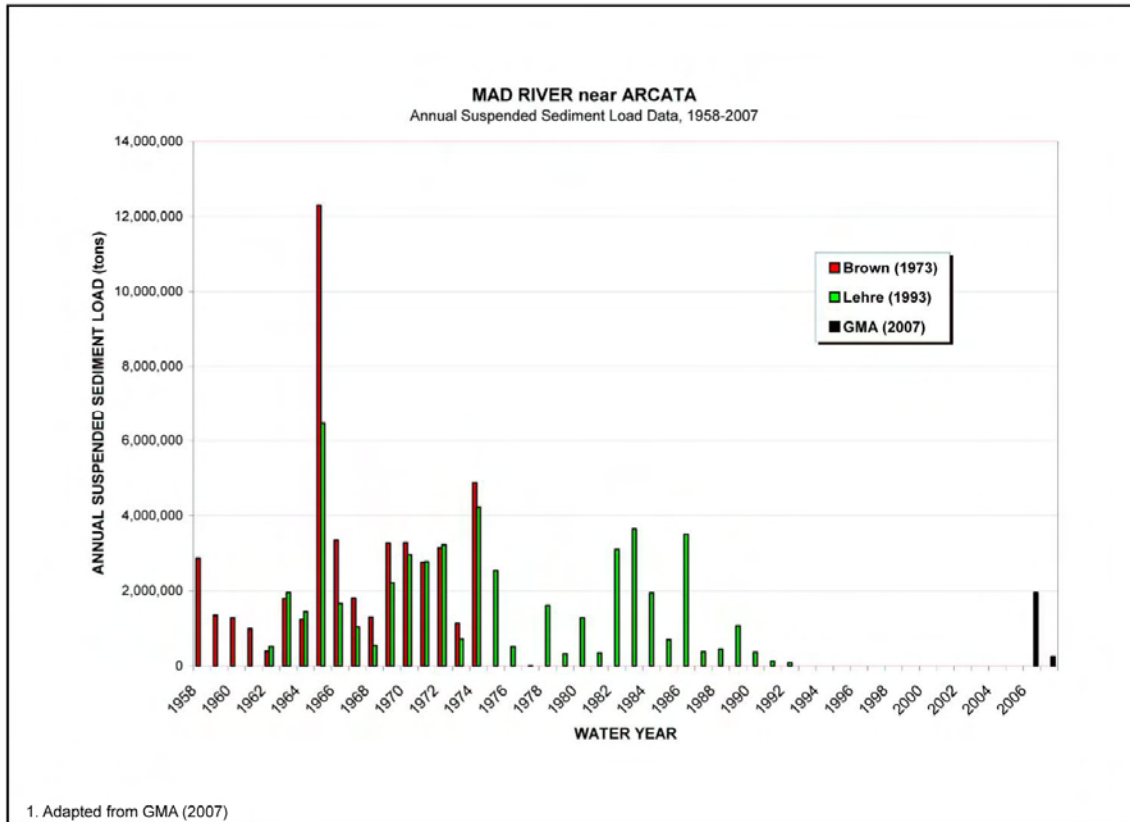
Figure 3. Comparison of measured suspended sediment load data.

Suspended loads at the Mad River near Arcata gage and at the Mad River near Forest Glen gage were computed by the USGS (Brown 1973) for the period 1958–1974 and by Lehre (1993) for the period 1962–1992. The USGS (Brown 1973) related annual discharge to SSC and applied this relation to the instantaneous discharge record, while Lehre (1993) applied the relation from Brown (1975) to the mean daily record. Annual suspended loads computed for the overlapping period 1962–1974 for these two analyses vary considerably at Mad River near Arcata (Figure 3) but agree well at Mad River near Forest Glen.

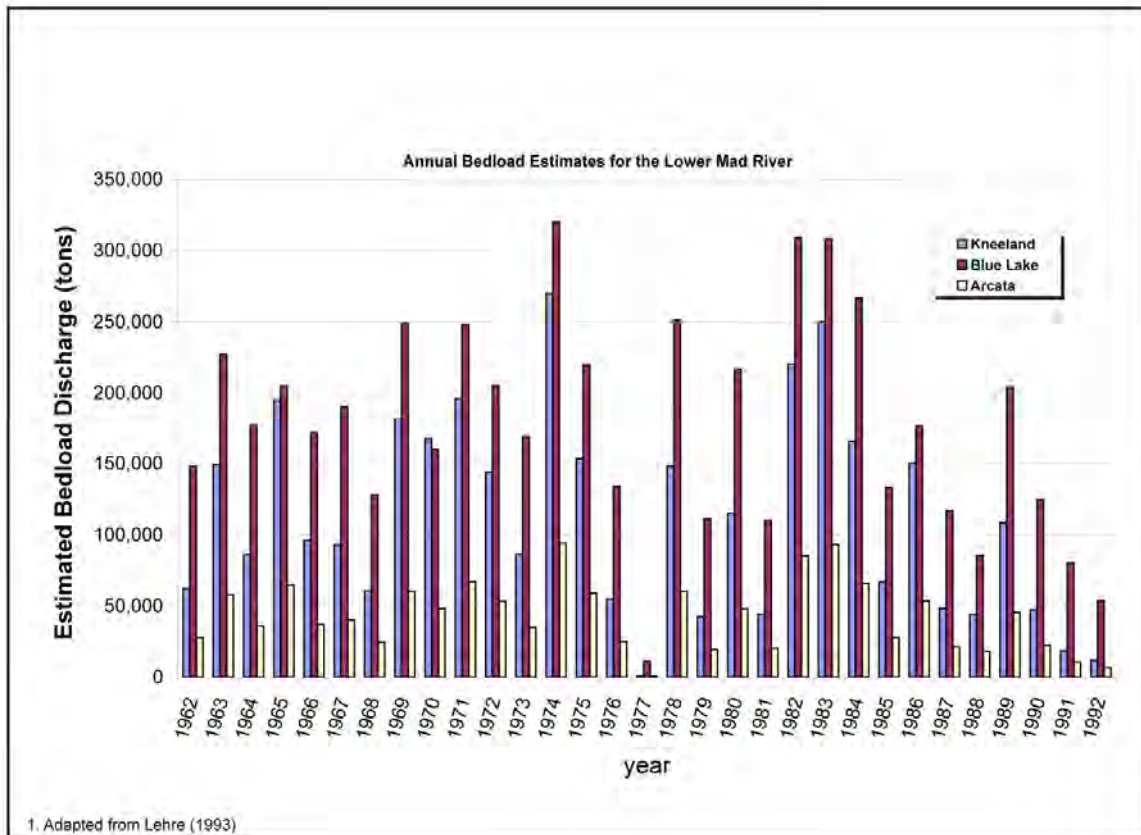
1. Adapted from Lehre (1993)
Figure 4. Annual bedload estimates for the lower Mad River.

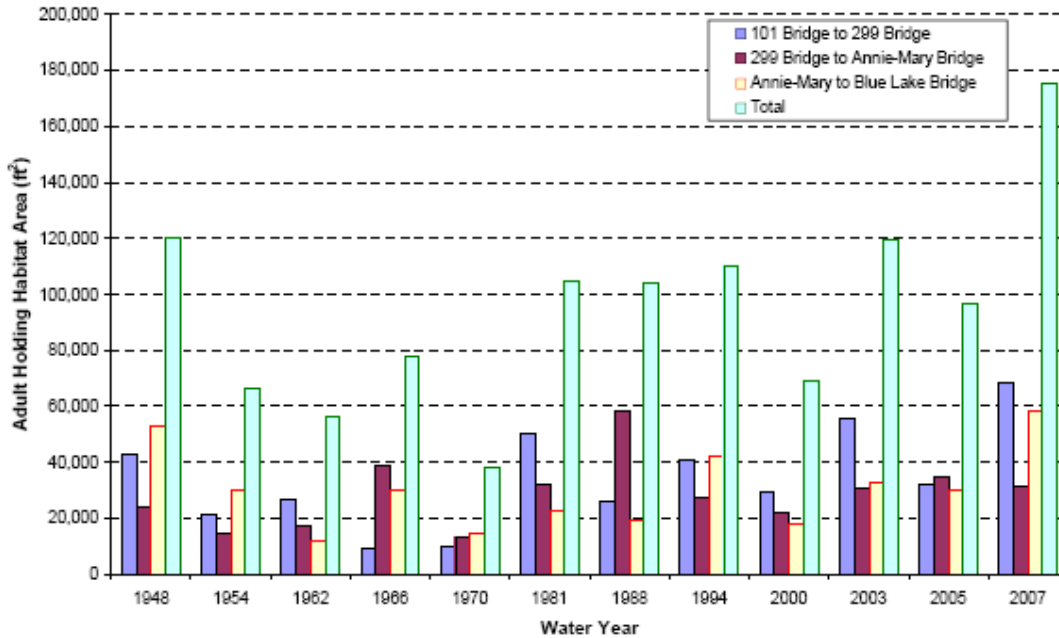
Figure 9. Adult salmon and steelhead holding habitat (ft²) in the lower Mad River from 1948 to 2007 (Trush 2008a).

Trush (2008a) conducted an analysis of instream salmonid habitat quantity from 11 sets of aerial photographs that spanned the years 1948 to 2007. Trush (2008a) analyzed changes to adult salmon and steelhead holding, juvenile coho salmon, Age 2+ steelhead, and spawning habitat within a reach extending from the mouth of the North Fork Mad River down to the Highway 101 Bridge. Trush (2008a) determined that instream habitat quantity decreased from the 1948 baseline during the 1950's through the early 1970s and then improved to, or close to, baseline levels in later years (Figures 9–11).

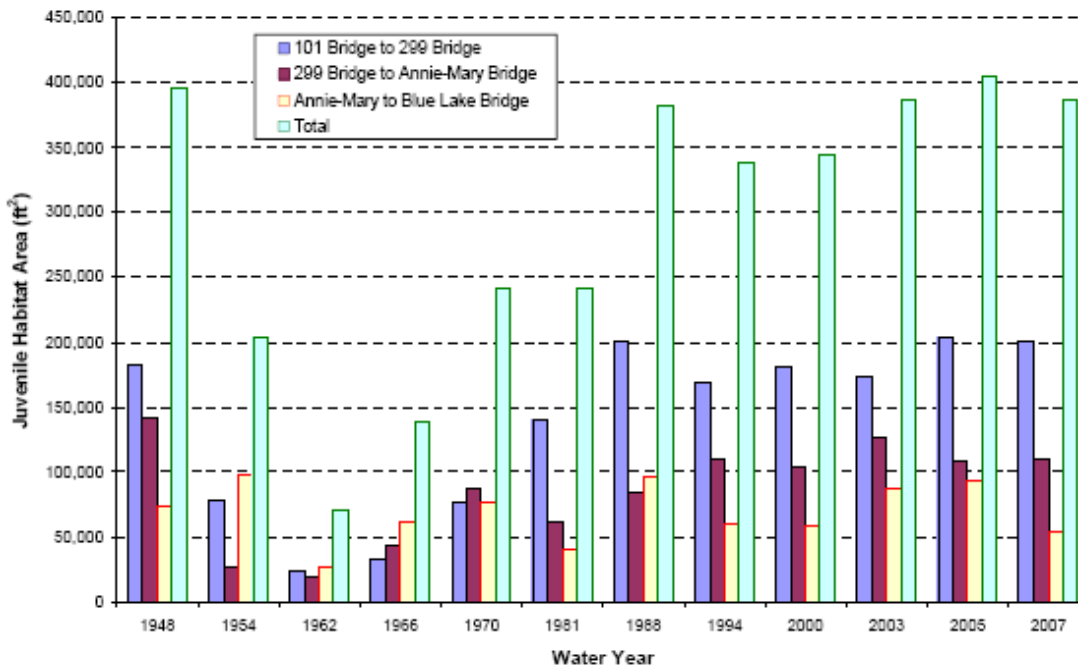
Figure 10. Juvenile Age 1+ coho salmon rearing habitat (ft²) in the lower Mad River from 1948 to 2007 (Trush 2008a).

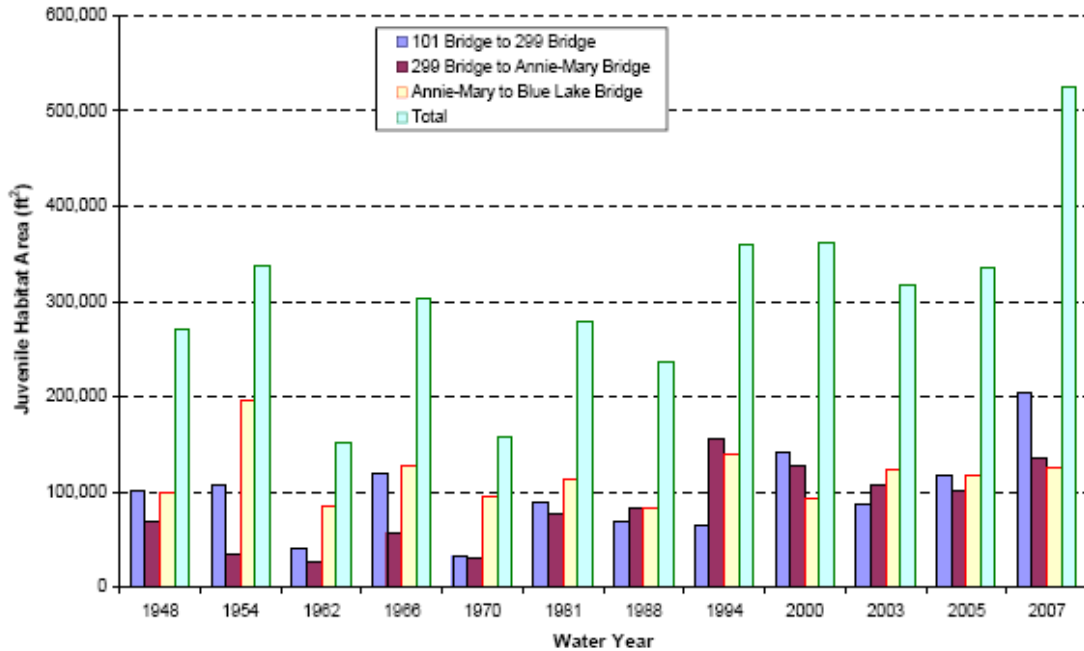
Figure 11. Juvenile Age 2+ steelhead rearing habitat (ft²) in the lower Mad River from 1948 to 2007 (Trush 2008a).

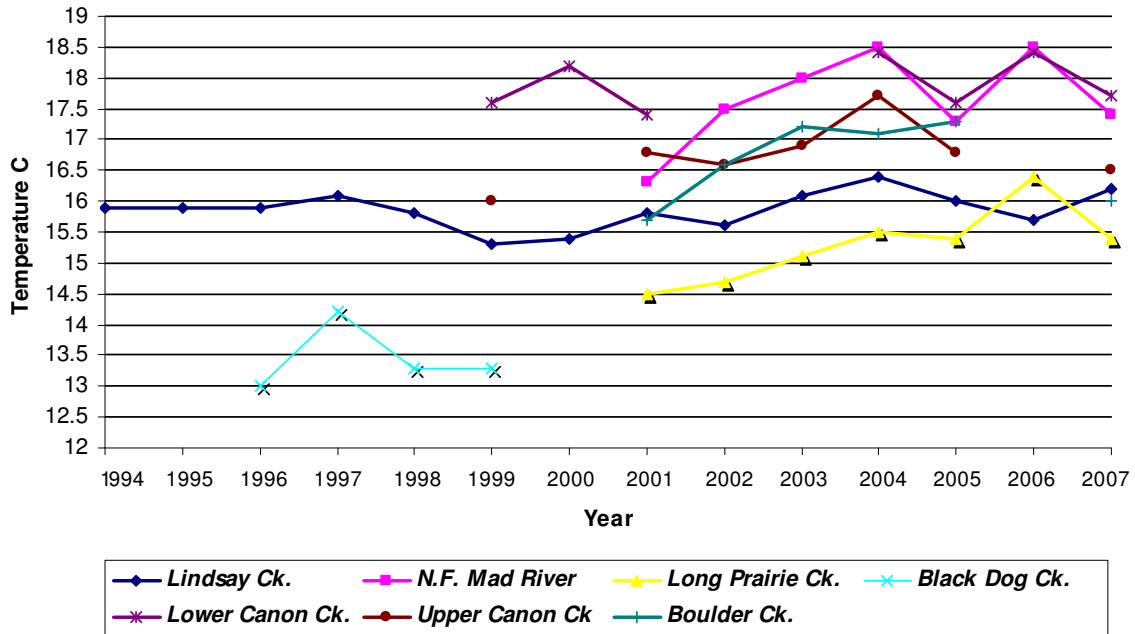
Figure 12. Maximum weekly average temperatures for selected streams within the Mad River basin.

Due to the difficulty in determining a stressful temperature threshold, this watershed analysis will use the 16°C mark as the stressful threshold for coho salmon and 18 degrees for steelhead. During most years, based on these somewhat arbitrary targets, Sullivan Gulch (Table 6-13), Long Prairie Creek, and Lindsay Creek are below stressful limits for coho salmon. Nearly all the creeks are below the stressful threshold for steelhead. The mainstem Mad River consistently exceeds stressful temperatures for both coho salmon and steelhead (Table 5-20).

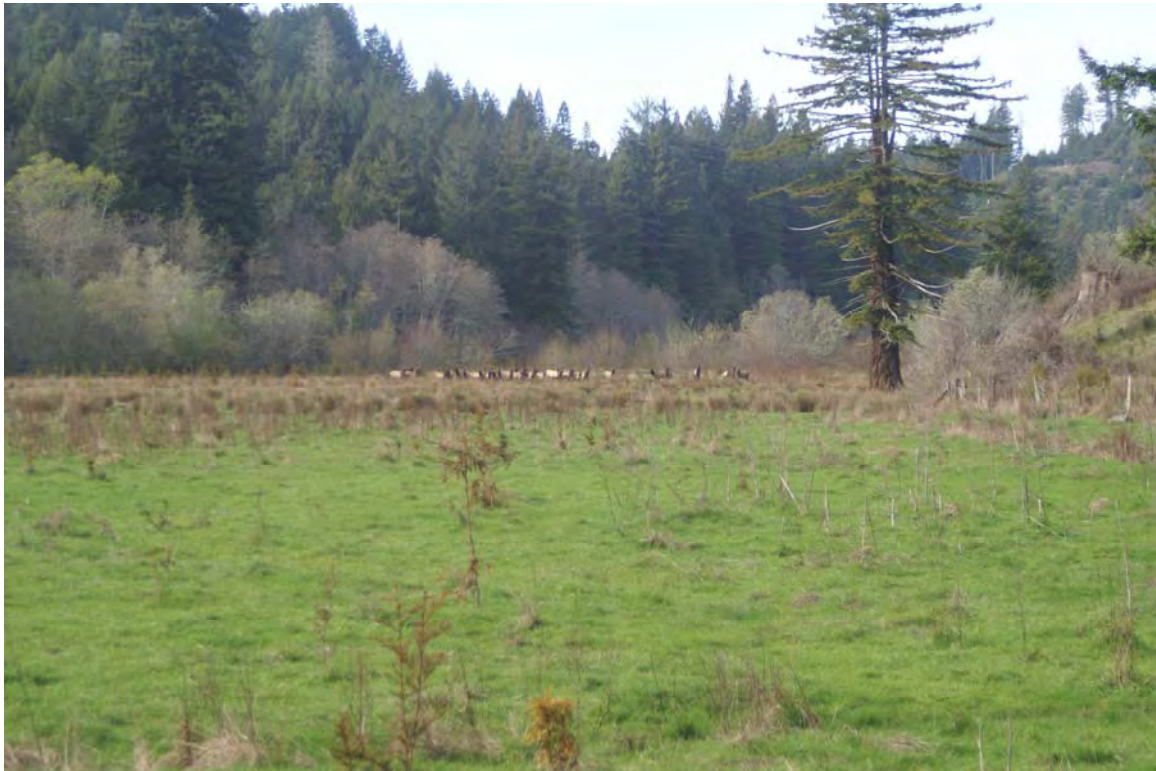
For a variety of reasons described elsewhere in this document, Hall and, especially, Mill Creeks have slowly aggraded causing drainage problems in the lower portions of their valleys. Significant changes have also occurred in Noisy Creek where, according to anecdotal evidence, six-foot deep pools existed through the 1970s.

Hall Creek Valley March 2007

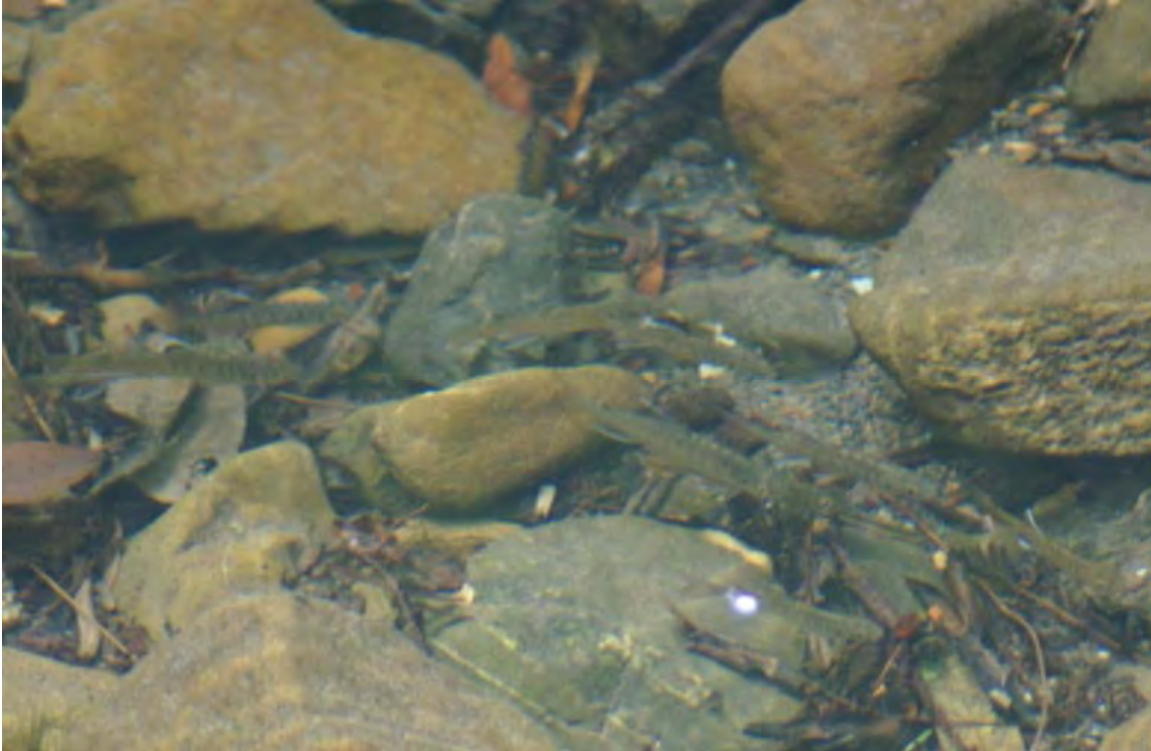
fish at a time spawning in Hall Creek as late as the mid 1990s. The property owners report having seen dozens of salmon spawning in Noisy Creek over a period of several hours in 2002. The property owners also report seeing juvenile salmon in both Hall and Noisy Creeks within the property in the spring and summer of 2007.

Juvenile Salmon in Hall Creek Spring 2007
