Penalty Calculation Methodology

D. Violation 1: Failure to Prohibit the Discharge of 1.121 Million Gallons of Untreated Sewage to Waters of the U.S from the Buena Vista Lift Station.

F. Violation 2: Failure to Prohibit the Discharge of 820,000 Gallons of Untreated Sewage to Waters of the U.S from the San Luis Rey Water Reclamation Facility.

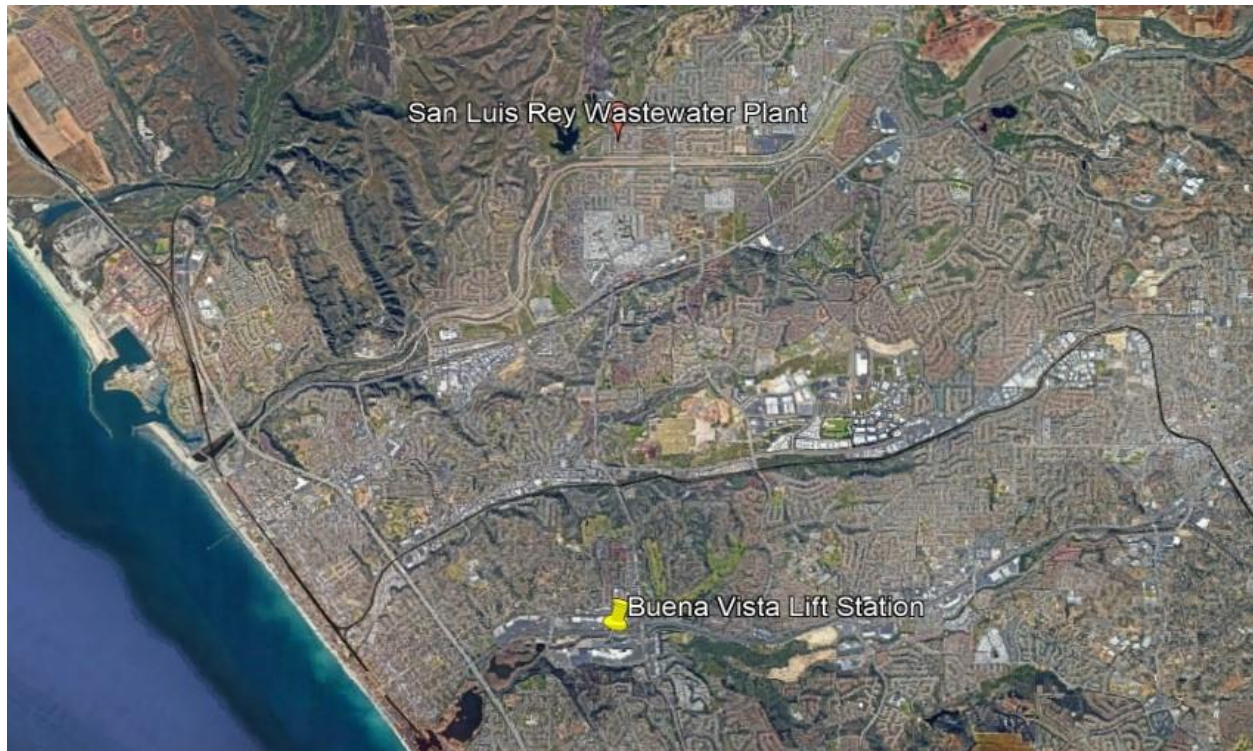
Figure 1. SSO Locations

Hydraulic overloading also overwhelmed the SLRWRF resulting in a discharge of 820,000 gallons of raw sewage to Windmill and Pilgrim Creek on April 10, 2020 (see Figure 1). Hydraulic overloading occurs when the incoming wastewater flow rate exceeds the system's designed flow rate. When this happens, the system can't treat the wastewater effectively.

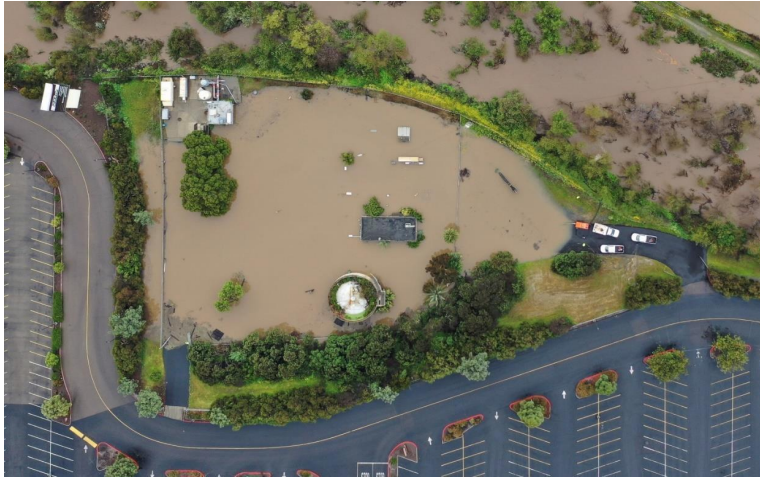
Figure 3. Buena Vista Lift Station April 10, 2020.

The April 10, 2020 rain event caused catastrophic flooding in the area of the Buena Vista Creek watershed. Flooding in the Creek closed all eastbound and westbound lanes on California State Route 78 at the El Camino Real overpass. At the time Buena Vista Creek was flooding, storm water overtopped the berm surrounding the facility and began filling in the BVLS (see Figures 2 & 3). When the creek breached the berm, stormwater flooded the dry well and shorted out the pumps, rendering the lift station inoperable.

Due to the road closures during the flood, collections staff arrived on site at 10:30 am on April 10 and at this point, the station was nearly underwater. It was difficult to access the station and assess the damage due to multiple road closures.

In response to the flooding of the lift station, the City attempted to conduct bypass operations. The bypass to Encina Wastewater Treatment plant was finally established on April 11, 2020 at 4:15 pm, under an existing contract for portable pumping equipment, pipes, hoses and 24-hour staffing to operate the pumps. The delay pumping out the facility and instituting the bypass resulted in a spill of 1,121,000 gallons of sewage.

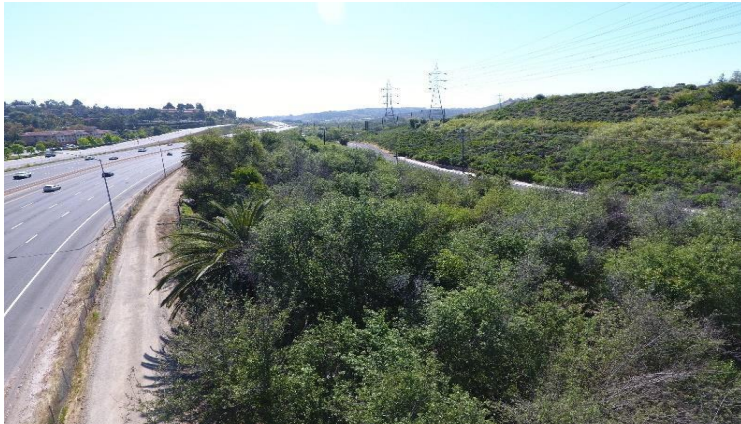
Figure 4. Dense vegetation within Buena Vista Creek, upstream of Buena Vista Lagoon

The City contends in its response to the Investigative Order that if the dense perennial vegetation (see Figure 4) and associated sediment build up in Buena Vista Creek had been maintained to promote adequate flow, the Creek would not have overtopped and the resulting SSO could have been avoided. The City does not have jurisdiction over maintenance activities within Buena Vista Creek. Buena Vista Creek is managed by the City of Carlsbad through the Buena Vista Creek Channel Maintenance District. The City of Carlsbad currently maintains 11.2 acres of Buena Vista Creek from Jefferson Street bridge east, to the South Vista Way bridge.

The permits² issued by some of the resource agencies (i.e. CA Department of Fish and Wildlife, CA Coastal Commission) have restrictions on the amount of creek clearing that is allowed each year; they also specifically prohibit dredging sediment buildup in the creek bed. Vegetation removal is only allowed using hand tools.
