**GROUNDWATER ELEVATION MEASUREMENT LOCATIONS**

CHEVRON STATION No. 9-1870  
28900 Rancho California Road  
Temecula, California

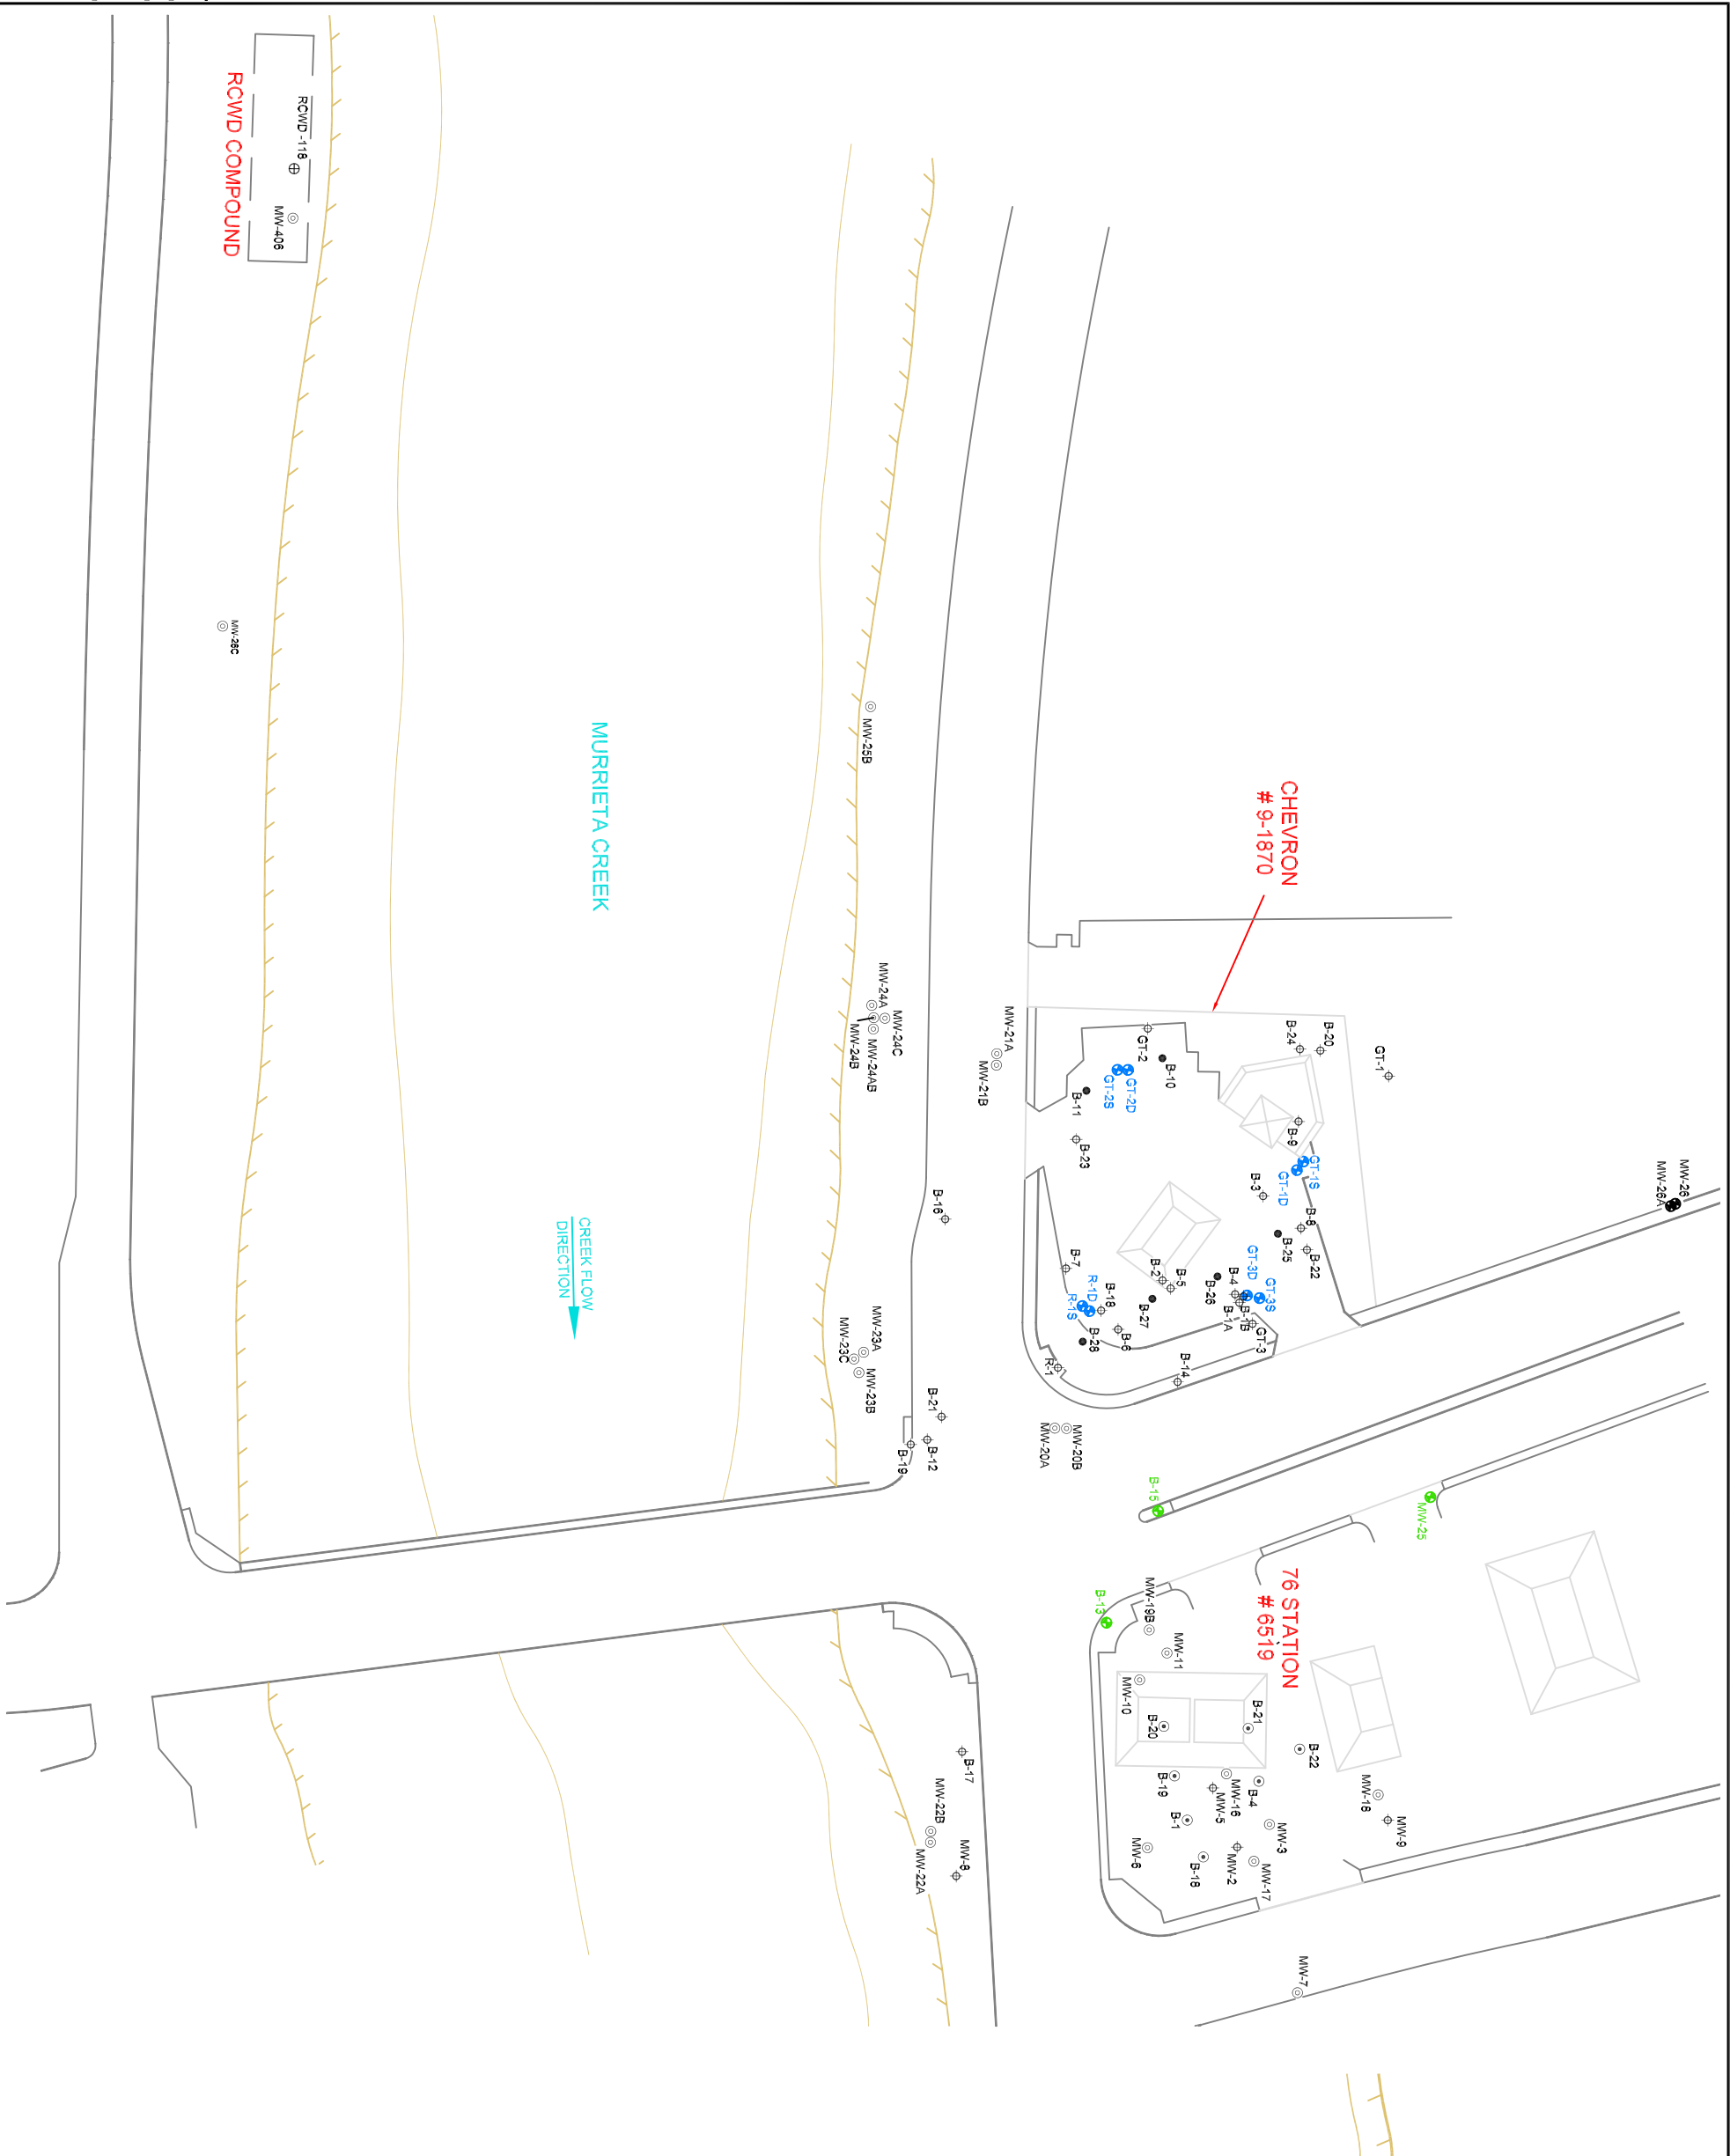
Figure By	Project No.	Figure
	MJJ	8468	
Date			
12/09/02			<b>2</b>

DATA COLLECTED FROM 10/16/02 THROUGH 10/28/02
