**Section A.13**

**City of Laguna Beach  
Heisler Park Area of Special Biological Significance  
Compliance Plan**

### A.13.2 Heisler Park Area of Special Biological Significance Drainage Area

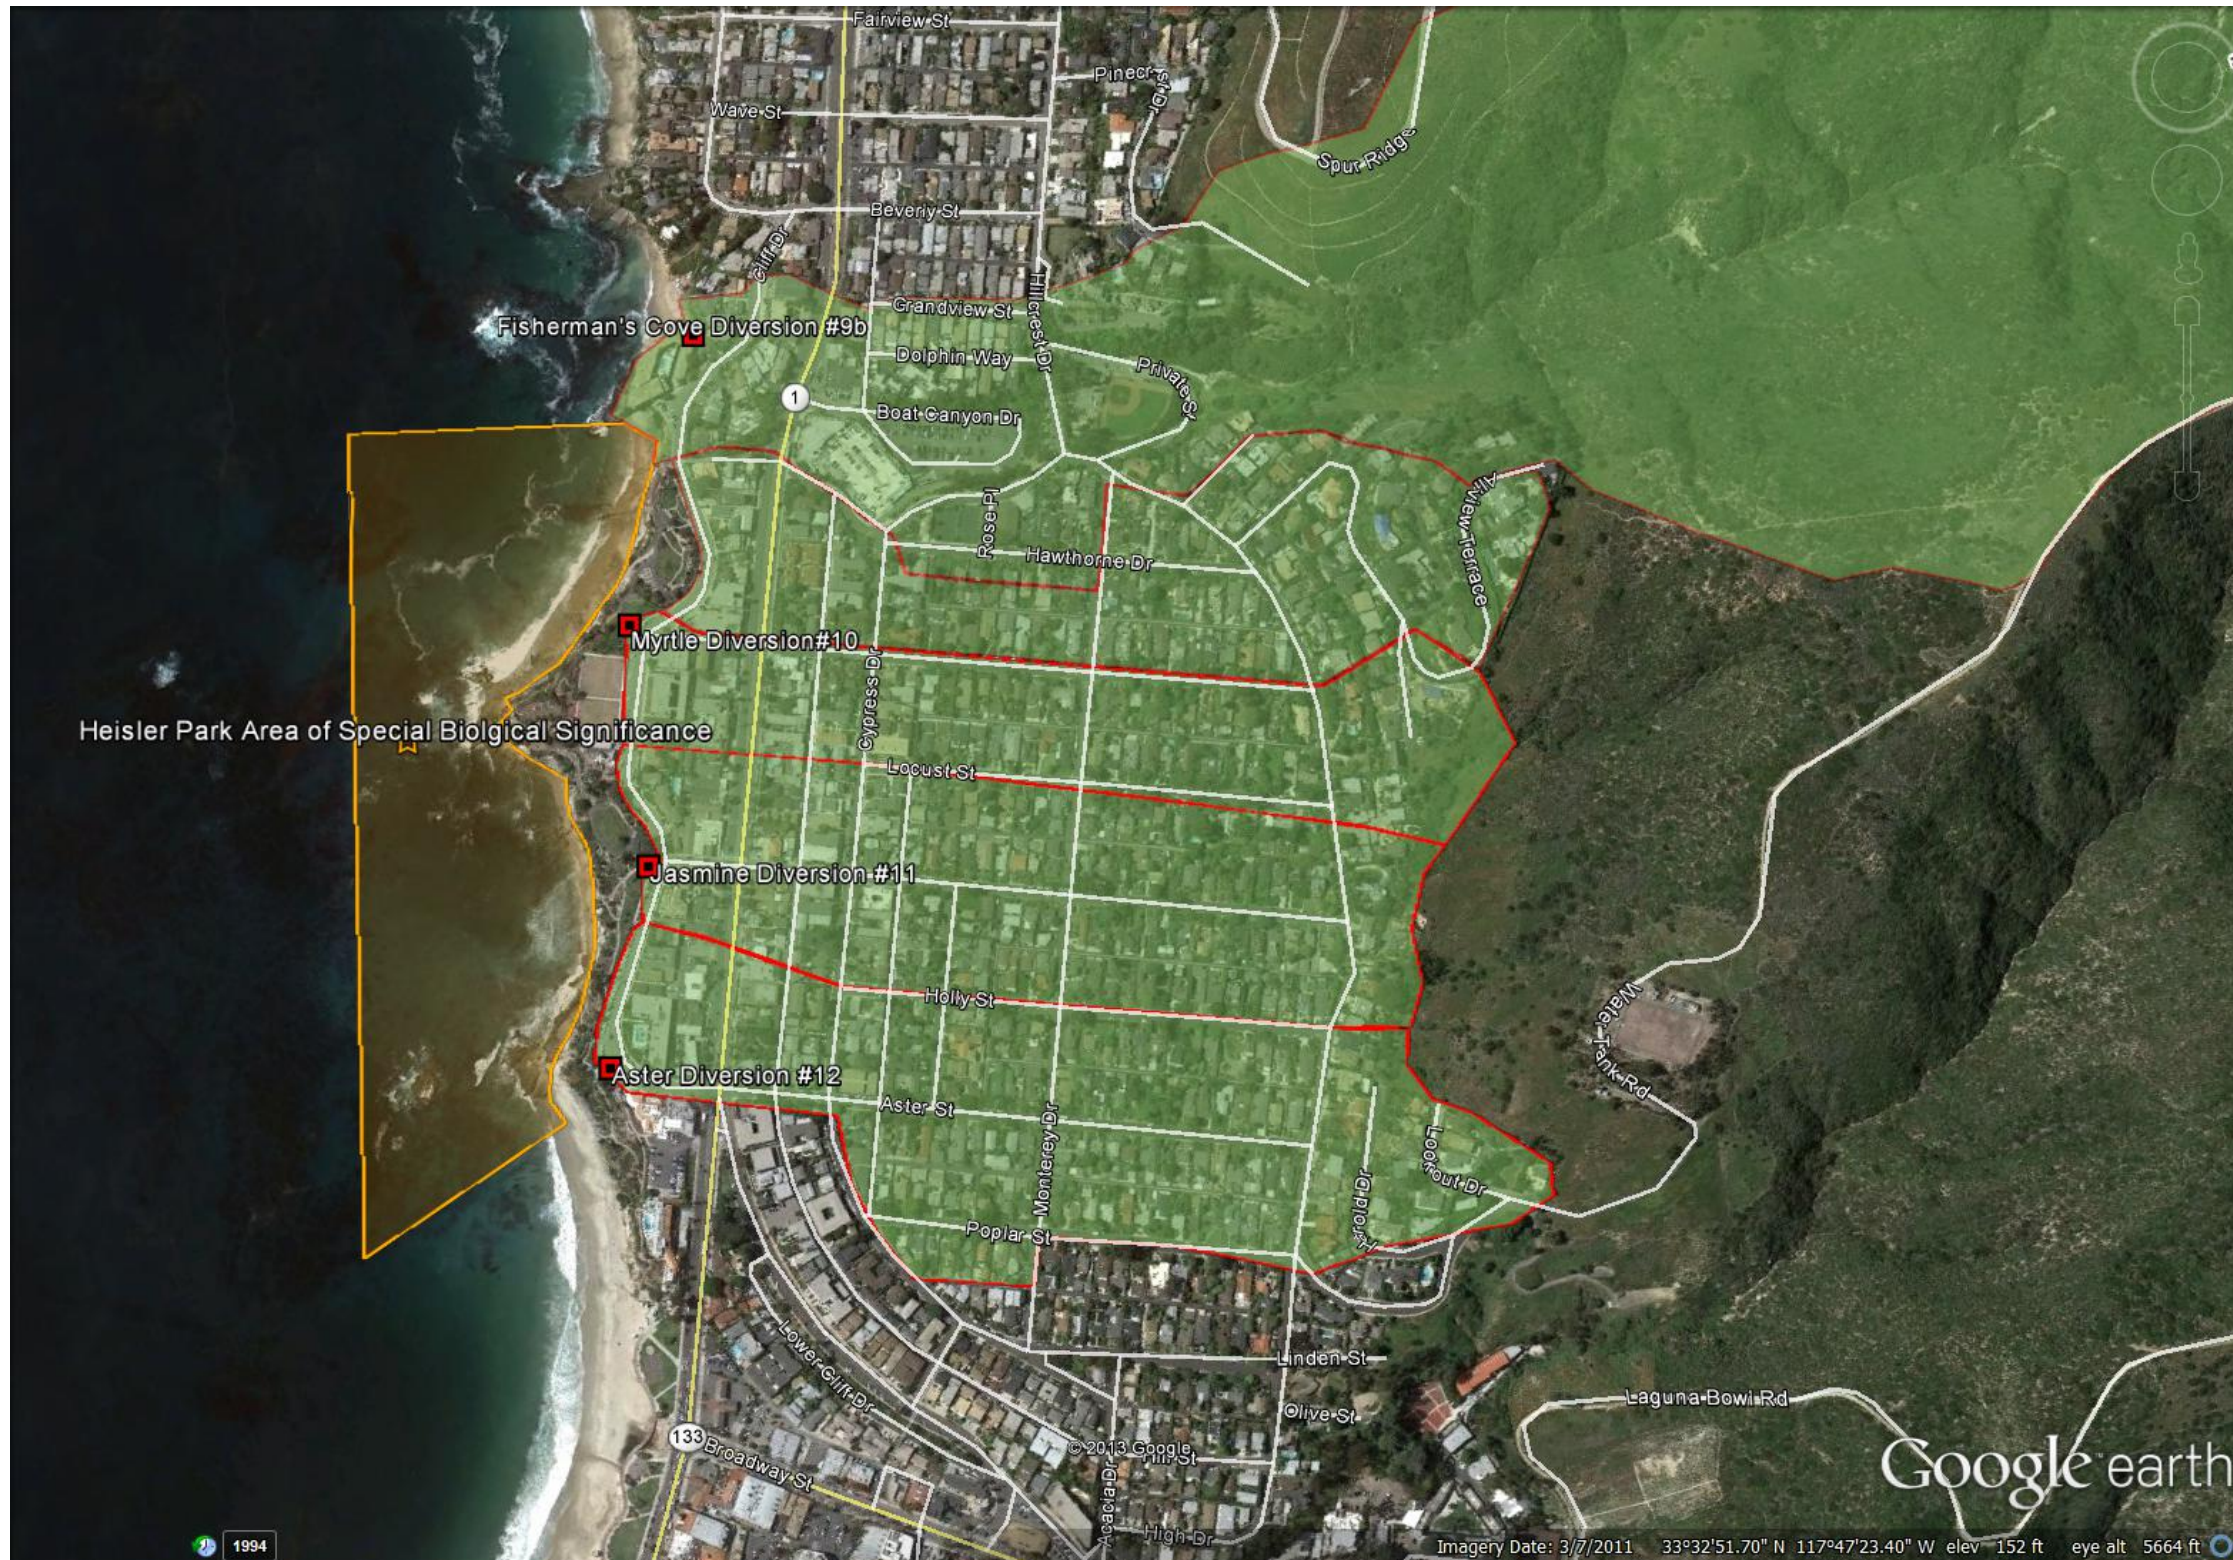
Map 1 - Heisler Park Area of Special Biological Significance and Associated Watershed

- Shaded green area indicates area that drains into nuisance water diversion unit.
- Red squares indicate nuisance water diversion units.
- Orange highlight area is the full extent of the Heisler Park ASBS.
- Heisler Park ASBS drainage area is mainly residential with several restaurants, hotels and light commercial business.

- As shown on the map in section A.13.2, there are four nuisance water diversion units that divert all non-authorized, non-storm water runoff away from the Heisler Park ASBS and into the sanitary sewer system. The three main diversion units located at Aster, Jasmine and Myrtle streets are continuous deflection separators (CDS Units) which remove trash, sediment and other small debris year round. The units are fully automated as of January 2013 allowing for year round operation of the units and the diversion of small storm events to the sanitary sewer. The 4<sup>th</sup> diversion simply diverts non-storm water. Within Heisler Park there are four small sump pumps that collect water from the Park's storm drain system. This water is pumped up to the CDS units for removal of trash and diversion to the sanitary sewer. Storm drain diversions are likely the single most effective method of keeping polluted water from entering the ocean.

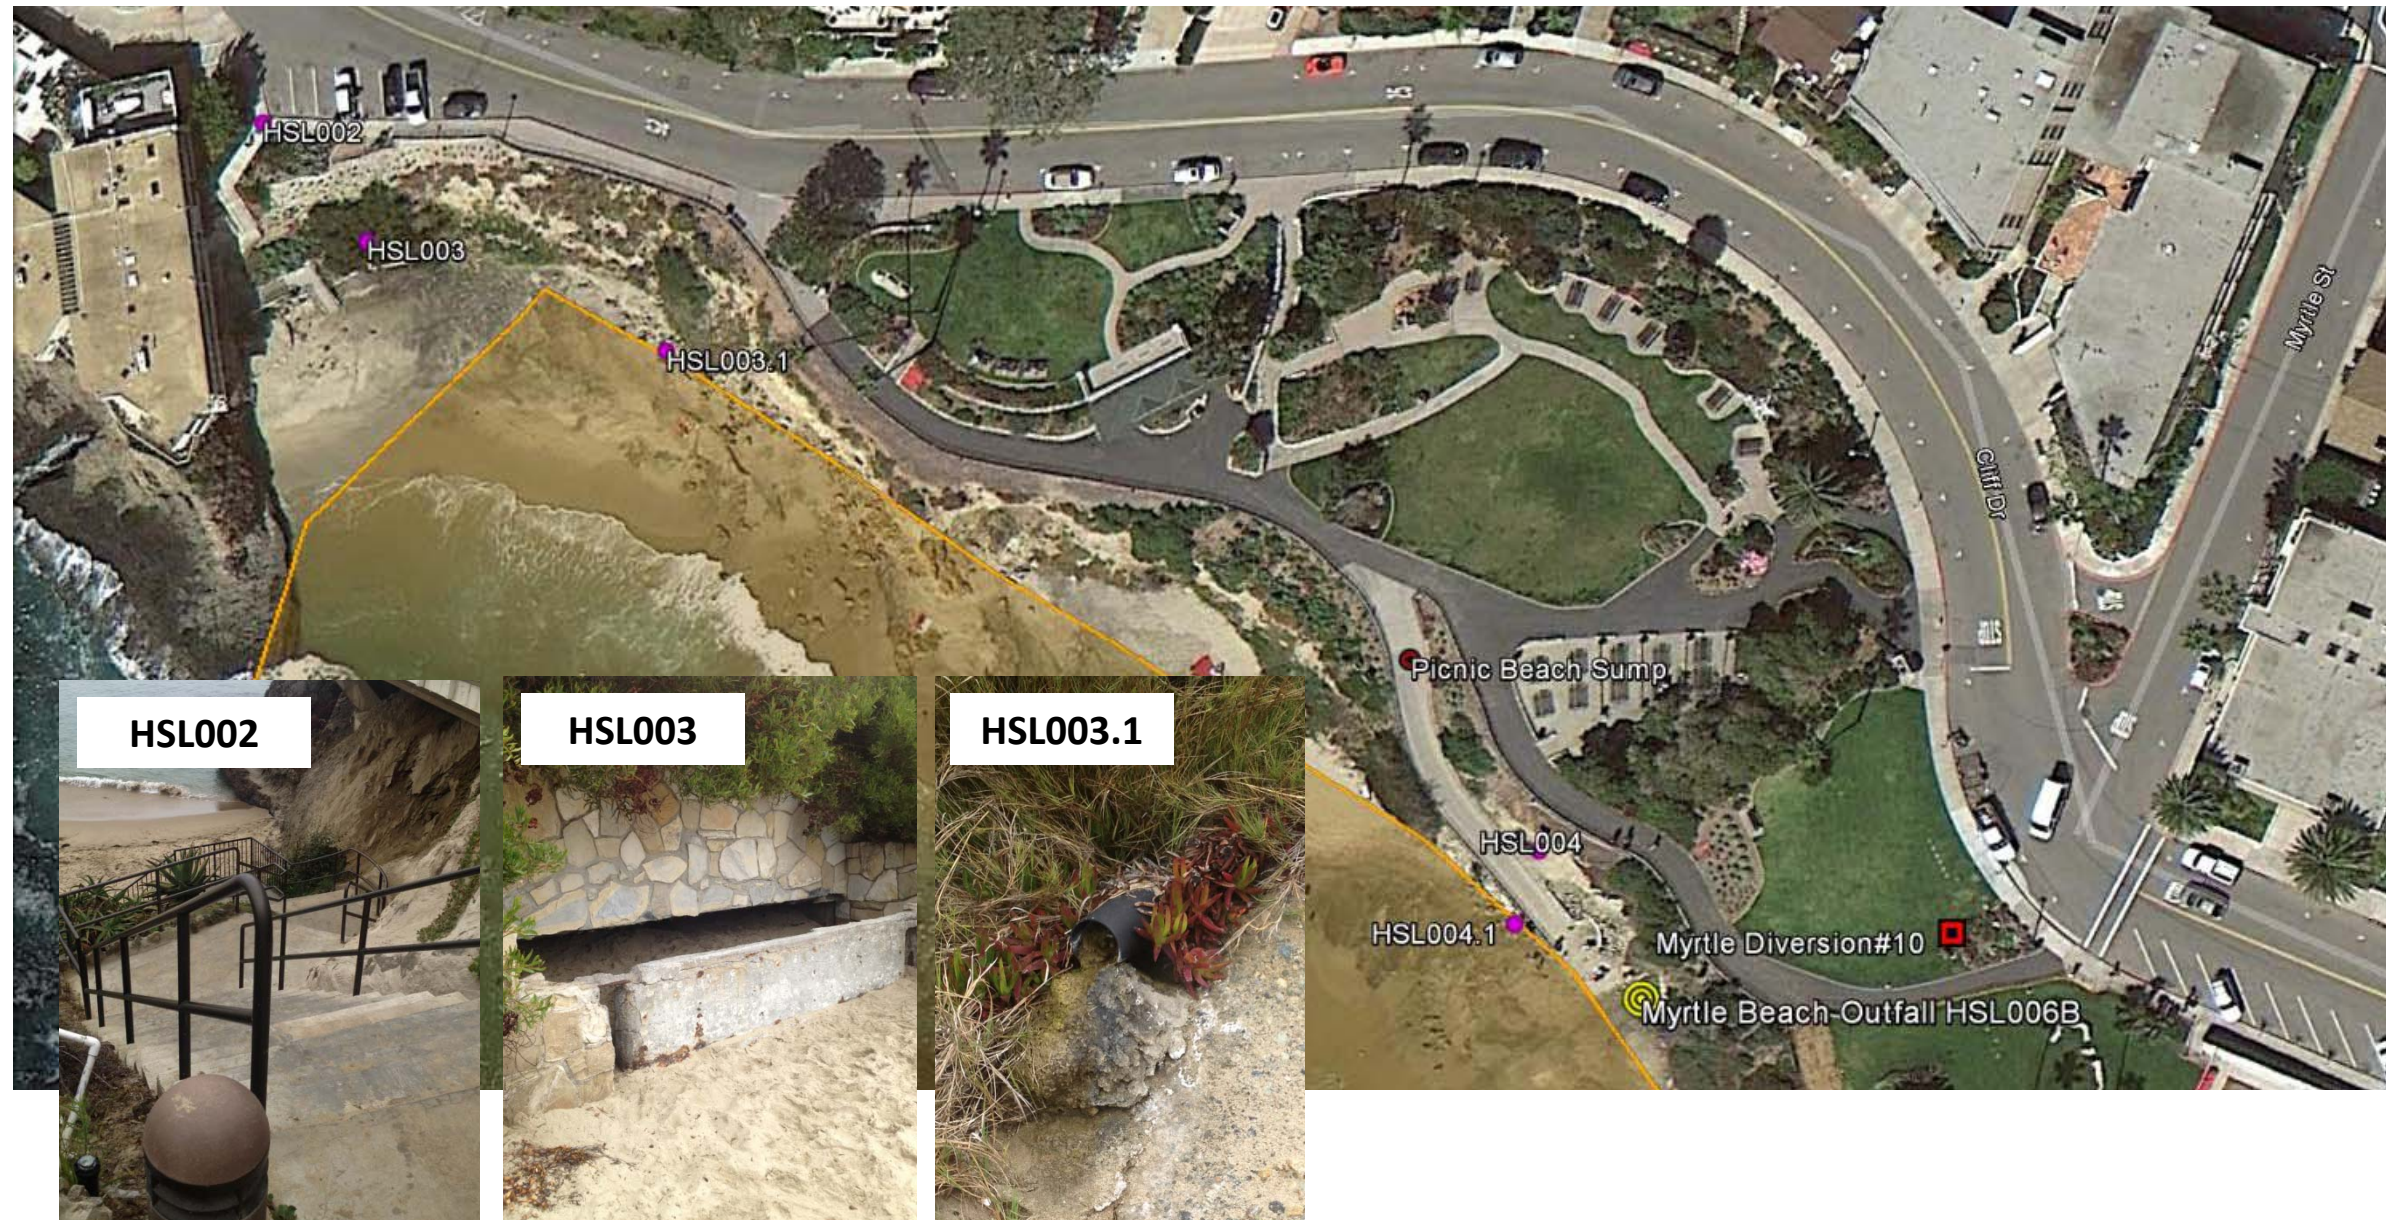
Map 2 - North Heisler Park ASBS Drainage/Diversion Summary

SampleID	SourceCode	SourceType	Longitude	Latitude	Beach Name	Type	Material	Flow	Location	Upstream Source	Shape	Width	Discharges Onto
HSL002	non-point	discharge	-117.79477	33.545152	Divers cove	Non-porous	concrete	When raining	On beach	urban watershed	Rectangular	-99.00	sand
HSL003	municipal/industrial storm drain	discharge	-117.79465	33.545033	Divers cove	non-porous	concrete	When raining	On beach	urban watershed	Rectangular	72-inch	sand
HSL003.1	small storm drains	discharge	-117.79428	33.544915	Divers cove	non-porous	pvc	When raining	On beach	urban watershed	round	4-inch	sand
HSL004	small storm drains	discharge	-117.79327	33.544418	Picnic Beach	non-porous	pvc	When raining	In bluff	urban watershed	round	4-inch	sand
HSL004.1	small storm drains	discharge	-117.79329	33.544348	Picnic Beach	non-porous	pvc	When raining	In bluff	urban watershed	round	12-inch	sand
HSL006B	Heisler ASBS, 18 inch	Storm Drain	-117.79315	33.544274	Picnic Beach	non-porous	pvc	intermittent	In bluff	urban watershed	round	18-inch	sand

Picnic Beach Sump Pump	In park drainage, pumped to CDS	sump pump	-117.79341	33.544604

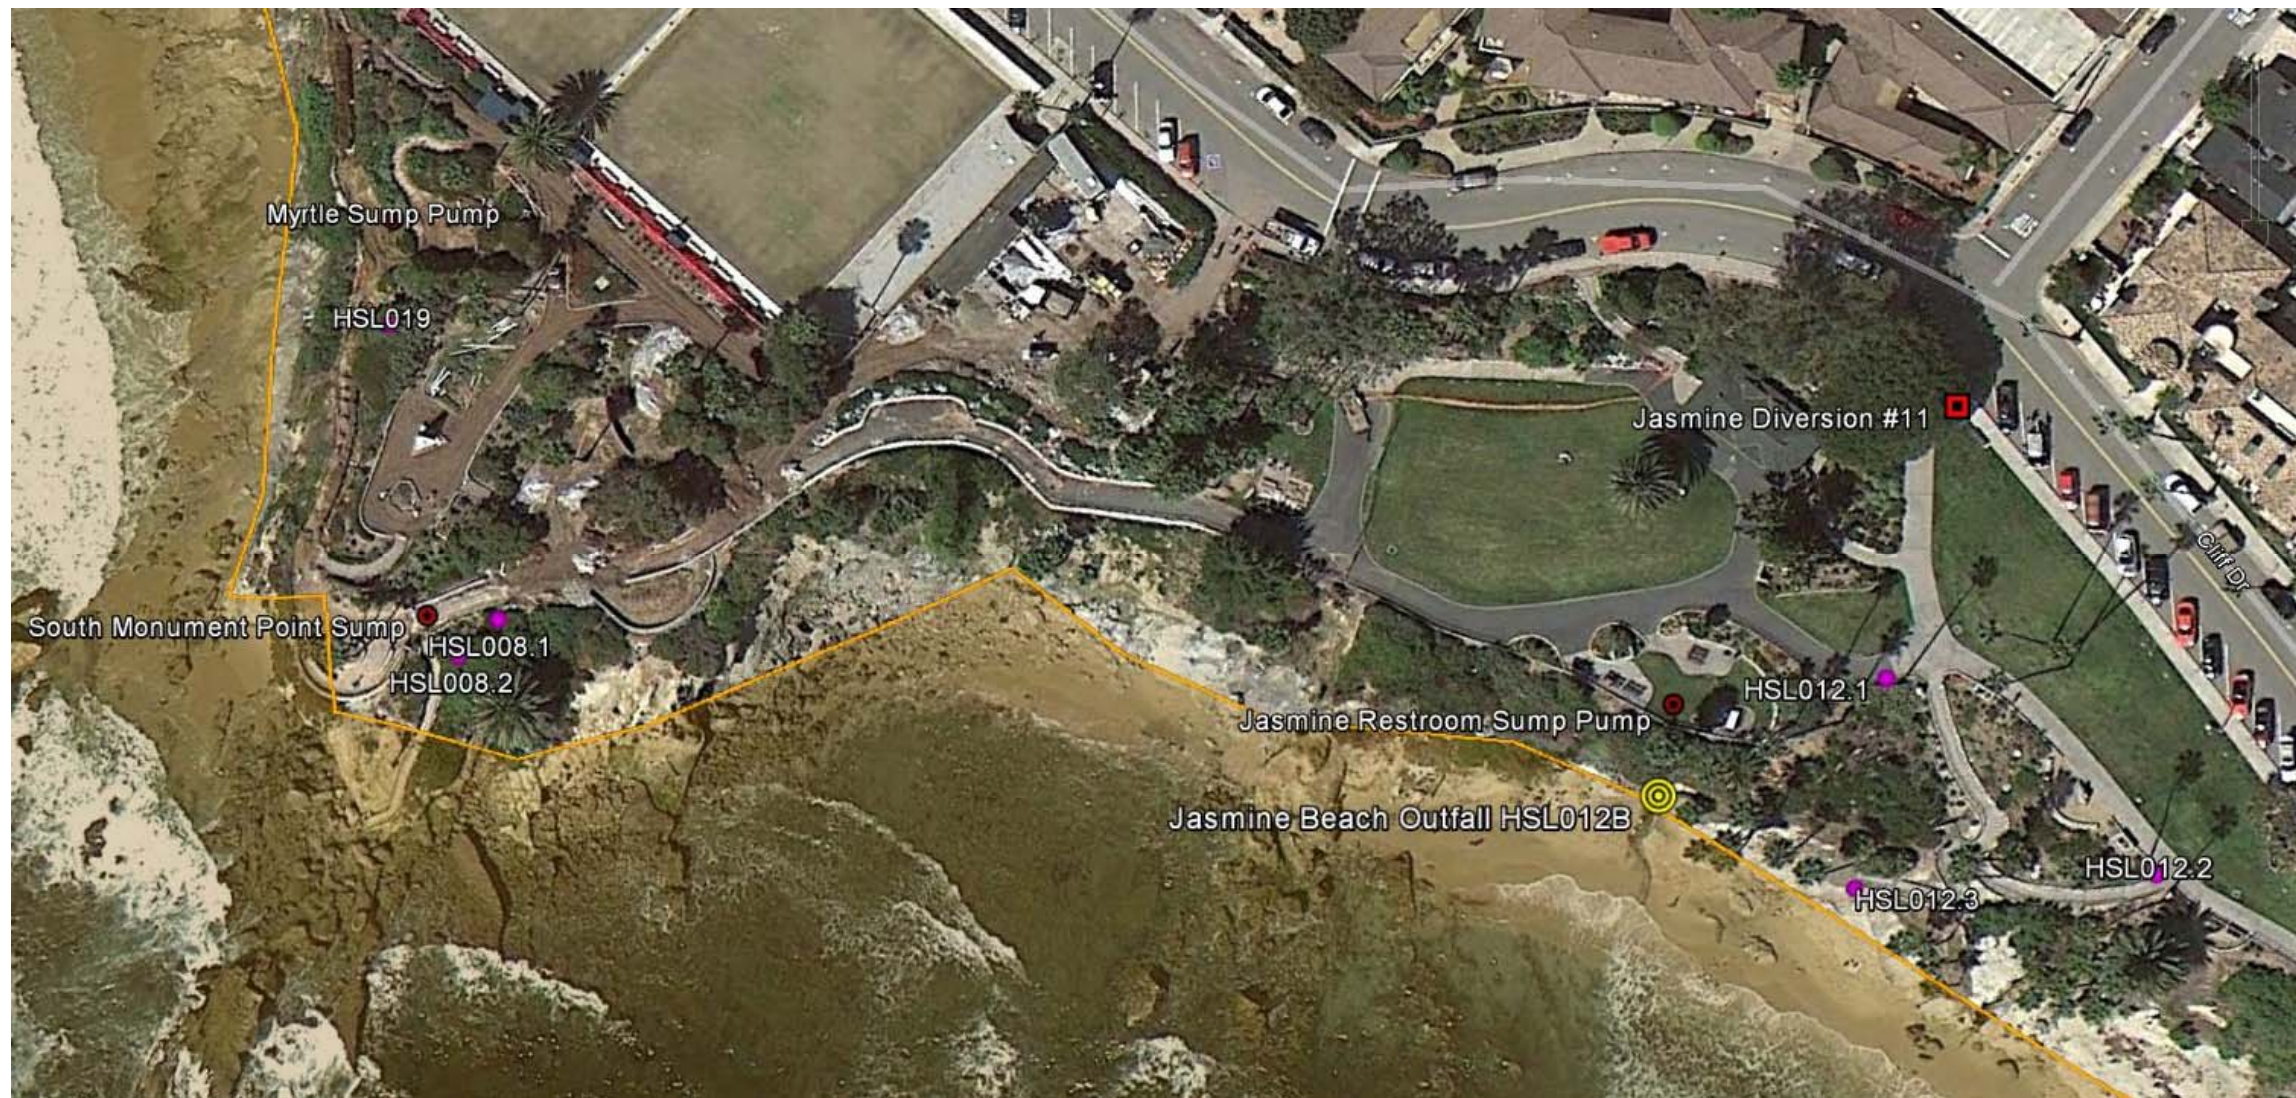
Map 3 – Central Heisler Park ASBS Drainage/Diversion Summary

SampleID	Source Code	Source Type	Longitude	Latitude	Beach Name	Type	Material	Flow	Location	Upstream Source	Shape	Width	Discharges Onto
HSL008.1	Small storm drain	discharge	-117.792288	33.543256	Rock Pile Beach	non-porous	PVC	When raining	In bluff	urban watershed	round	6-inch	bluff
HSL008.2	Small storm drain	discharge	-117.79222	33.543195	Rock Pile Beach	non-porous	PVC	When raining	In bluff	urban watershed	round	6-inch	bluff
HSL012B	Jasmine Heisler ASBS 18-inch	storm drain	-117.790762	33.543436	Rock Pile Beach	non-porous	PVC	Intermittent	In bluff	urban watershed	round	18-inch	sand
HSL012.1	Non-point	discharge	-117.790556	33.543611	Rock Pile Beach	non-porous	Concrete	When raining	Sidewalk/Ramp	urban watershed	rectangular	-99.00	sand
HSL012.2	Non-point	discharge	-117.790191	33.543505	Rock Pile Beach	non-porous	Concrete	When raining	Sidewalk/Ramp	urban watershed	rectangular	-99.00	sand
HSL012.3	Small storm drain	discharge	-117.790506	33.543409	Rock Pile Beach	non-porous	PVC	Intermittent	Bottom of ramp	groundwater	round	4-inch	sand

HSL019	Municipal/Industrial storm drain	discharge	-117.79245	33.5435	Divers cove	non-porous	Metal	When raining	In bluff	unknown	round	4-inch	bluff
Jasmine Restroom Sump	In park drainage, pumped to CDS	sump pump	-117.790782	33.543528									
South Monument Point Sump	In park drainage, pumped to CDS	sump pump	-117.792272	33.543224									
Myrtle Sump Pump	In park drainage, pumped to CDS	sump pump	-117.7925	33.543611

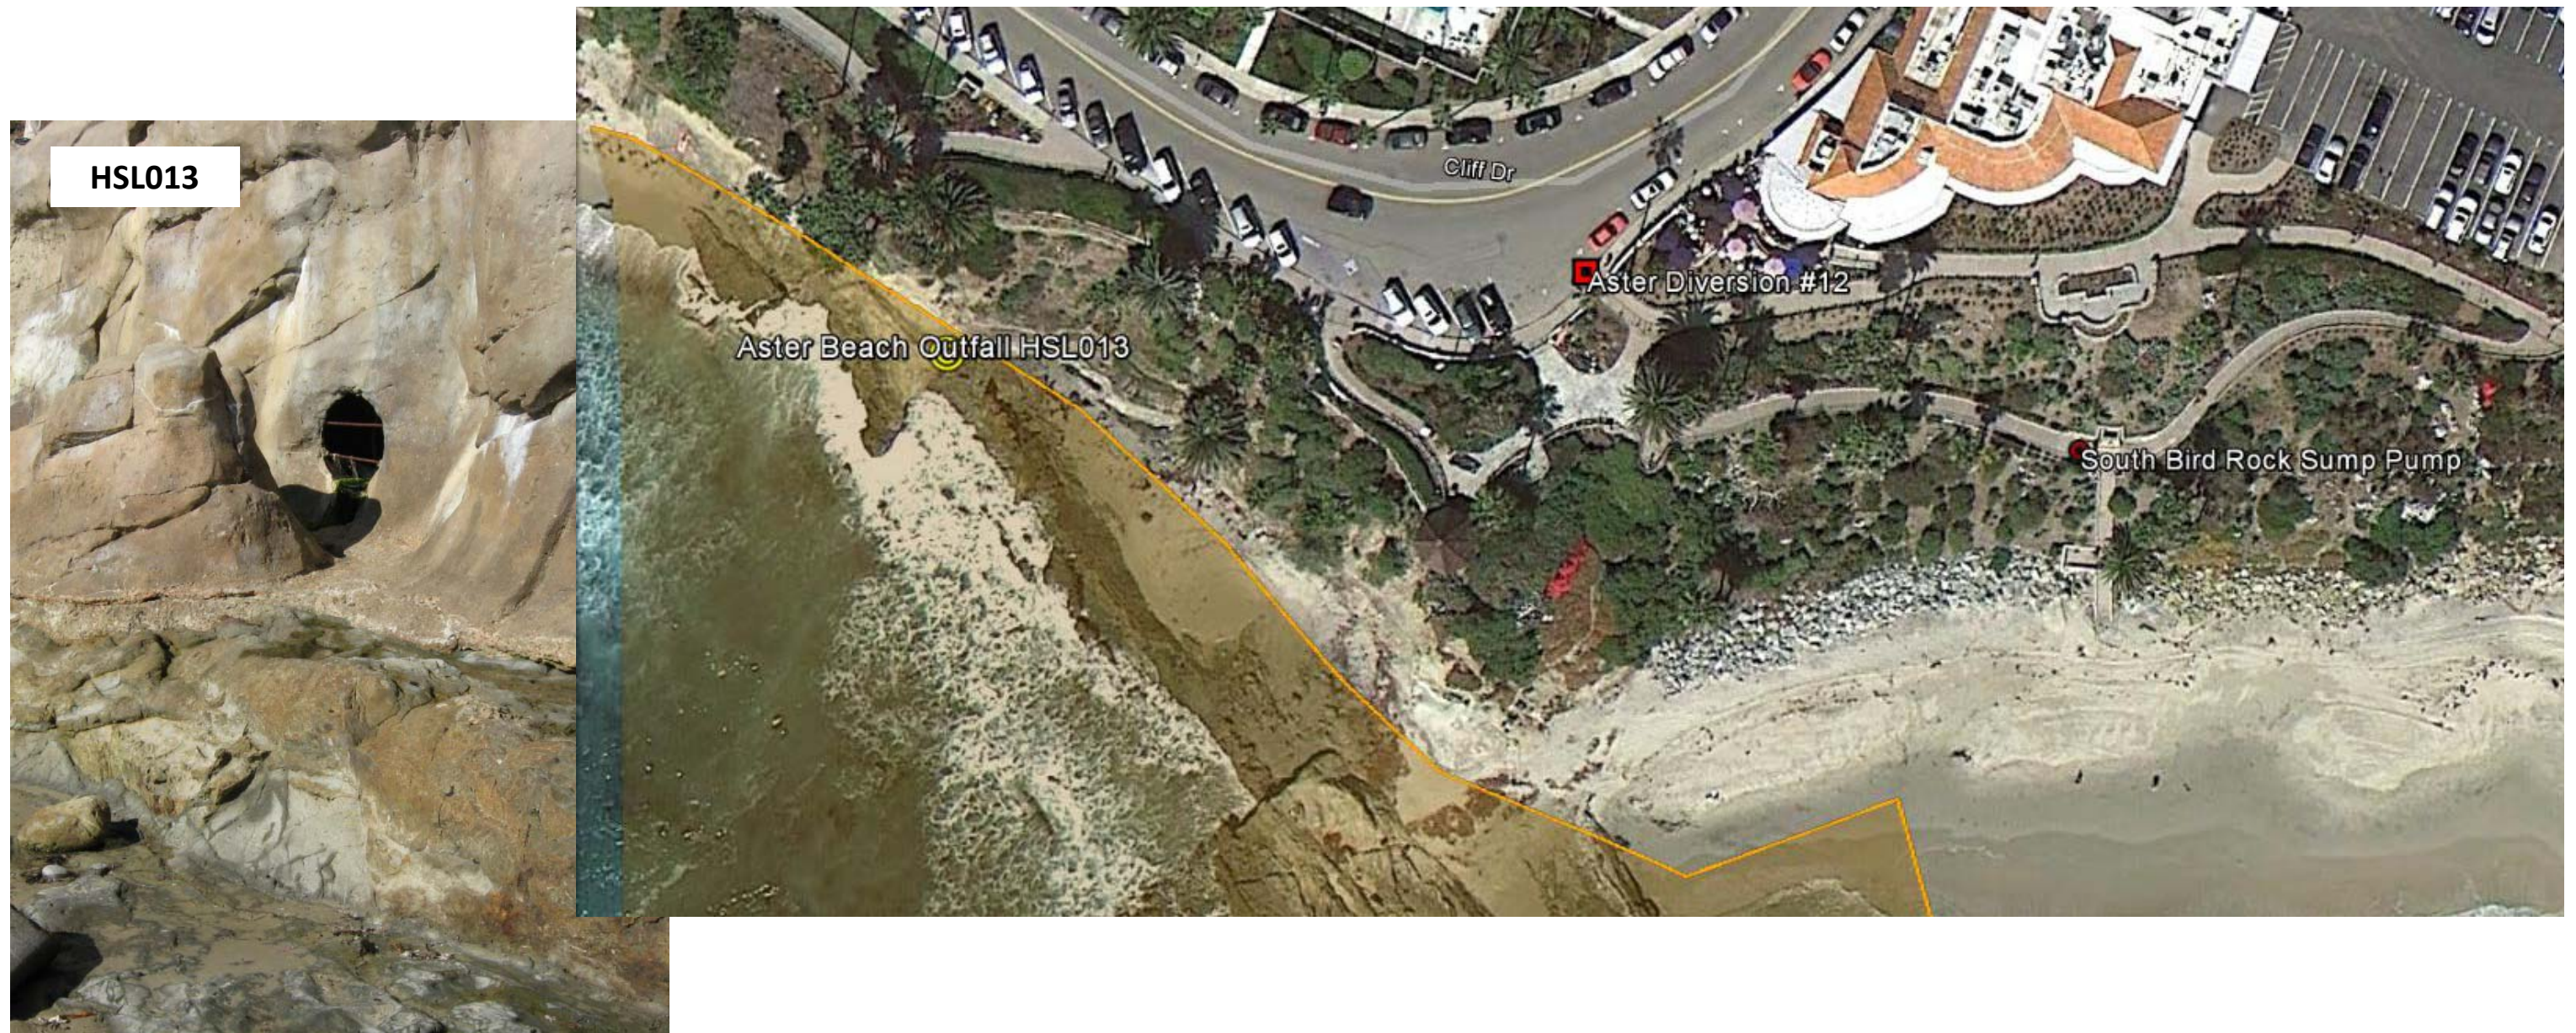
Map 4 - South Heisler Park ASBS Drainage/Diversion Summary

SampleID	Source Code	Source Type	Longitude	Latitude	Beach Name	Type	Material	Flow	Location	Upstream Source	Shape	Width	Discharges Onto
HSL013	municipal/industrial storm	discharge	-117.78965	33.54305	Bird Rock	non-porous	concrete	When raining	base of bluff	urban watershed	round	24-inch	mixed
South Bird Rock Sump Pump	In park drainage, pumped	sump pump	-117.78829	33.542946

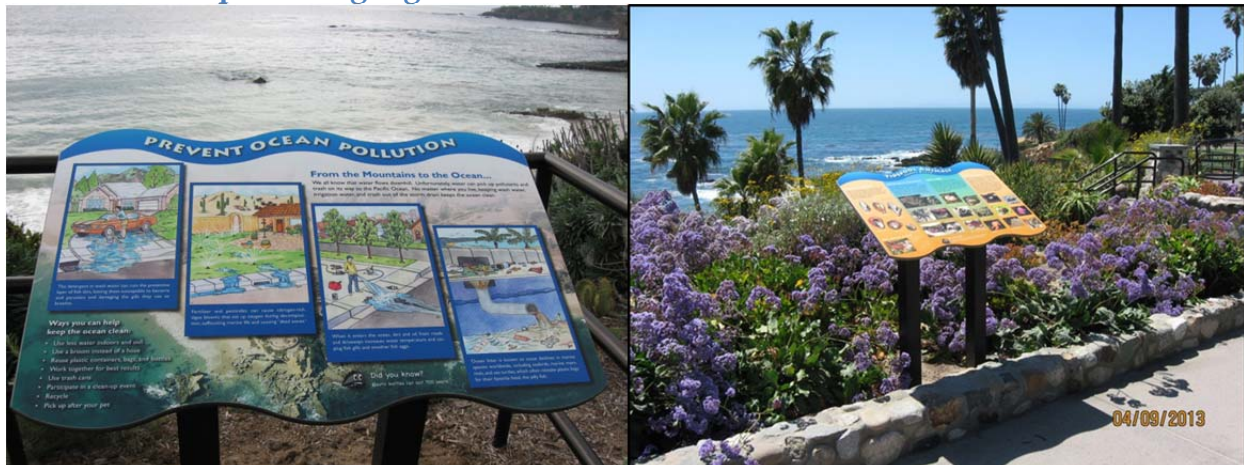
### Photos - Examples of signage located within Heisler Park.

- The City follows a robust public outreach program as outlined in Section A.6.3 of the LIP. In addition, within Heisler Park special signage has been incorporated into the park landscape regarding storm water pollution, the sensitive ASBS and best management practices for protecting the ocean. Laguna Beach also has a full time Marine Protection Officer and volunteer docents that provide education and outreach to the many visitors to Heisler Park beaches.

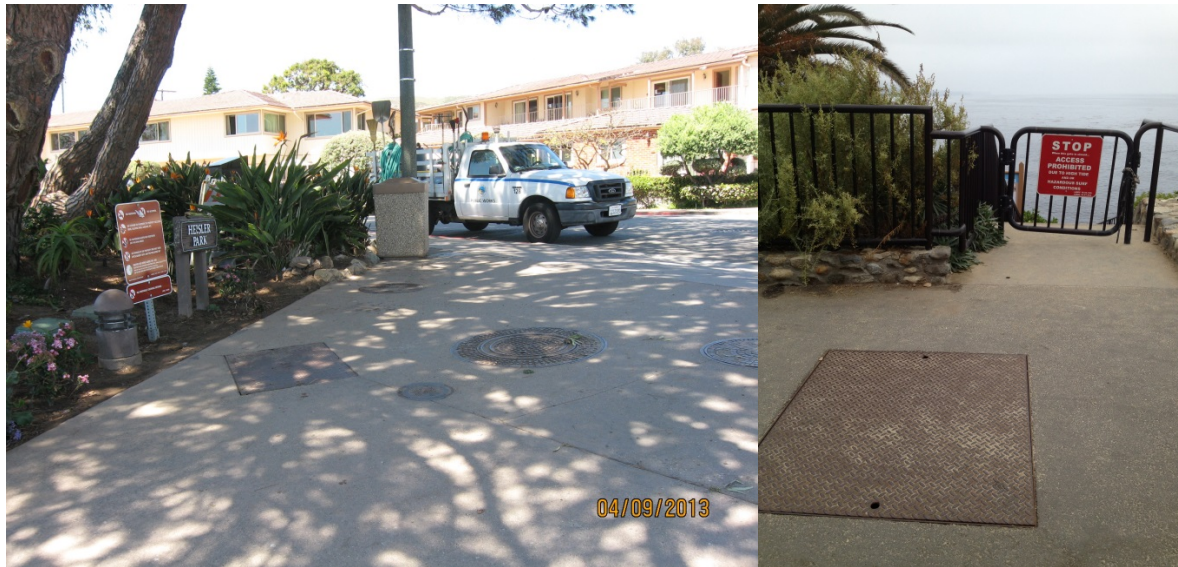
Photo – Jasmine Street Diversion Unit/Lid to sump pump.

- Maintenance of Diversion Units - Diversion maintenance includes monthly inspections of each unit and quarterly cleaning. Debris in the units is measured and recorded into an annual spreadsheet. All diversion inspection and cleaning activities are tracked in the City's Lucity Computerized Maintenance Management System Database.

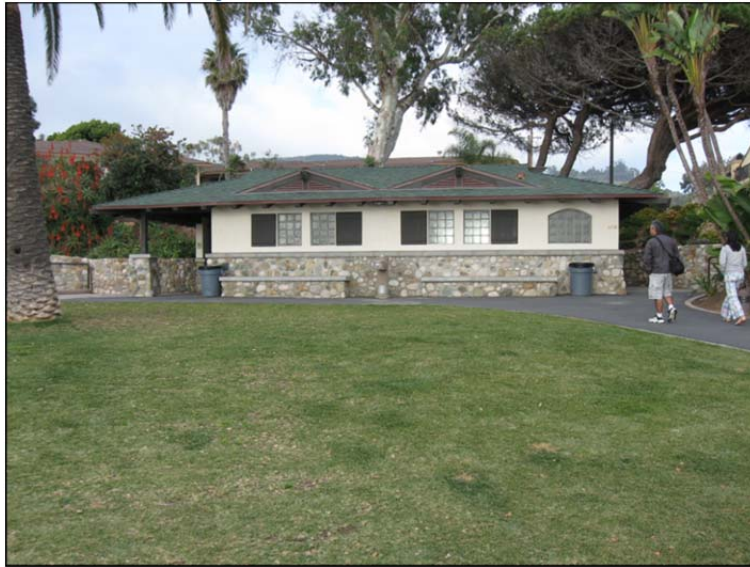
**Photo – Rebuilt restroom facility.**

- Two public restrooms inside Heisler Park were rebuilt to replace aging existing facilities which posed a significant threat of failure and subsequent sewer spillage. The Main Beach lift station (located adjacent to Heisler Park) was completely rebuilt and the adjacent restroom facility was removed. A sewer spill in this heavily used beach area could have major impacts on human health due to elevated bacteria levels in the ocean. The marine habitat could also be negatively affected by the influx of organics and nutrients found in sewage. Clean and sanitary public restrooms may prevent individuals from using the ocean or surrounding park areas as toilets. Rebuilding the lift stations to provide more reliable service and adding fail-safe's to prevent backflow from the main further mitigates the risk of spills.

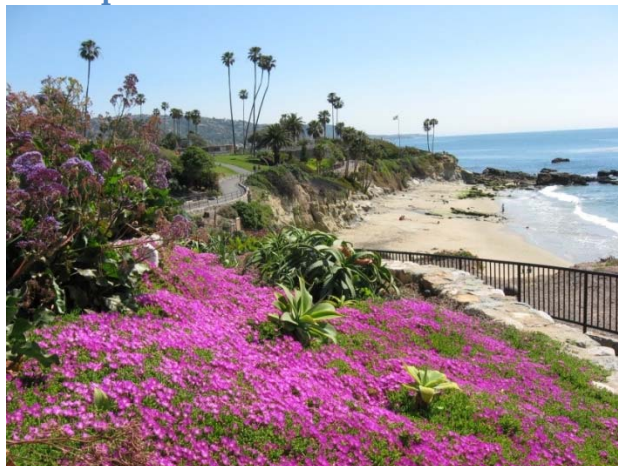
**Photo – Bioswale terraces capture flow for biofiltration and infiltration.**

- Heisler Park completed a major renovation in 2012 which incorporated a number of LID site design BMPs including bioswales, disconnection of storm drains, tilted pathways and infiltration zones to give both nuisance water flows and storm water flows a chance to infiltrate on site prior to entering the storm drain system. The benefits of this approach to drainage include elimination of trickling dry weather flows into the storm drains, maximizing onsite capture of storm water flows prior to discharge, biofiltration of all flows, and utilization of flows to optimize irrigation efficiency.
- Maintenance – The LID site design BMPs are inspected daily during staff maintenance rounds at the park. The sprinkler system is checked for broken sprinkler heads, proper spray path and efficient water use.

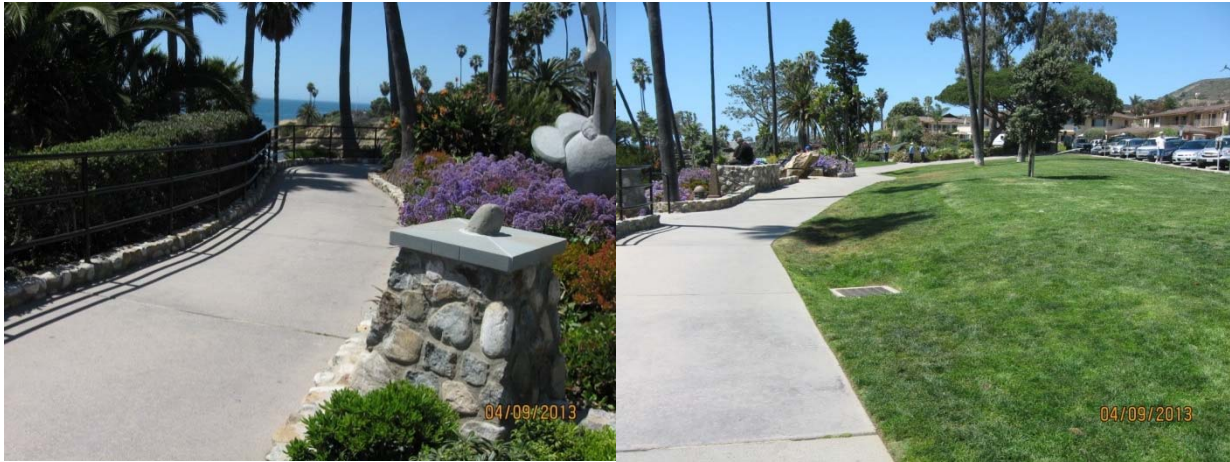
Photos - Pathways and surrounding terrain are tilted toward a depressed bioswale for infiltration.

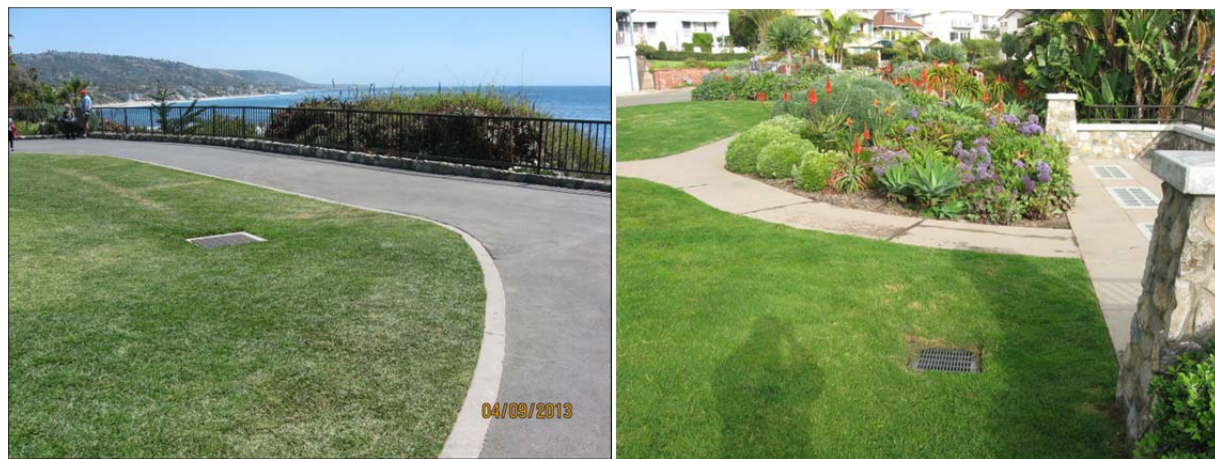
Photo- All Storm Drain inlets are disconnected from other hardscape to promote infiltration.

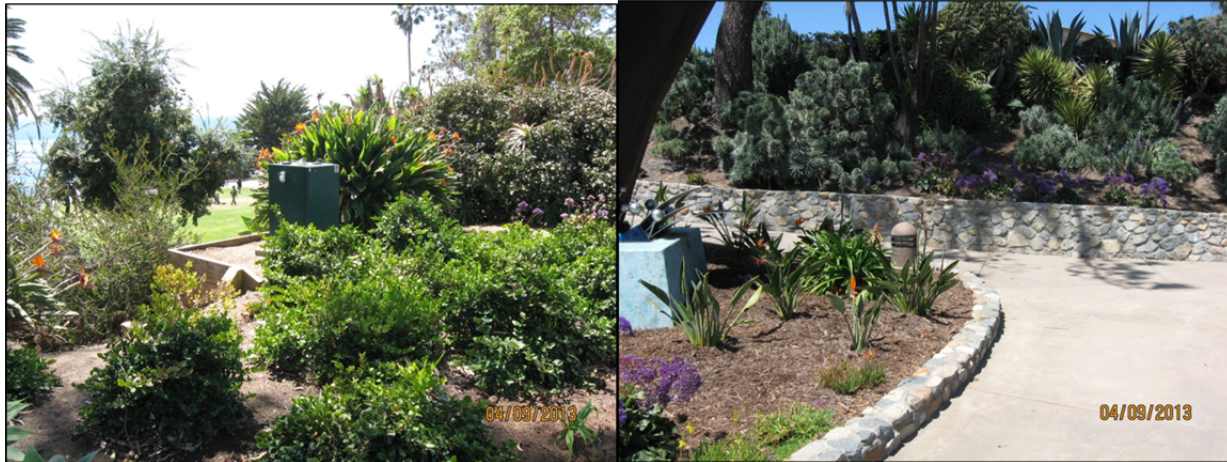
Photos – SmartTimer irrigation controller with antennae on top, water-wise plants in landscaped area.

- During the Park renovation several landscaping structural BMPS were incorporated including; replacing all irrigation lines and heads within the project area with new equipment, converting the existing timer clocks to satellite controlled Smarttimer irrigation clocks and replanting graded areas with water-wise and native plants where appropriate. The improvements to the irrigation and landscaping help prevent excess runoff by reducing water waste through leaks and over irrigation. These systems are checked daily to ensure proper operation and fixed immediately upon identification of problems.

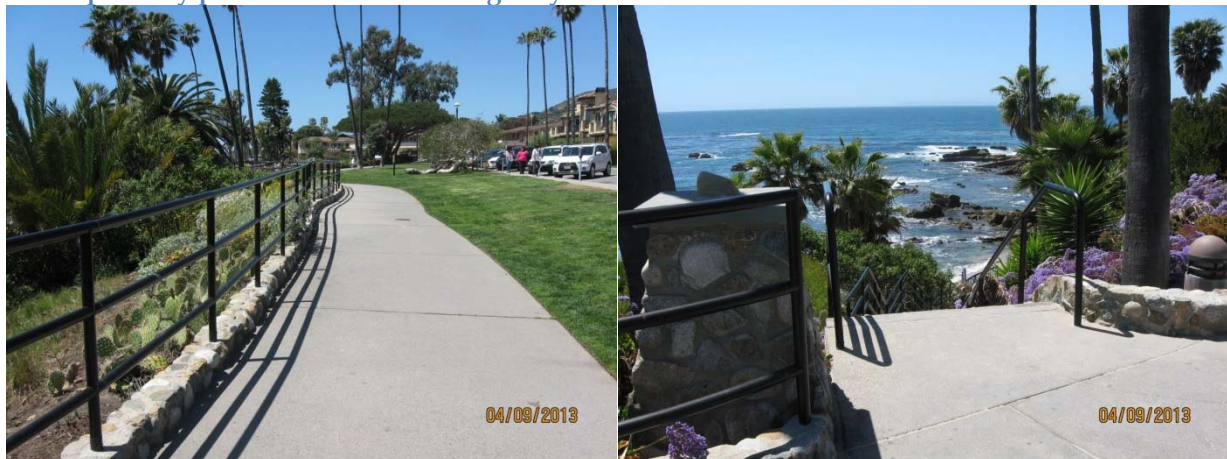
Photos – Curbs, railings and improved stairs to beach ensure visitors are not destroying the bluff tops. Tilted pathway push sheet flows to the grassy area for infiltration.

- The bluffs along the coast of Heisler Park were eroding rapidly due to increased sheet flows and point source discharges from both paved and landscaped areas. Wet weather events caused rapid erosion but nuisance dry-weather flows also contributed to the problem. Besides acute dangers from collapsing hillsides and rockfalls, the long term effects of sedimentation in the ASBS could be profound. The Park renovation addressed excess erosion of the bluffs by controlling access and redirecting surface flows into bioswales for infiltration using a curb and walkway along the bluff top for conveyance.

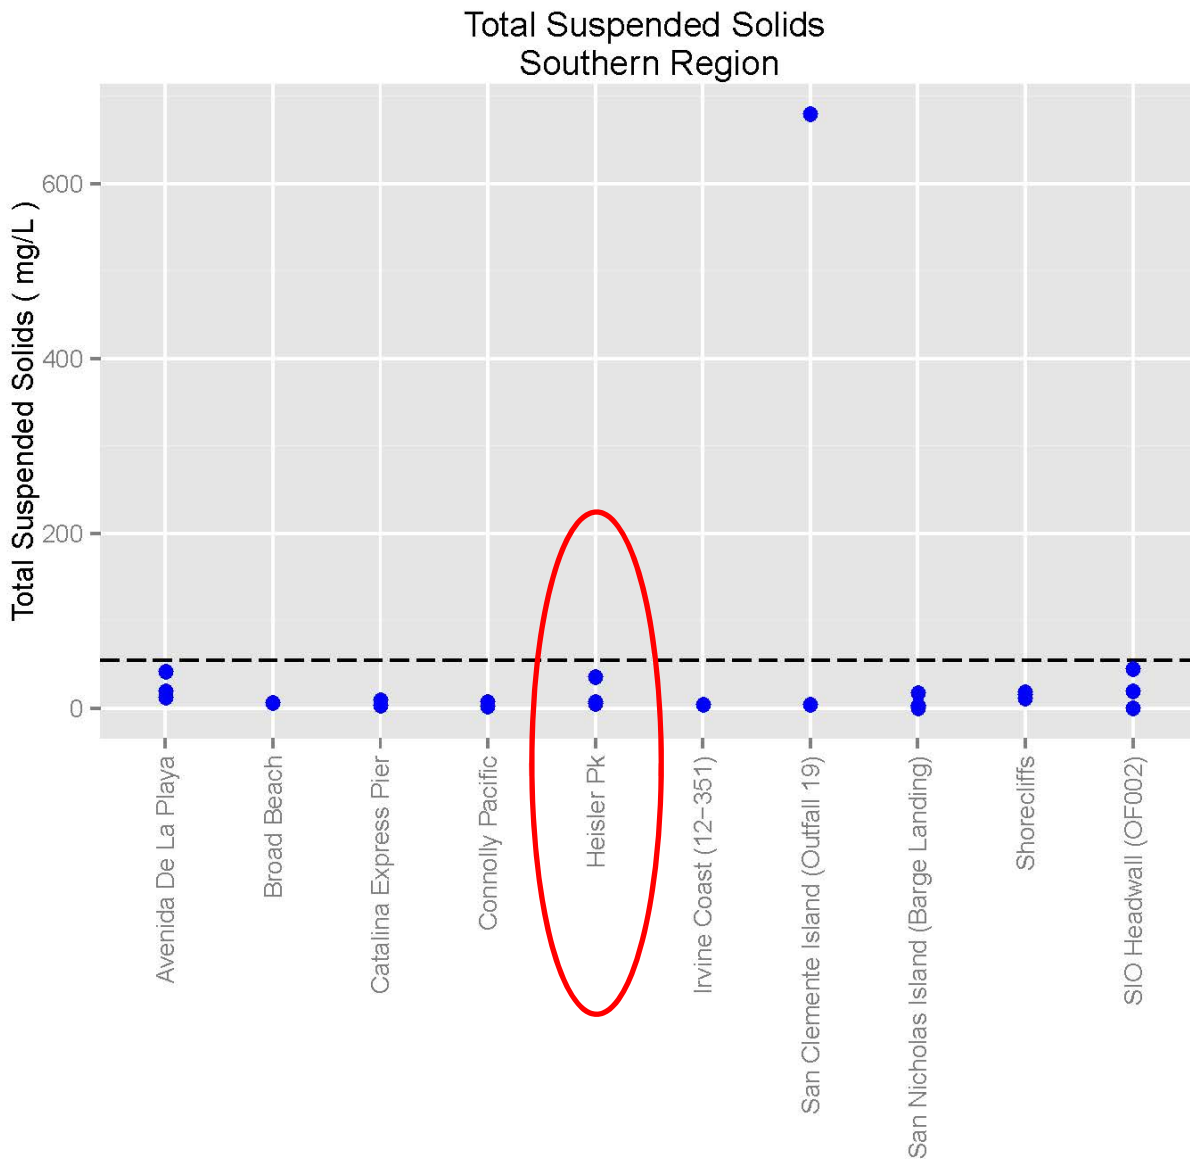
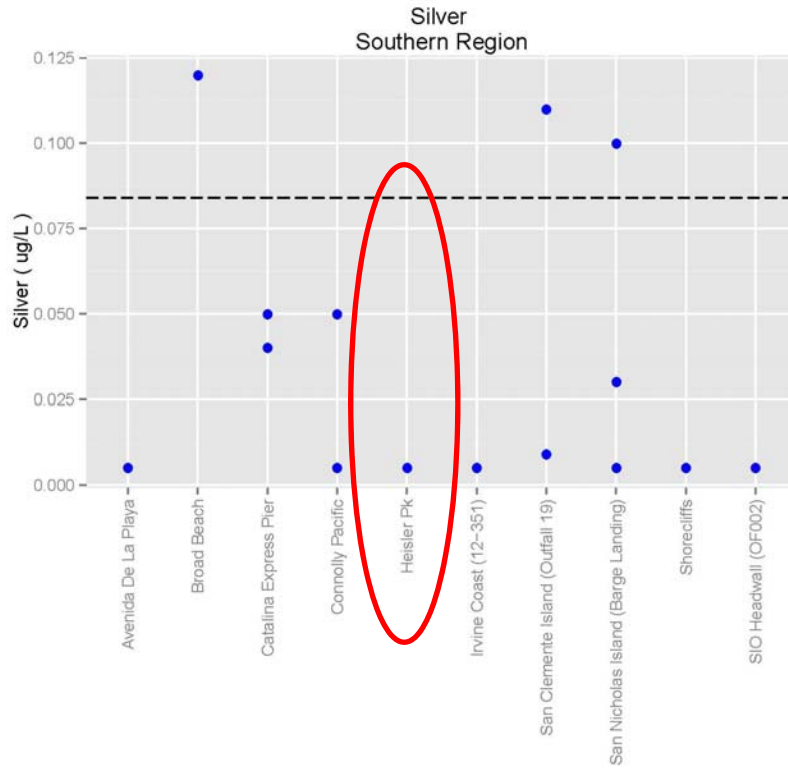
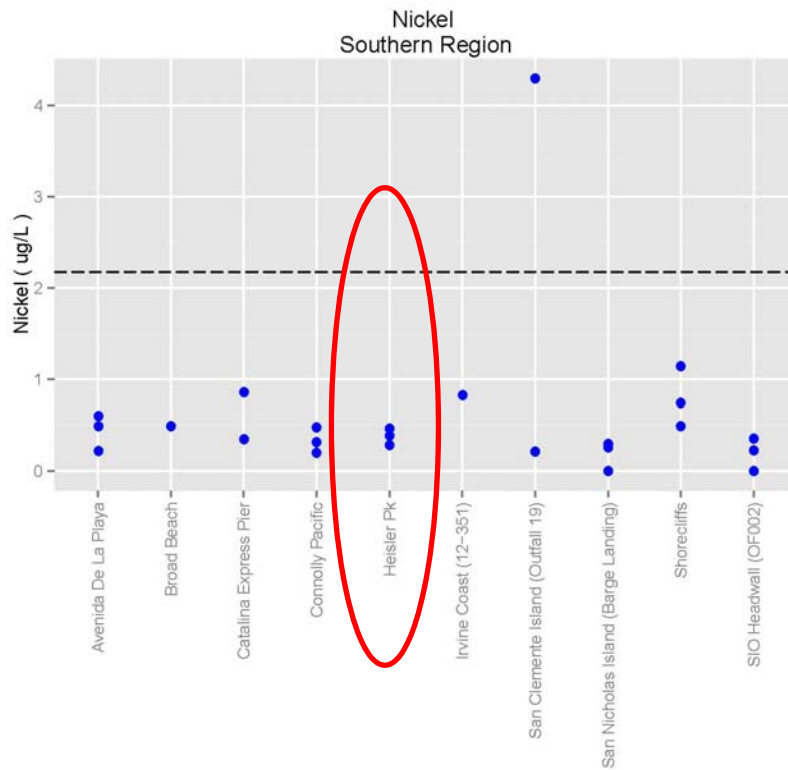
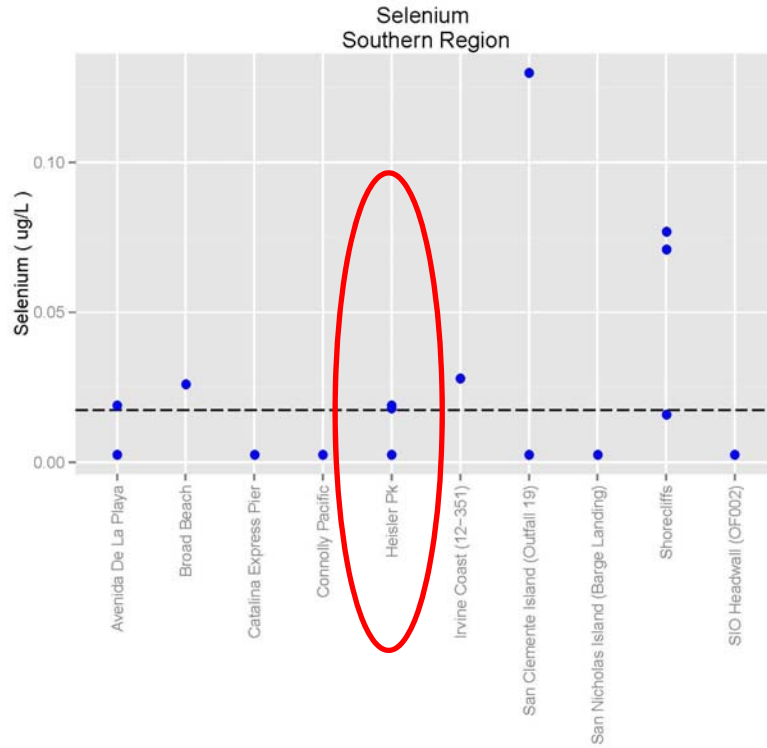
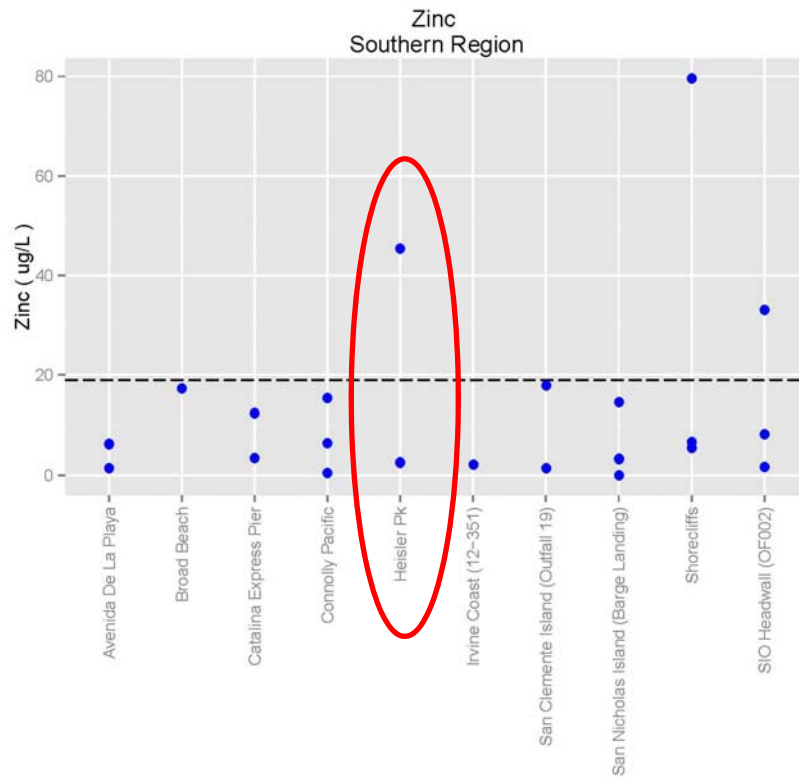
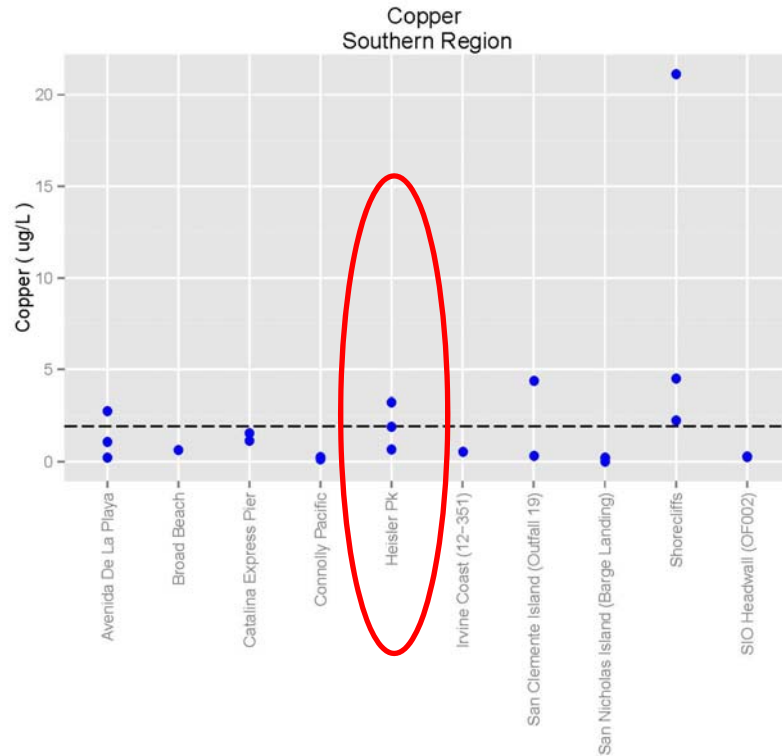
The SCCWRP compared the established Natural Water Quality Guidelines against the actual discharge data. This comparison determines if ASBS area discharges meet natural water quality conditions. The dashed line on the following charts represents the natural water quality condition that each ASBS discharge results should be below. The

- Metals - The metals shown above were above the natural water quality guidelines but were below the Ocean Plan established limits. The City of Laguna Beach continues to work to remove pollutants from storm water discharge. The strategic operation of the diversion units located within the Heisler Park ASBS is expected to reduce the amount of metals entering the ASBS. Dry season nuisance flows and small storm events are directed to the sanitary sewer.
