**Section A.13**

**City of Laguna Beach  
Heisler Park Area of Special Biological Significance  
Compliance Plan**

### A.13.2 Heisler Park Area of Special Biological Significance Drainage Area

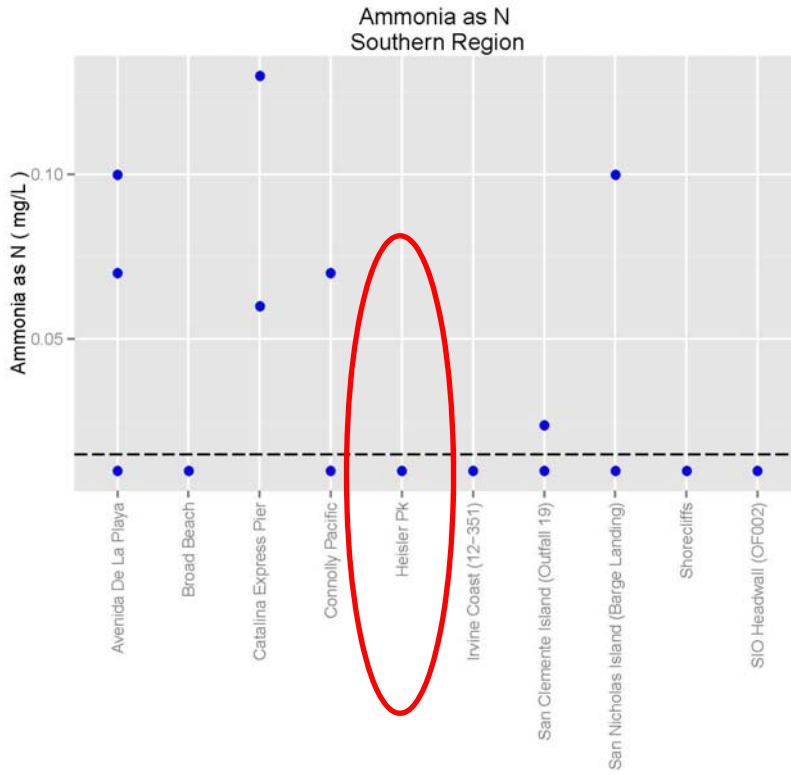
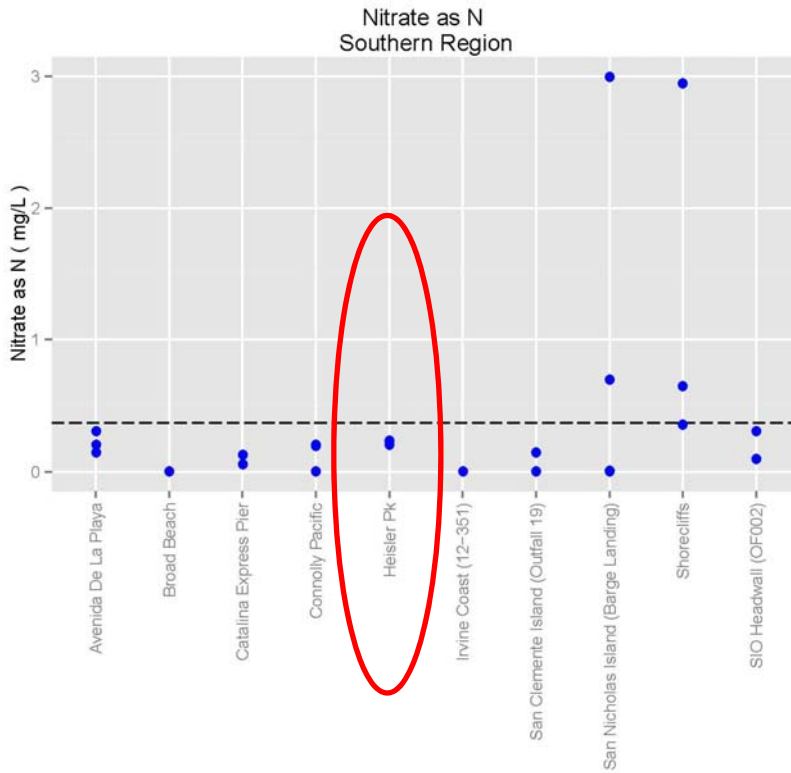
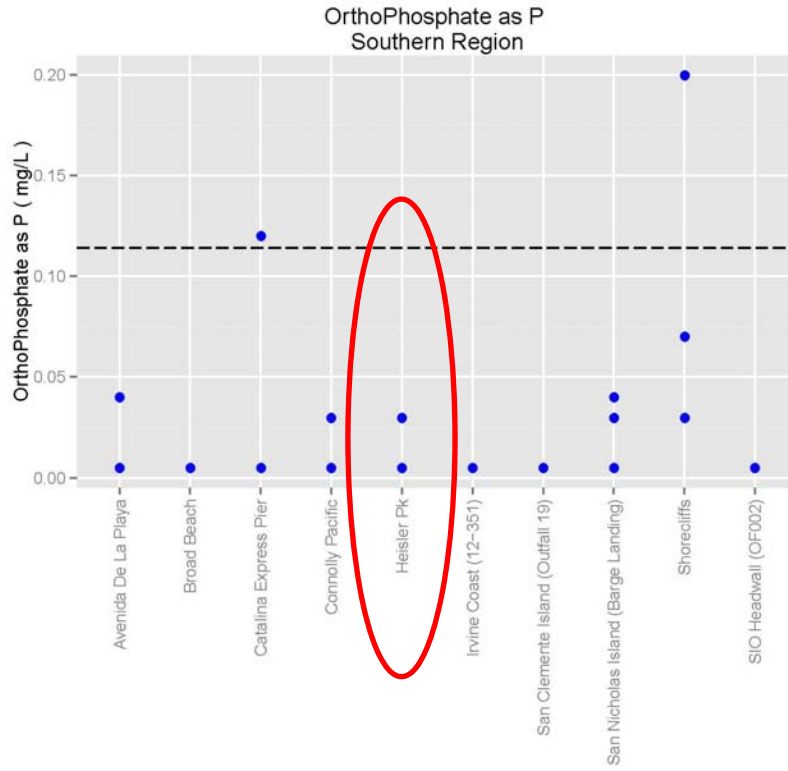
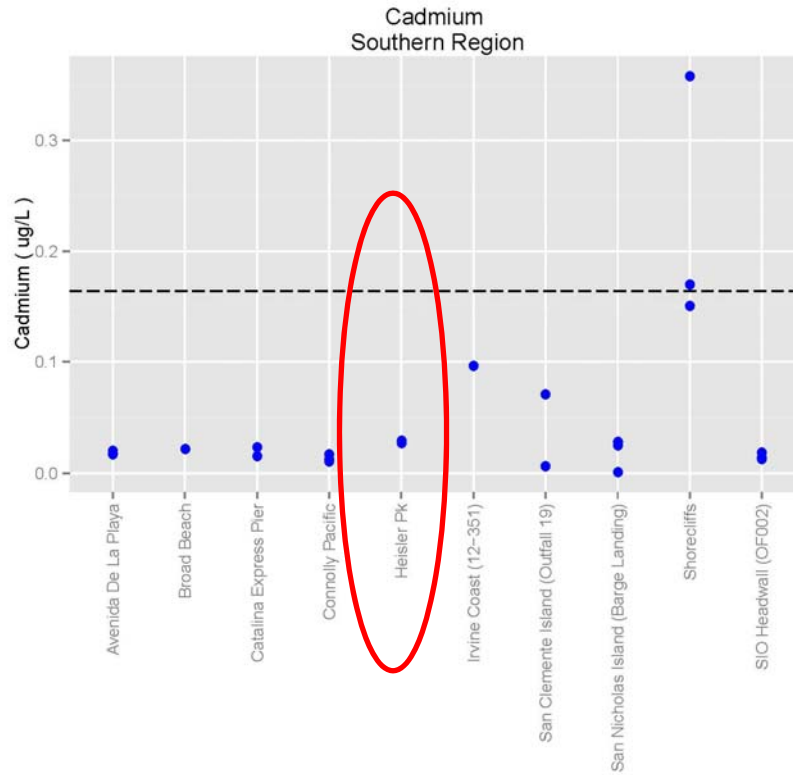
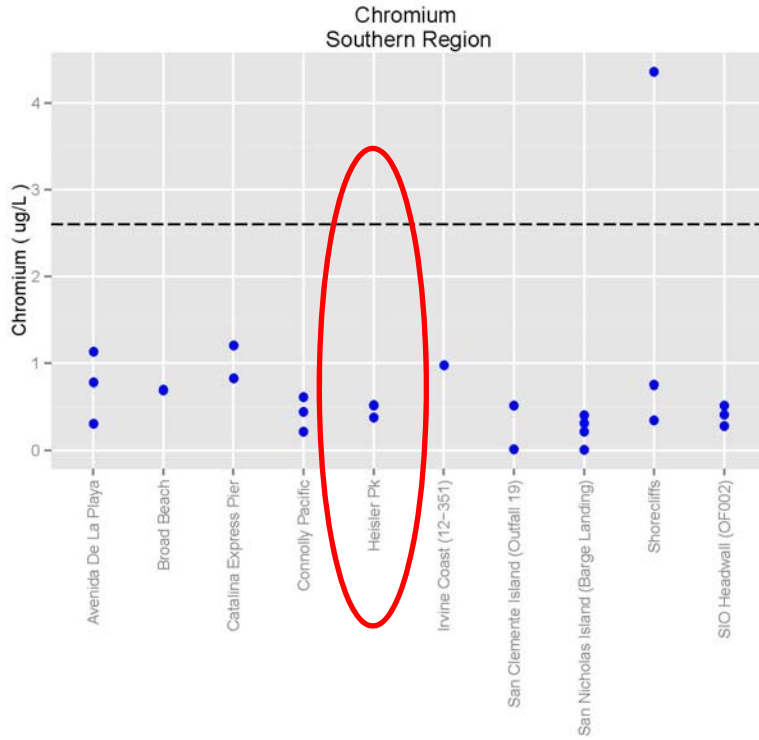
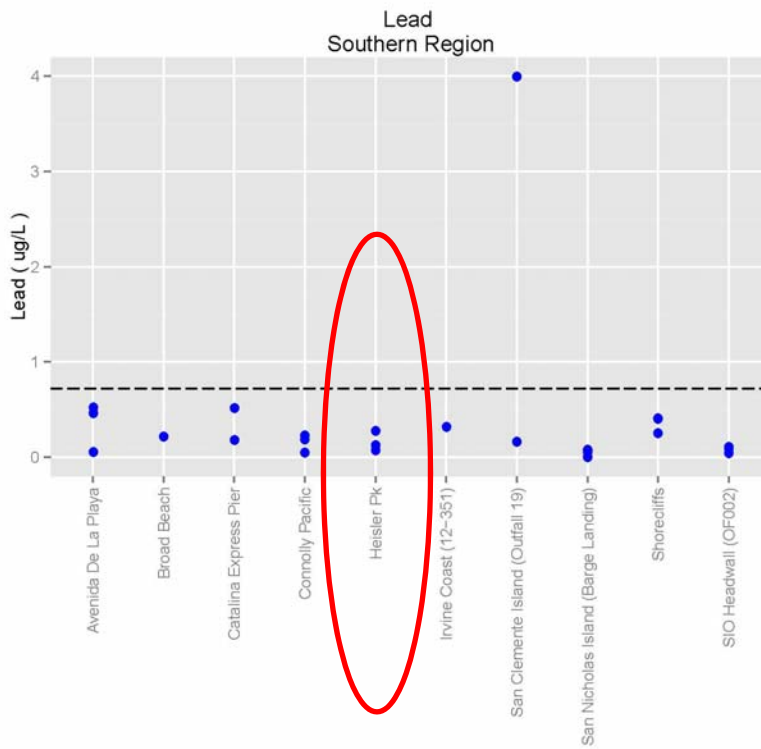
- Metals - The metals shown above were above the natural water quality guidelines but were below the Ocean Plan established limits. The City of Laguna Beach continues to work to remove pollutants from storm water discharge. The strategic operation of the diversion units located within the Heisler Park ASBS is expected to reduce the amount of metals entering the ASBS. Dry season nuisance flows and small storm events are directed to the sanitary sewer.

The SCCWRP compared the established Natural Water Quality Guidelines against the actual discharge data. This comparison determines if ASBS area discharges meet natural water quality conditions. The dashed line on the following charts represents the natural water quality condition that each ASBS discharge results should be below. The

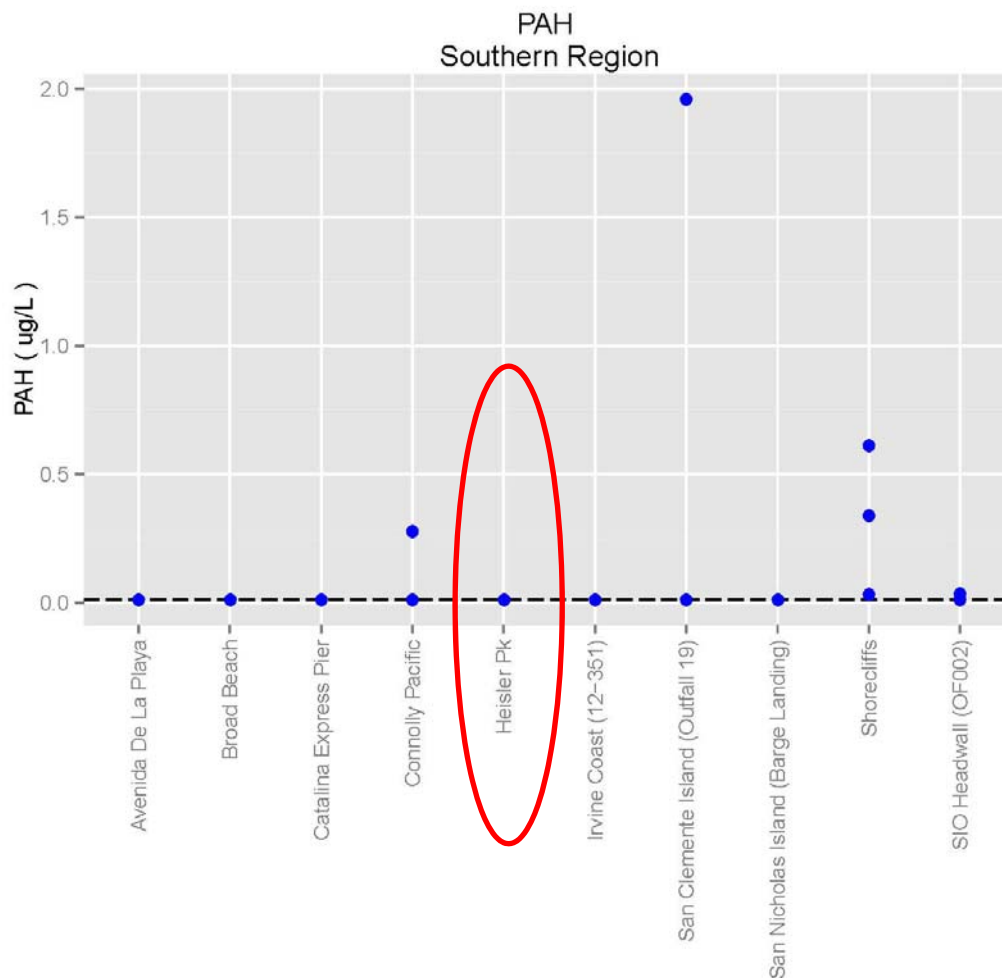
- PAHs - Several PAHs were detected during the Bight 13 sampling. Likely sources of the PAHs are road runoff from the highly traveled Coast Highway and nearby parking lots. Although the PAH results were above the Ocean Plan levels, the results were just at the natural water quality guidelines. The more nuanced operation of the diversion units located within the Heisler Park ASBS is expected to reduce the amount of PAHs entering the ASBS. Dry season nuisance flows and small storm events will be directed to the sanitary sewer. The automation of these units was completed in September 2013.
