DIVISION OF WATER RIGHTS DROUGHT CURTAILMENT INSPECTION

Inspected water rights: A011786, A001024
Inspection date: 06/17/2015
SWRCB Investigator: Janelle Heinzler, WRCE
Participating agency investigator: _____

LEHR – A001024 and A011786 - 2015 Curtailment Inspection Photos

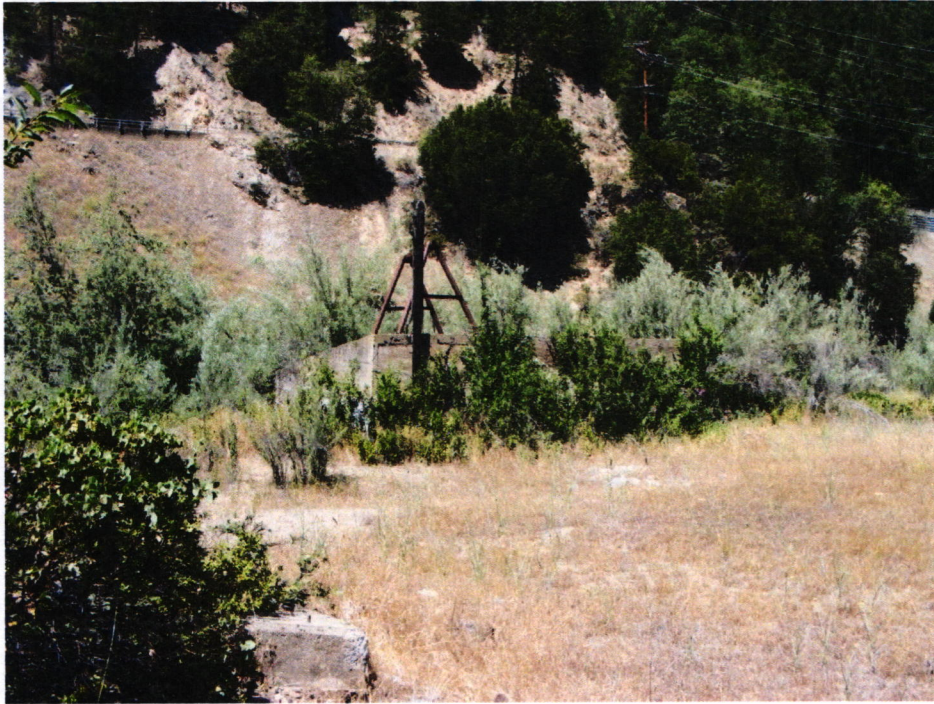
POD on East Branch of North Fork Feather River – POD not being used until development is determined for POU

A011786 POD is not in operation since the mill has been closed down. Owner wants to develop the area and begin using water again. The POD is not located at the POD location described in A011786 but it is on the same source.

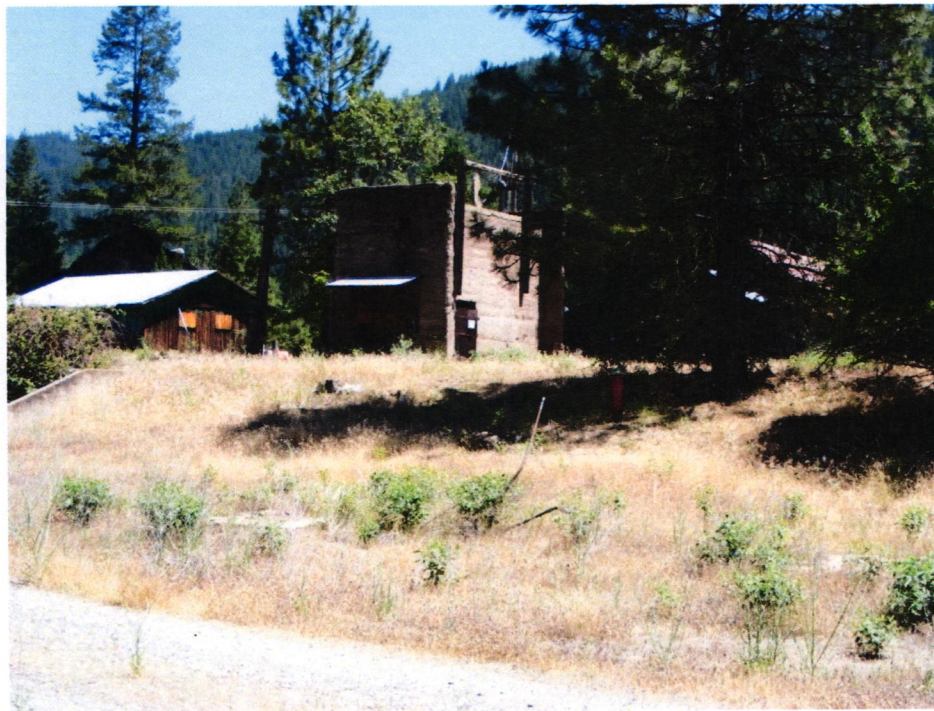
Abandoned lumber mill site POU

The POU was a lumber mill which is no longer in use. The owner wants to redevelop the area and use the water right for domestic purposes. At this time, any existing domestic use in the area is from springs. The owner has one 3600 gallon tank which was fed from the POD on the river and if rehabilitated in the future would be used for fire protection, irrigation of domestic use but is minimal if at all. The river POD is not functional. The east and west springs have 5000 gallon tanks for domestic use when they are used. At this time they are not being used and water returns to the river. The system needs rehabilitation before it could be used. The "riparian" water from the river is not being pumped from the authorized POD location and is being sold to fill logging trucks for dust control on what appears to be non-riparian land which the owner said is located 15 miles up Henchman Ravine. I discussed with the owner that he may not legally continue this practice.
