Marble Mountain Ranch Water Rights Investigation: Water Use Technical Memorandum

Prepared for:
Mid Klamath Watershed Council
38150 California 96
Orleans, California 95556
Contact: Will Harling

Prepared by:
Cascade Stream Solutions, LLC
295 E. Main, Suite 11
Ashland, OR 97520
Contact: Joey Howard, P.E.

Water Use Technical Memorandum

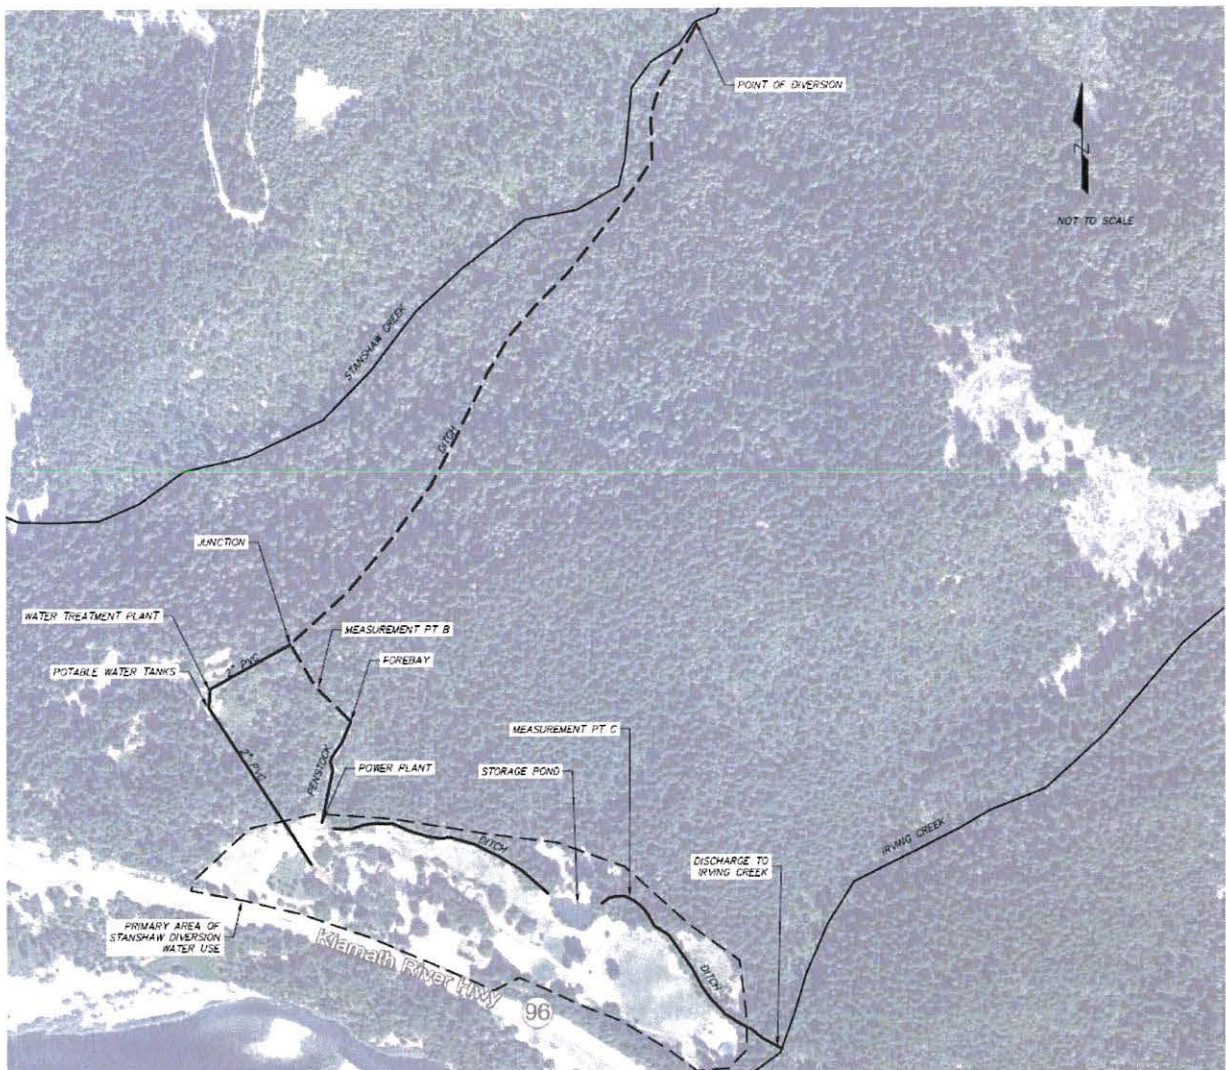
Figure 2. Water Conveyance Map

The point of diversion is located on Stanshaw Creek about 0.68 miles upstream of the Highway 96 crossing. A channel spanning gravel and cobble push-up dam diverts water that does not seep through the dam into a diversion ditch. The amount diverted typically varies with available stream flow, independent of demand. Under typical late spring, summer, and fall flow conditions (less than about 3 to 4 cfs), the majority of creek flow is diverted into the ditch. Conveyance from the point of diversion to the ranch is gravity driven. Flows are conveyed from the point of diversion about 0.5 miles to a junction where flows can be conveyed to a water treatment plant to the southwest, and to a forebay and penstock to the southeast that services the power generation facility and the pressurized irrigation system. The conveyance structures between the point of diversion and the junction consists of unlined and lined reaches of ditch. The lined reaches are lined with culvert pipe cut to form half round pipe sections. These semi-circular pipe sections include corrugated HDPE pipe with smooth interior walls and corrugated metal pipe. One section of pipe was measured to be 30 inches in diameter. The other sections appeared to be the same diameter.

The ditch follows along a steep heavily treed hillslope. Geomorphic processes and biotic activity influence the ditch conveyance capacity and requires frequent maintenance to maintain desired conveyance capacity. Douglas Cole states the ditch conveys a maximum of about 4 to 5 cfs when the ditch is in good condition. Sediment deposition in the canal results from ingestion of sediment from Stanshaw Creek, hillslope sloughing, and landslides. Changes in elevation of the outboard canal berm (side opposite the hillslope) have the potential to influence canal conveyance capacity as well. The berm elevation may change as a result of erosion due to overtopping and slumping and sloughing of the hill slope. Animal activity, such as trampling by elk, may also reduce the berm crest and result in increased overtopping and reduced conveyance capacity.

Mr. Cole monitors diversion flow at a location in the canal downstream of the junction point that provides water to the water treatment plant. Water levels are monitored in a half section of corrugated metal pipe. He has marked the inner diameter of a 30 inch diameter corrugated metal pipe to create water level gage that he refers to as the Stanshaw Gage and the units as Stanshaw Units. At flows below 13.3 Stanshaw Units¹, there is insufficient water to generate hydropower to meet demand. The Ranch's power system is currently configured to accept power from one generation source: the hydropower generator or diesel generator. When Stanshaw Creek diversions are insufficient to meet all demands, the Ranch relies on a diesel generator for power and water is generally consumed for irrigation and guest needs. Diversion flows are not reduced when hydropower generation ceases. During these times, flows in excess of the flow required for irrigation and domestic use are conveyed to Irving Creek.

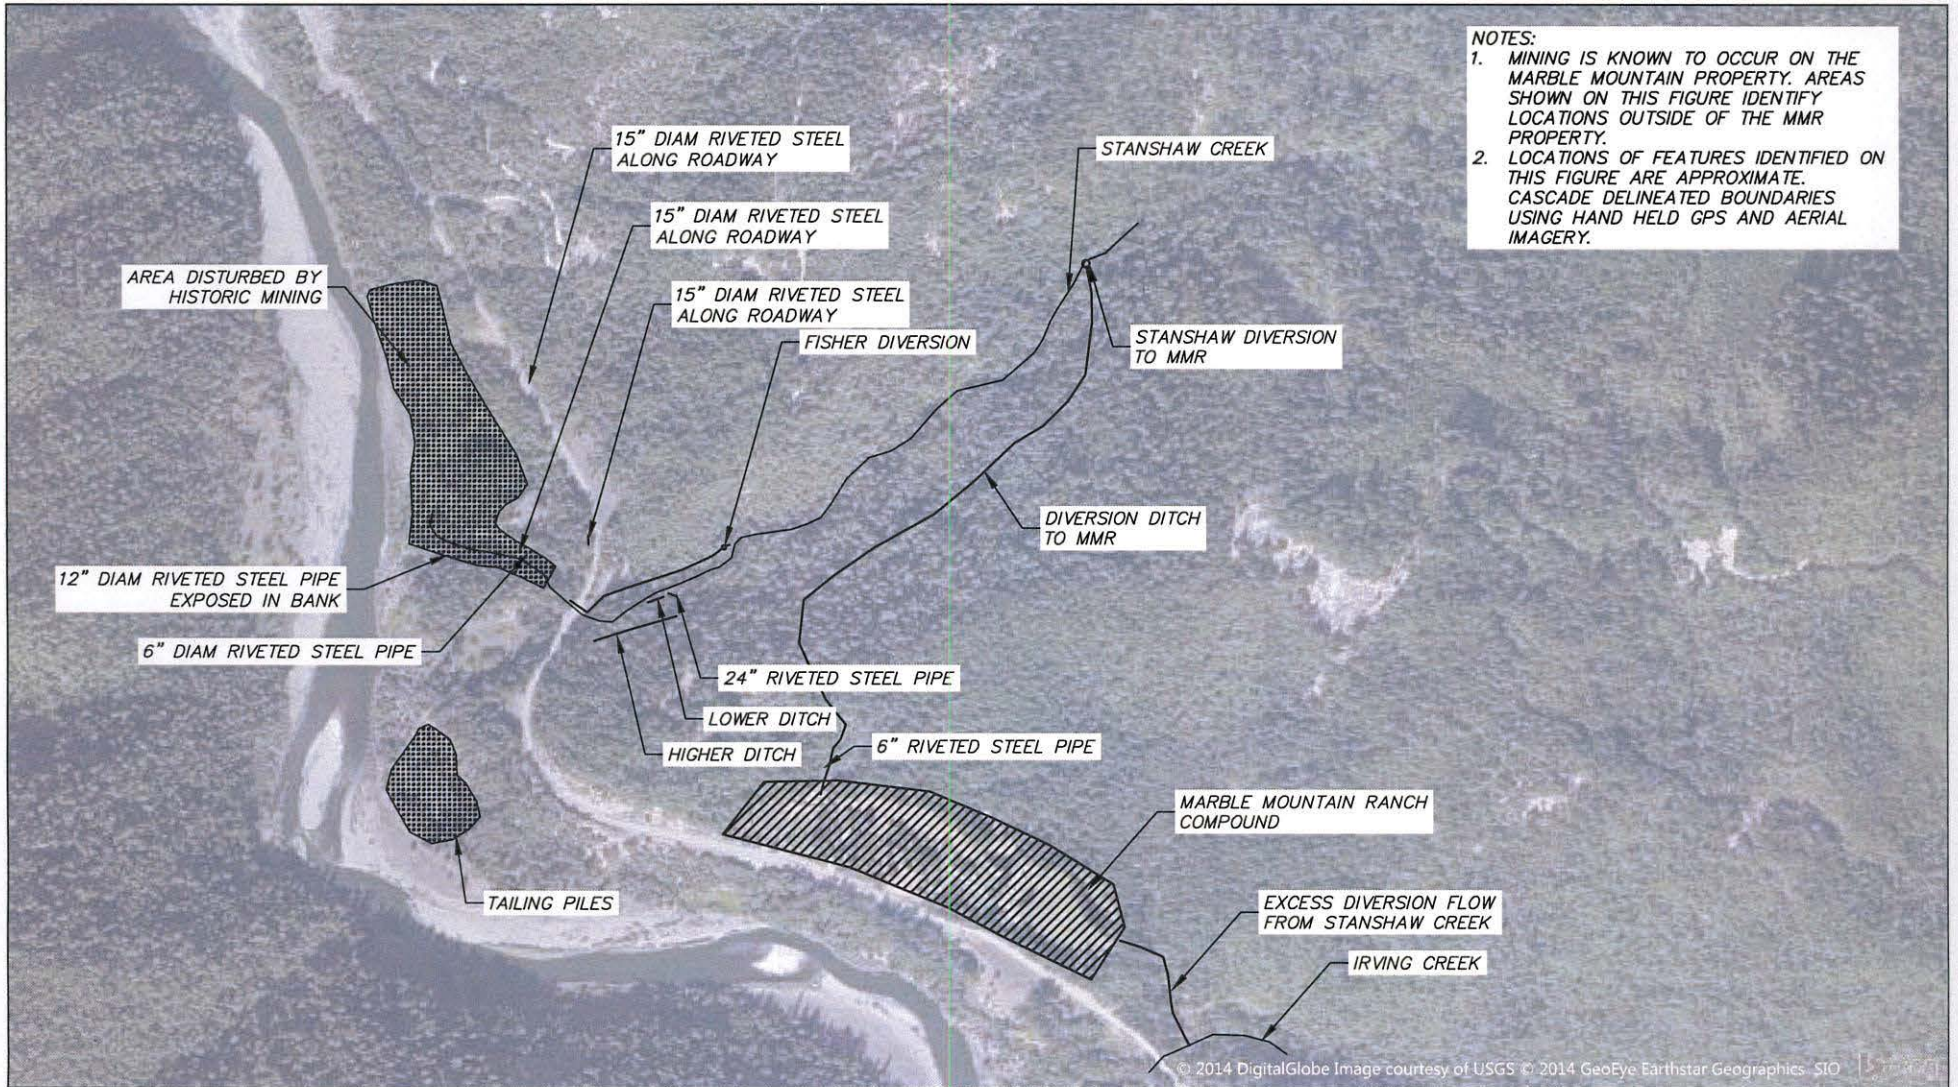
Marble Mountain Ranch
Water Rights Investigation
 Figure 3. Location Map of Historical Mining
 Artifacts and Areas of Disturbance

The original water right claim was for 15 cfs. Cascade does not have documentation of how much water was actually used for hydraulic mining. The land area upon which mining could have occurred was much larger than the current area of MMR. Stanshaw Creek flow may have been higher in historic times than it is today. However, it is not likely that Stanshaw Creek flowed at a rate sufficient to allow diversions of 15 cfs except possibly during very high flow periods. In any event, during the late 1800's and early 1900's, the majority of the water used was probably for mining, with smaller amounts devoted to domestic and irrigation purposes. This pattern probably persisted from the 1860's to the time hydraulic mining activities decreased and then ceased. From about 1920's or early 1930's to the early or mid-1950's, a period of approximately 15-30 years, seasonal irrigation appears to be the primary consumptive use with lesser amounts used for year round domestic purposes. Figure 3 shows locations outside of the Marble Mountain Ranch Property where mining related activities likely occurred.

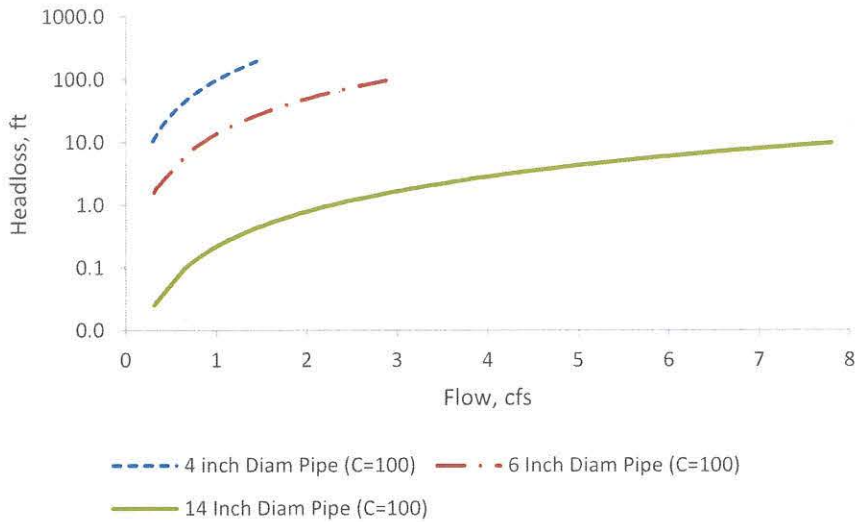
Figure 4. Pipe Headlosses

The flow rate required to generate power is a function of the total static head minus the headlosses referred to herein as net head. Headlosses include losses due to pipe friction and minor losses such as the inlet, bends, reducers, and outlet. For the purposes of this investigation, minor losses were considered to be small compared to friction losses in the pipe. Because we don't know the true pipe size used to convey water from the ditch to the power plant at the time Lue Hayes purchased the property, Cascade modeled headloss and potential power generation from a 4 inch and 6 inch diameter pipe as well as the 14 inch pipe that currently conveys water down the hillslope, a vertical distance of about 200 feet. As illustrated in Figure 2, the pipe diameter can significantly influence headloss. The headloss curves shown in Figure 2 were computed assuming a pipe length of 500 feet, the estimated

length of the pipe, using Hazen-Williams formula for headloss. The loss coefficient was assumed to be 100, which is often used for “old unlined or tar-dipped cast-iron pipes in good condition” (Roberson et al. 1998). Figure 3 shows the change in net head with flow at the Pelton wheel for three different pipe sizes: a 4 inch diameter pipe, the pipe diameter Hayes stated conveyed water to the Pelton wheel prior to his purchase of the property; a 6 inch diameter pipe, the diameter of pipe that currently is abandoned near the existing 14 inch pipe; and a 14 inch pipe, which currently exists. Assuming a static head of 200 feet, the net head decreases dramatically with flow in a 4 inch diameter pipe and is relatively constant in a 14 inch pipe as shown in Figure 3.

Equation 3. Hazen-Williams Headloss Equation (Imperial Units)

$$h_L = \frac{4.73 * L * Q^{1.852}}{C^{1.852} * D^{4.87}}$$

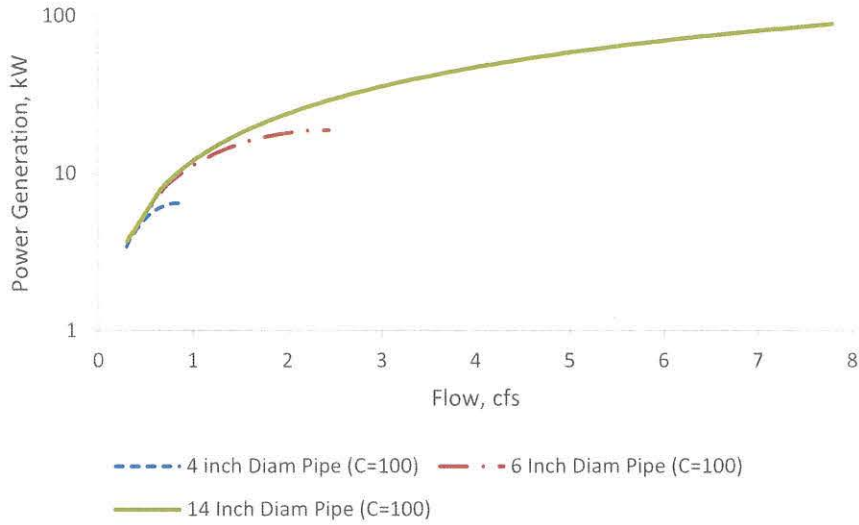
Figure 6. Power Generation Rating Curves

The change in power production is dramatically influenced by the pipe size as shown in Figure 4. Assuming an efficiency of 70 percent for the time prior to Cole’s power plant upgrades, peak power

generation of 6.47 kW occurs at a peak flow of 0.85 cfs for a 4 inch diameter pipe, 18.8 kW at a flow of 2.4 cfs for a 6 inch diameter, and 174 kW at a flow of 22 cfs for a 14 inch pipe (the current pipe size.) These estimates are based on a static head of 200 feet, Hazen-Williams coefficient of 100, and pipe length of 500 feet and were calculated using Equation 1.

Cascade developed power flow rating curves to estimate power production using readily available information and standard engineering equations. Energy production from a Pelton wheel can be characterized as a function of the fluid density (ρ), acceleration due to gravity (g), flow rate (Q), total dynamic head (ΔH), and the efficiency of the Pelton wheel and electrical system (μ) as shown in Equation 1. In this case, the fluid is water and assumed to have a constant density of 1000 kg/m³ (62.4 lbs/ft³). Computations are based on a gravitational acceleration of 9.81 m/s² (32.2 ft/s²). Total dynamic head was computed by subtracting the static head by the headloss through the pipe. Headlosses through the pipe was computed using the Hazen-Williams equation. The formula is presented in Equation 2. Power generation efficiency was assumed to be 70 percent prior to Douglas Coles acquisition of the property and 80 percent after his acquisition.

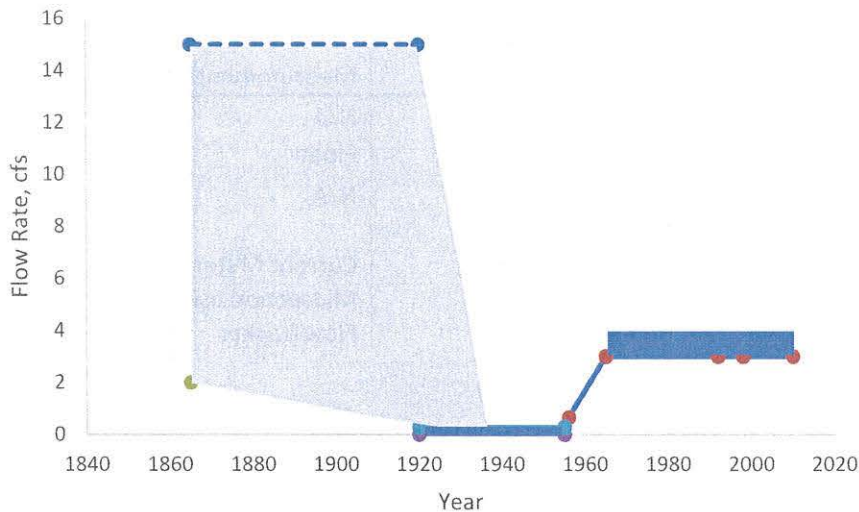
Figure 7. Water Use for Mining and Hydropower Generation

Cascade used the power generation estimates and statements provided by Hayes and Cole as well as readily available information to estimate water use over time. During the active mining period from 1865 to 1920's/1930's, the shaded area in Figure 5 shows the amount of the water right Stanshaw acquired (approximately 15 cfs), and the average summer base flow for Stanshaw Creek (approximately 2 cfs). Diversion rates likely varied seasonally between these ranges, although an analysis of Stanshaw Creek average flows by season (Miller, 2000) showed that even average winter flows are well below 15 cfs. Uses from 1920's/1930's until 1955 when Lue Hayes purchased the property for based on available evidence, was between 0 and 0.36 cfs. Figure 2 illustrates how water use for mining and hydropower has changed over time.

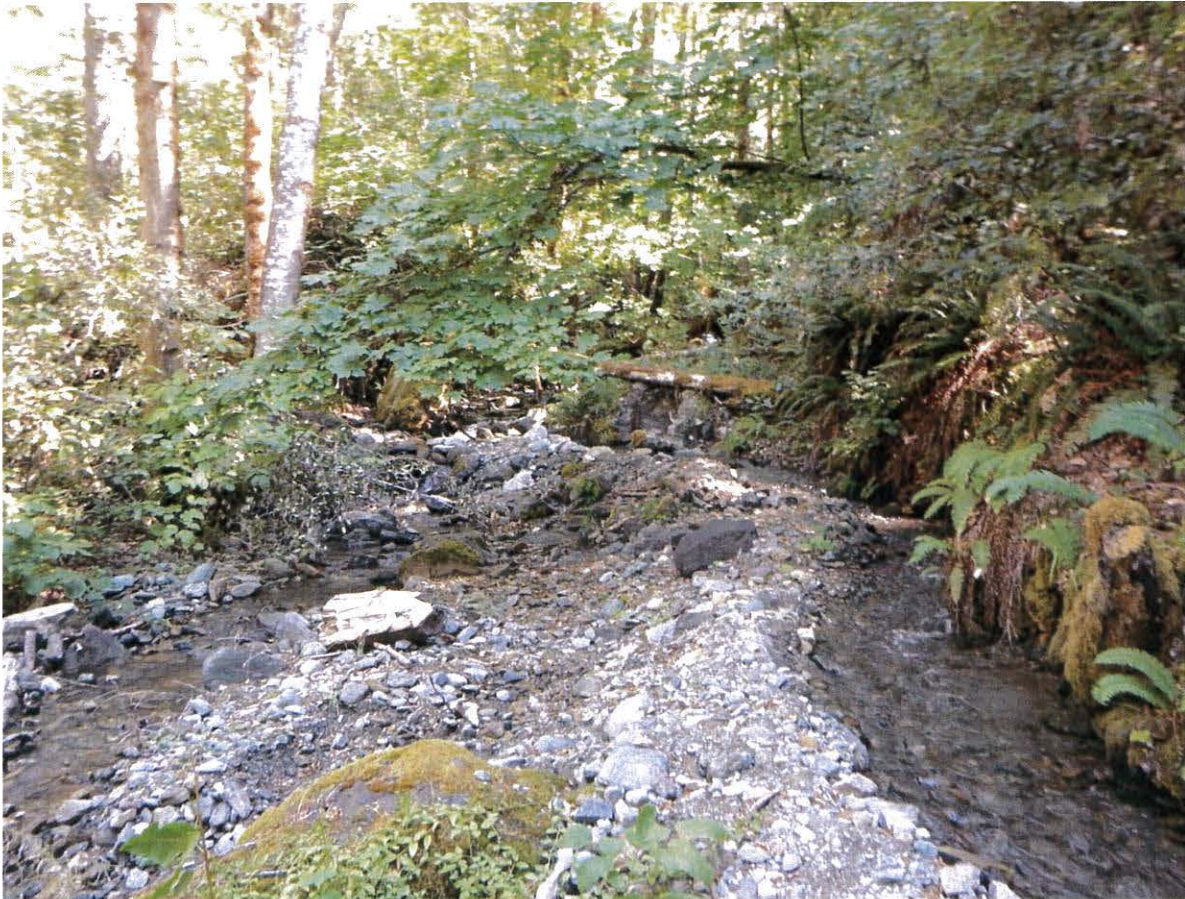
Photograph 1. Point of Diversion on Stanshaw Creek

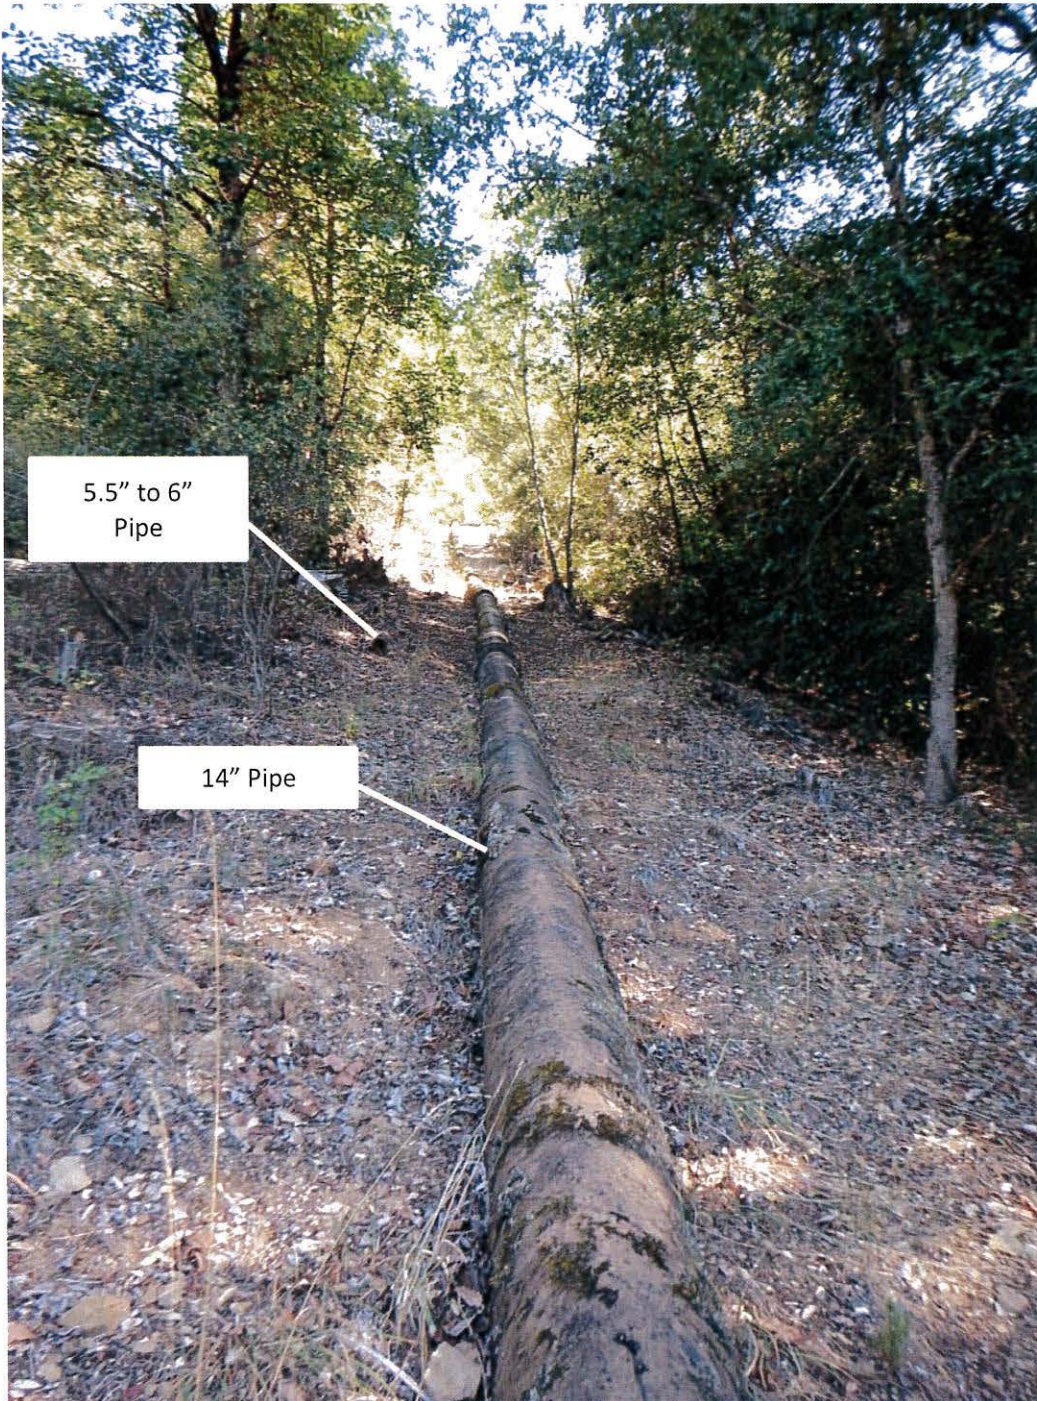
Photograph 2. 14" Diameter Penstock installed by Lue Hayes after he purchased the property in 1955.

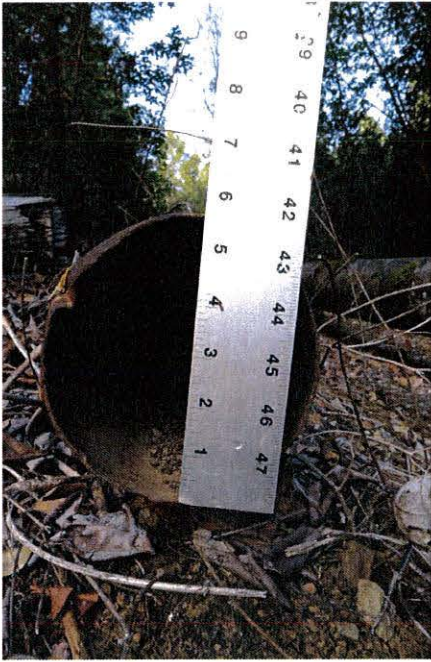
Photograph 3. Pipe adjacent to 14" Pipe. End of pipe was crimped making estimation of Interior diameter imprecise.

The statements by Lue Hayes in 1998 and 2000 and Jerry Hayes statement reported in the June 16th, 2014 comment letter appear contradictory; however, their reference to the power production remains relatively consistent. There is presently an approximately 6 inch diameter steel pipe that lies parallel and offset about 5 to 10 feet from the existing 14 inch pipe. A photograph of the pipe is provided in Appendix A. Cascade was unable to verify the origin or use of this pipe.

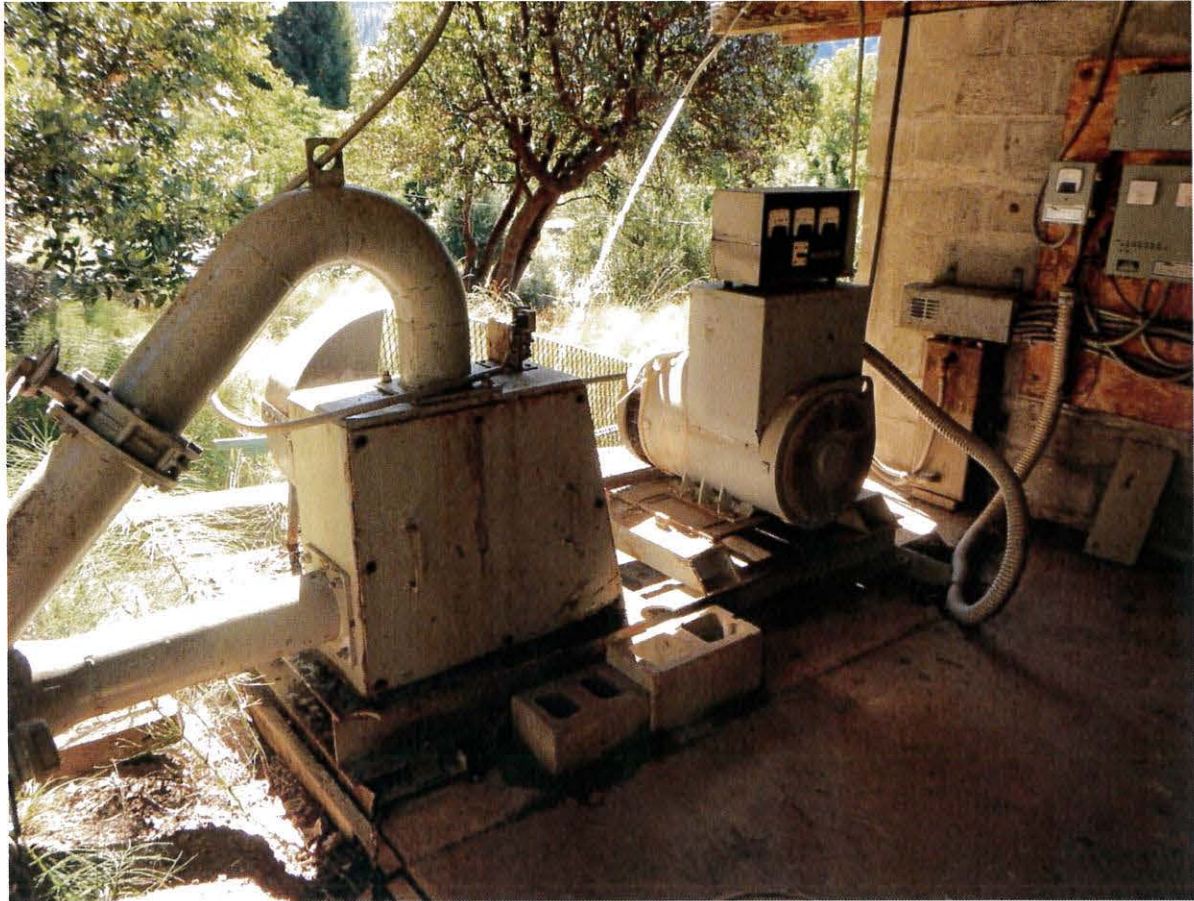
Photograph 4. Micro-hydro power plant diversion flows enter from the pipes on the left of the photograph. Heated effluent from the heat sink resistor is visible near the top of the photograph near the roof beam.

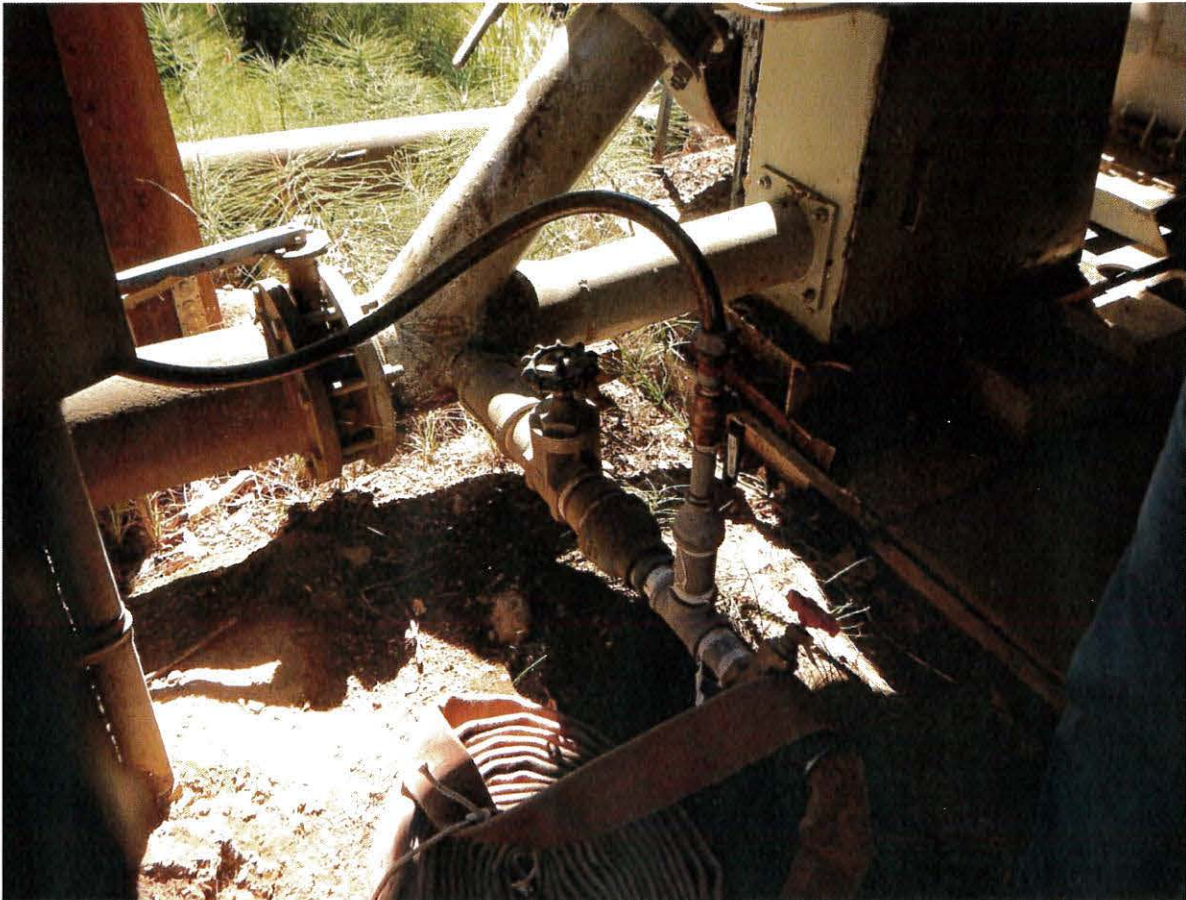
Photograph 5. Junction near hydro-power unit. Large diameter pipes convey water to Pelton wheel. Small diameter pipe that tees at a 90 degree angle conveys water to heat sink resistor and hose.

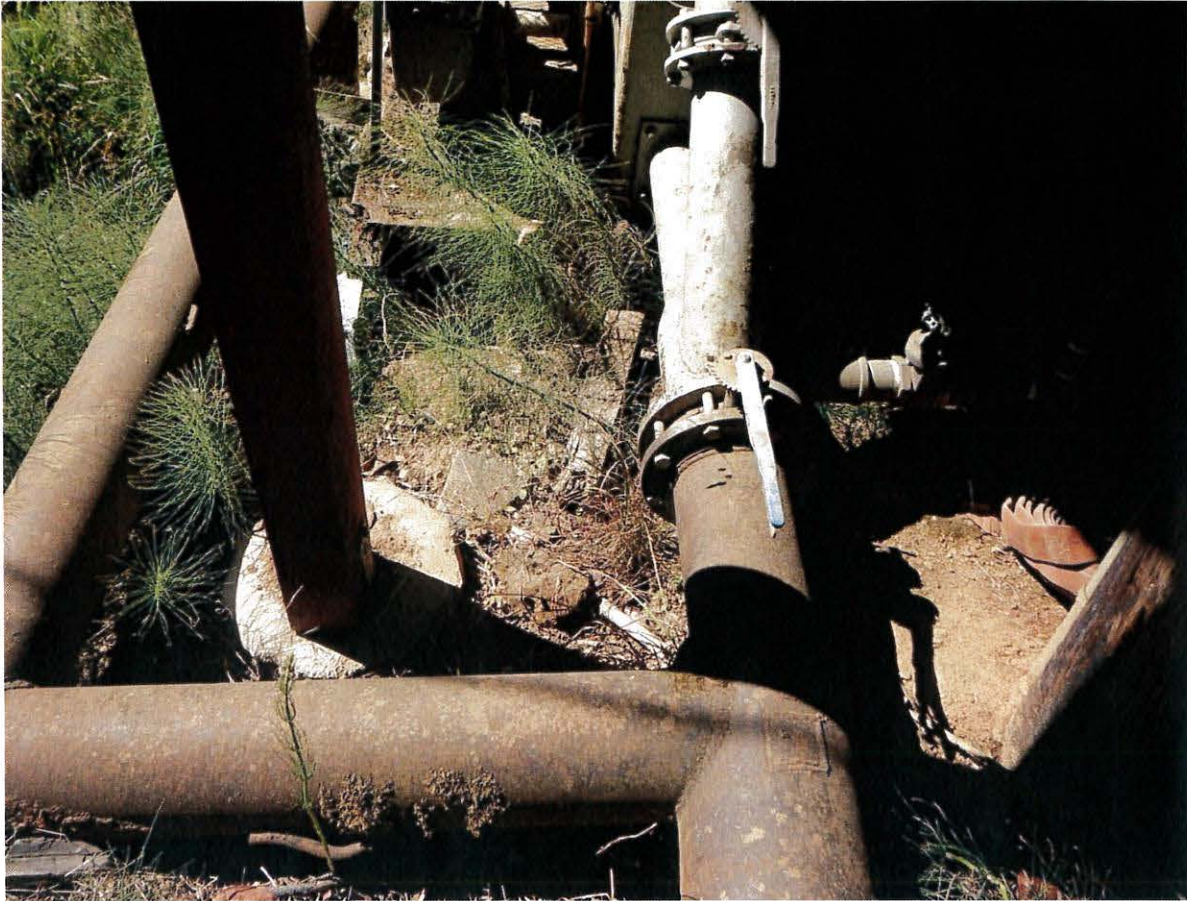
Photograph 6. Junctions near power plant. Tee near the bottom of the photograph serves as junction for flow to power plant and irrigation system. Flow conveyed into the pipe to the left of the photograph serves the irrigation system.

Irrigation and fire prevention flows are conveyed through a short run of nine inch diameter steel pipe to four inch diameter PVC pipe that extends from the junction at the power plant to sprinkler guns located in pastures and hose bibs and couplers located throughout the property.

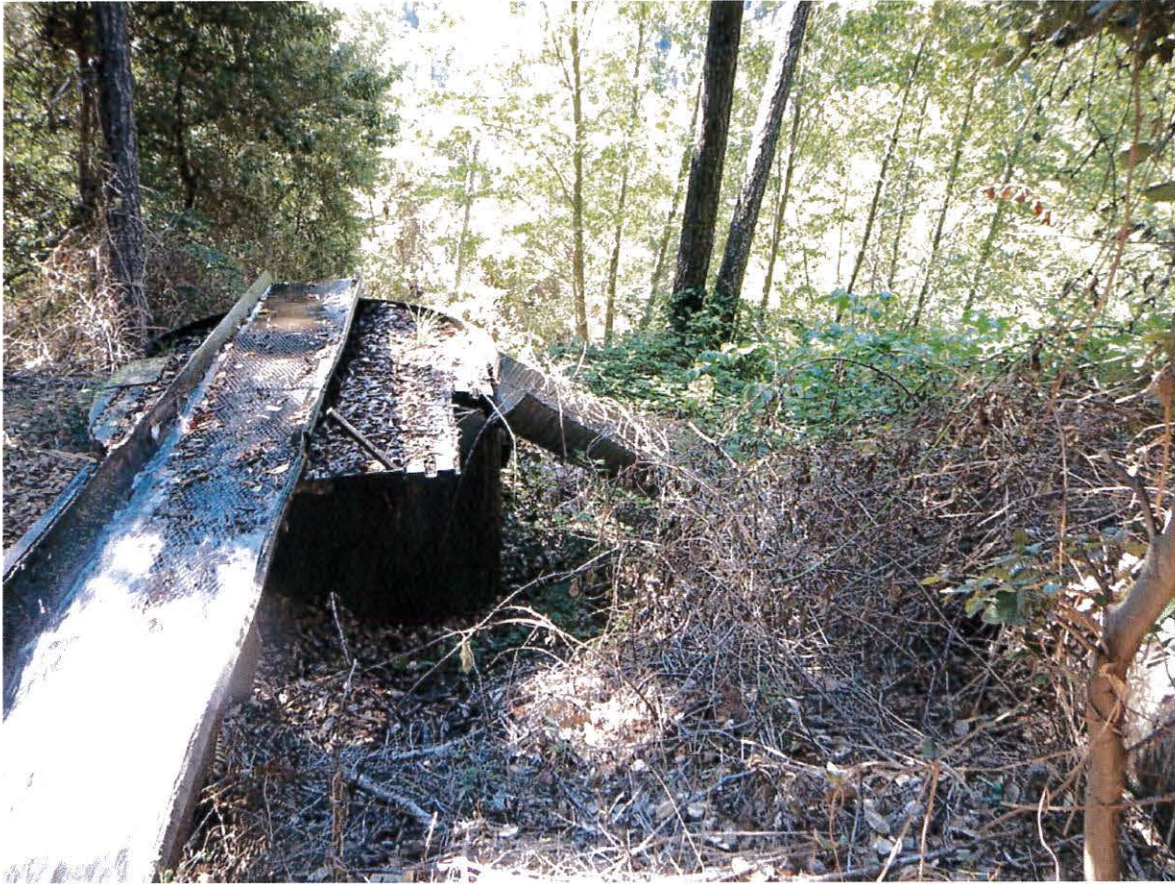
Photograph 7. Forebay to pressurized system. Flows enter system through the screen in the half pipe section.

Water conveyed to the forebay travels along lined and unlined ditches to the forebay tank where the water is screened for debris and enters the pressurized conveyance system. Water is conveyed a horizontal distance of about 430 feet and a vertical distance of about 200 feet through 13.5 inch interior diameter smooth walled plastic pipe and 14 inch steel pipe to a junction immediately upstream of the power plant. The power plant consists of a Pelton wheel driven by two pressurized jets. Discharge from the power plant is conveyed in a ditch to a pond. The pond is used for recreation and water storage for fire prevention. Flows from the pond are conveyed in a ditch to the south across the ranch, and then drops off a headcut, down a ravine and into Irving Creek. Excess diversion leaving the pond and flowing towards Irving Creek were measured on one occasion to be about 1 cfs. The water used for power generation is not re-used for irrigation or domestic purposes.

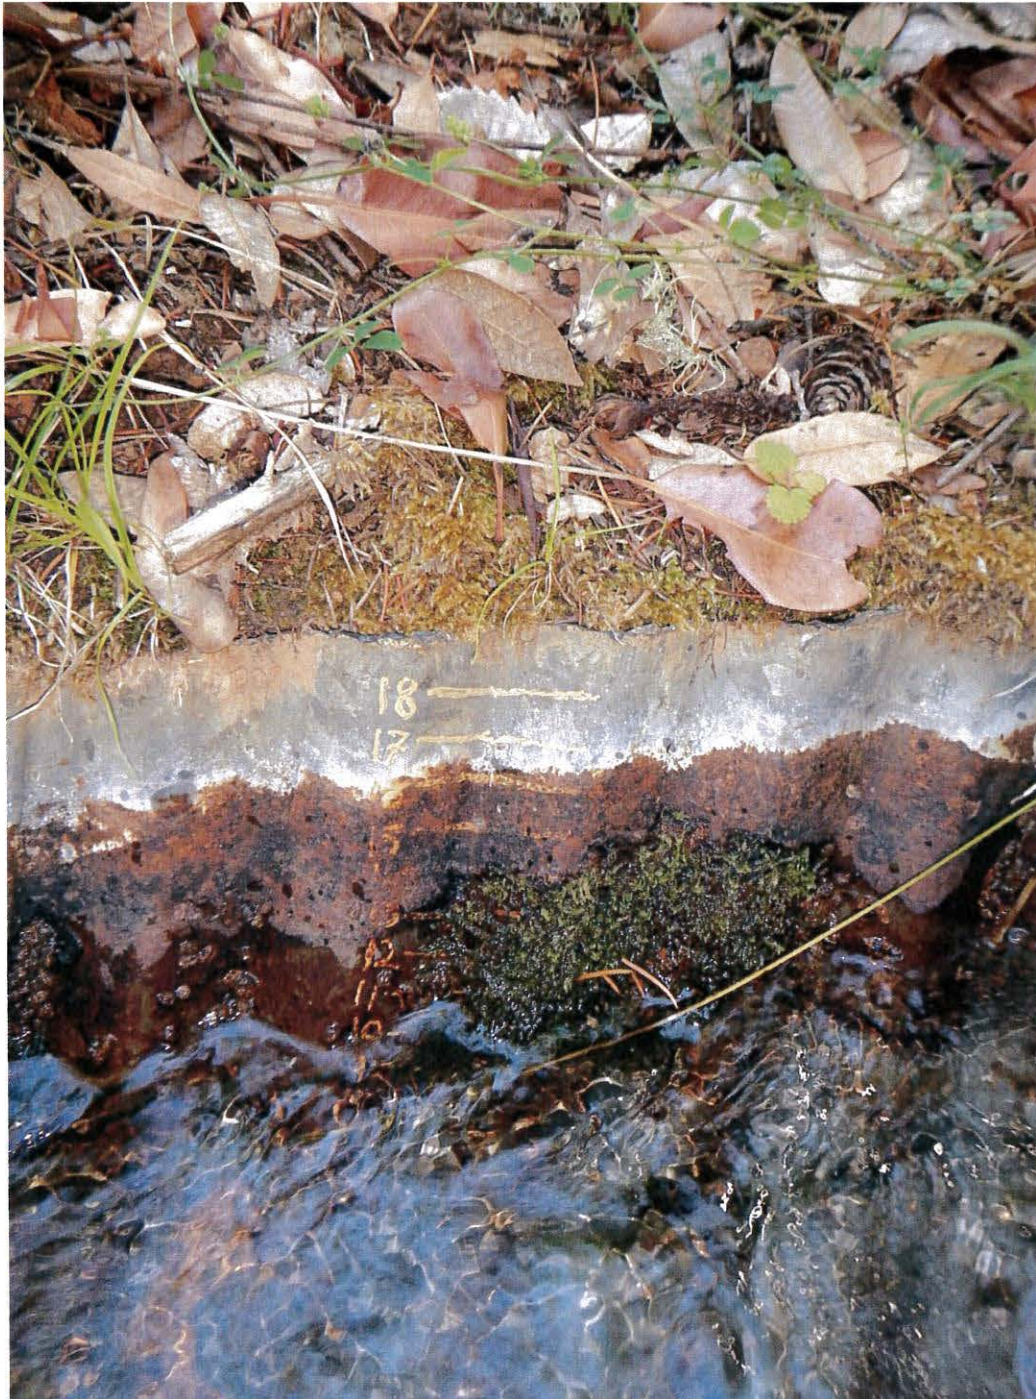
Photograph 8. Stanshaw Gage developed by Douglas Cole.

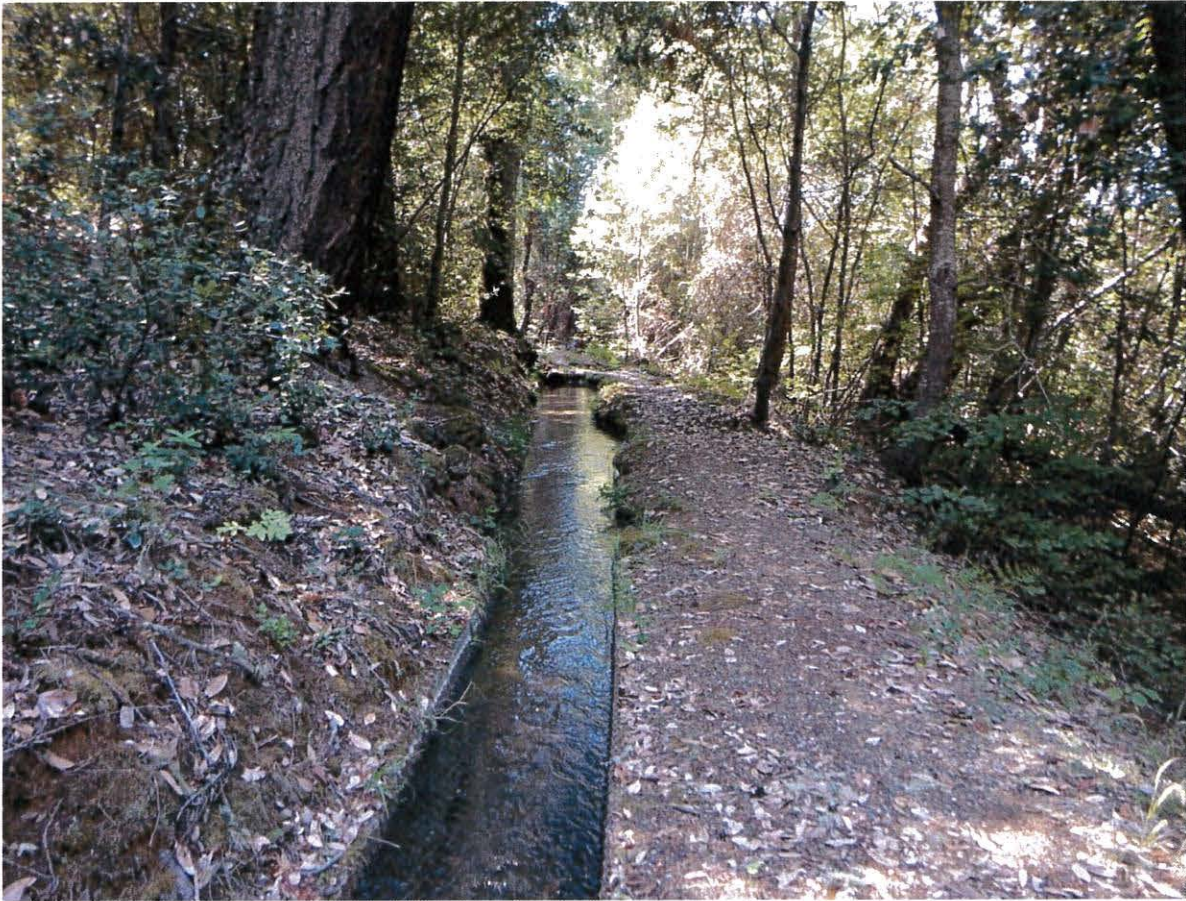
Photograph 9. HDPE pipe lining ditch.

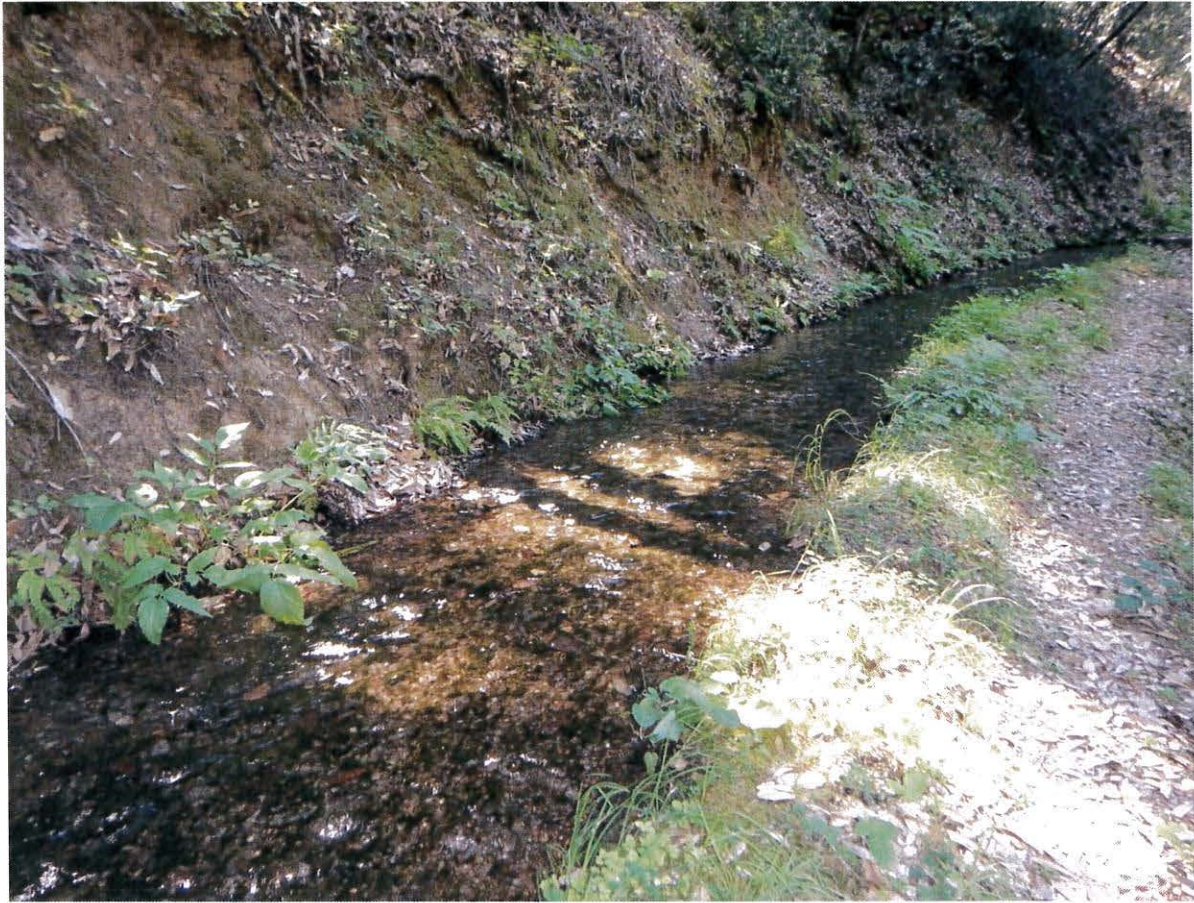
Photograph 10. Unlined ditch.

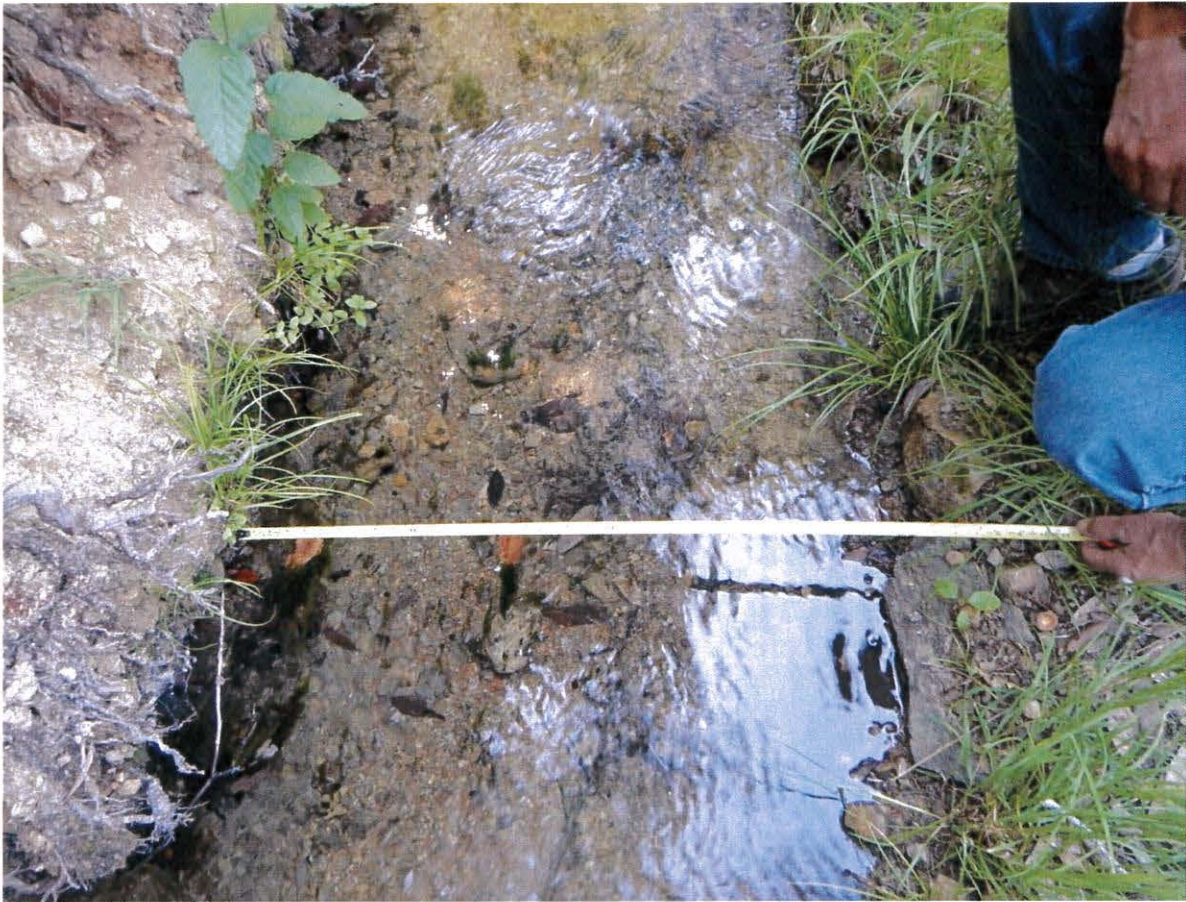
Photograph 11. Narrow location in canal, top width about 3.3 feet

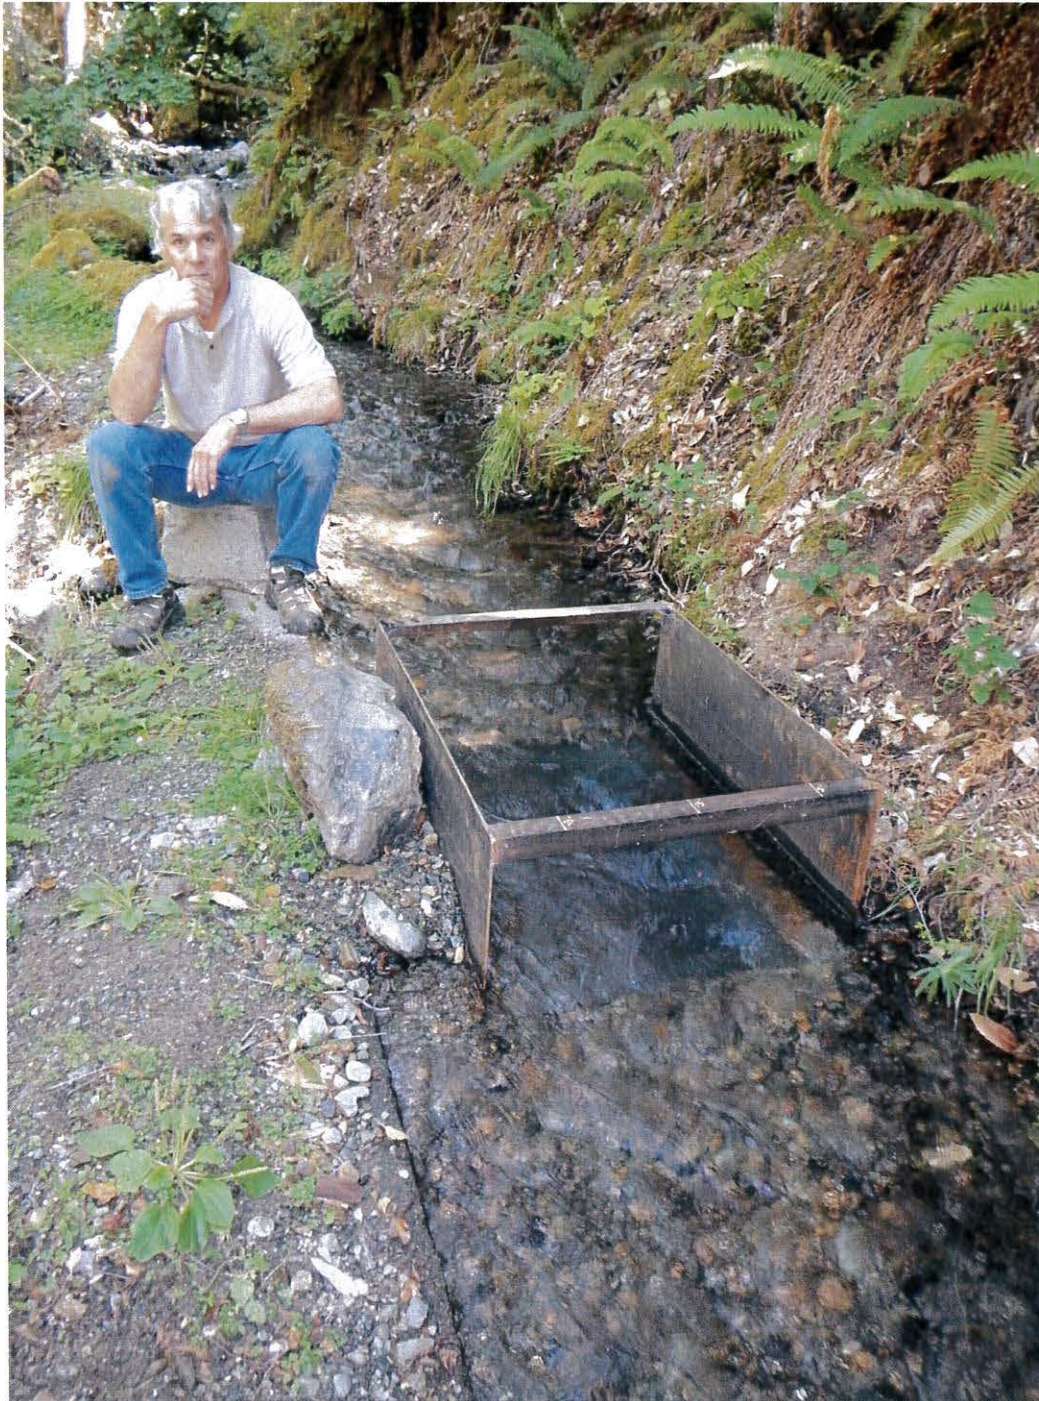
Photograph 12. Measurement Point A established by Douglas Cole near point of diversion.

In addition to these reported measurements, in June of 2013, Doug Cole established three measurement locations to quantify flow through his diversion system. These locations are shown in Figure 1. They consist of rectangular metal boxes 1.57 feet deep by 2.5 feet wide. Mr. Cole measures velocity and flow depth at 0.417 feet (5 inches), 1.25 feet (15 inches), and 2.083 feet (25 inches) from the interior box edge to compute a flow rate. Measurement location A is near the point of diversion, B is located between the treated water and power/irrigation flow junction, and C is located near the outlet of the pond.

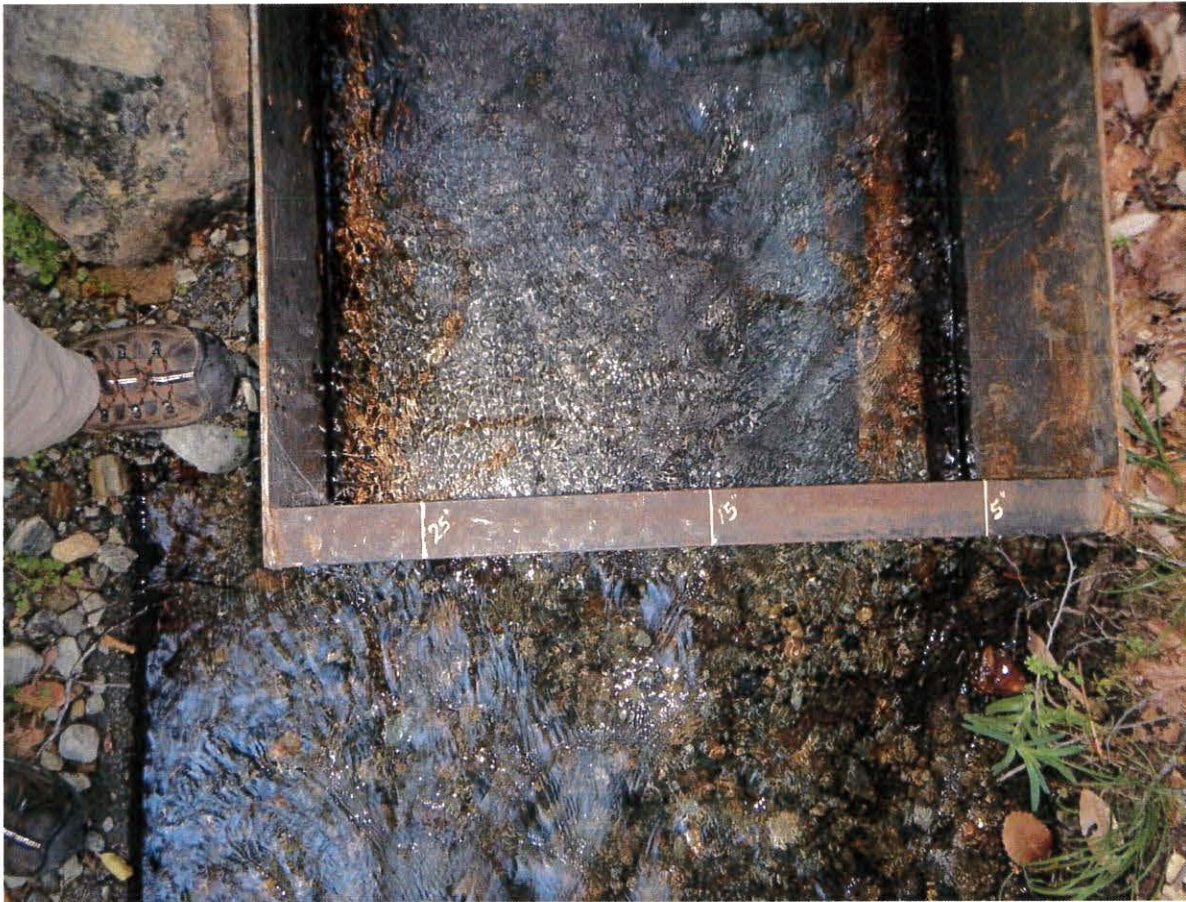
Photograph 13. Markings on metal bar indicate measurement locations.
