Marble Mountain Ranch Water Rights Investigation: Water Use Technical Memorandum

Prepared for:
Mid Klamath Watershed Council
38150 California 96
Orleans, California 95556
Contact: Will Harling

Prepared by:
Cascade Stream Solutions, LLC
295 E. Main, Suite 11
Ashland, OR 97520
Contact: Joey Howard, P.E.

Water Use Technical Memorandum

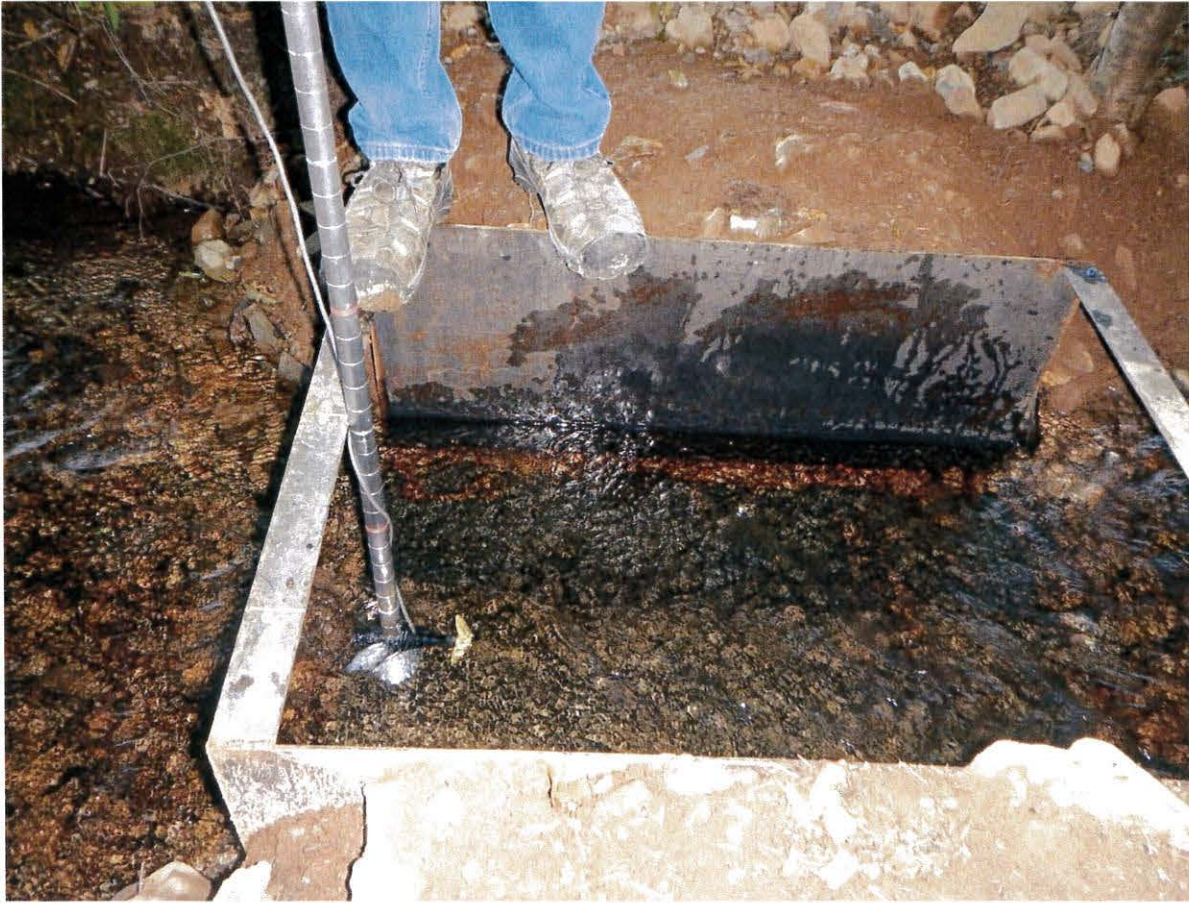
Photograph 14. Measurement conducted using Swoffer meter.

Cascade measured flows at flow measurement points A, B, and C on August 27, 2013. Measured flows are listed in Table 11. At the time of the measurements, 1.68 cfs was diverted into the ditch near the point of diversion. A combined amount of about 0.36 cfs was treated for use as potable water or infiltrated into the unlined ditch. About 1 cfs was discharged to Irving Creek. At the time of the measurement, the diesel generator was operating because diversion flows were insufficient for hydropower generation. As stated in Section 5.2, the electrical transmission system is currently setup to only accept power from one generation source: hydropower generator or diesel generator. At the time of these measurements, Cascade identified the maximum transmission loss was less than 0.36 cfs, the maximum consumptive use was 0.68 cfs, there was no hydropower generation, and flow discharged to Irving Creek was about 1 cfs.
