Marble Mountain Ranch Water Rights Investigation: Water Use Technical Memorandum

18 November 2014

Marble Mountain Ranch Water Rights Investigation

Water Use Technical Memorandum

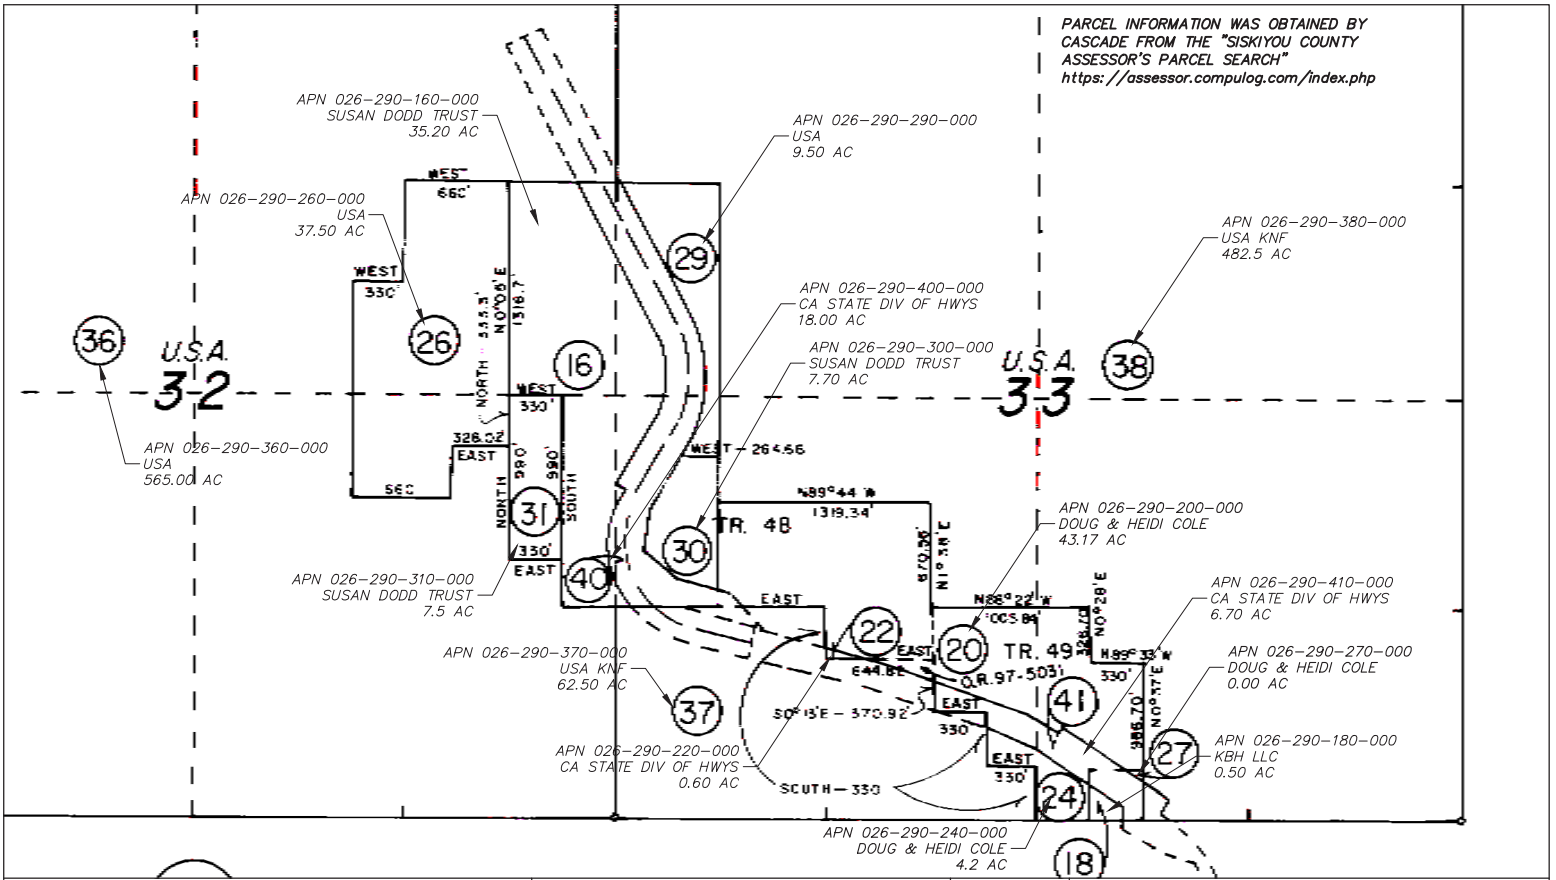
Marble Mountain Ranch is located along Highway 96 in Somes Bar, California (Latitude 41° 28' 00", Longitude 123° 30' 12"). The Cole family own and operate the ranch, which presently serves as a commercial guest ranch that provides activities such as horseback trail riding, whitewater rafting, kayaking, shooting, fly fishing, and boating activities for guests. The ranch is located on properties identified by Siskiyou County Assessor Parcel Numbers (APN) 026-290-200-000 (43.17 acres), 026-290-240-000 (4.20 acres), 026-290-270-000 (0.00 acres). It should be noted that APN 026-290-270-000 likely has an area between 0.05 and 0.1 acres, based Cascade's review of Assessor Parcel Maps and Google Earth parcel boundaries. Figure 1. Provides ownership and parcel information from the Siskiyou County Tax Assessor.

PARCEL INFORMATION WAS OBTAINED BY CASCADE FROM THE "SISKIYOU COUNTY ASSESSOR'S PARCEL SEARCH" <https://assessor.compulog.com/index.php>

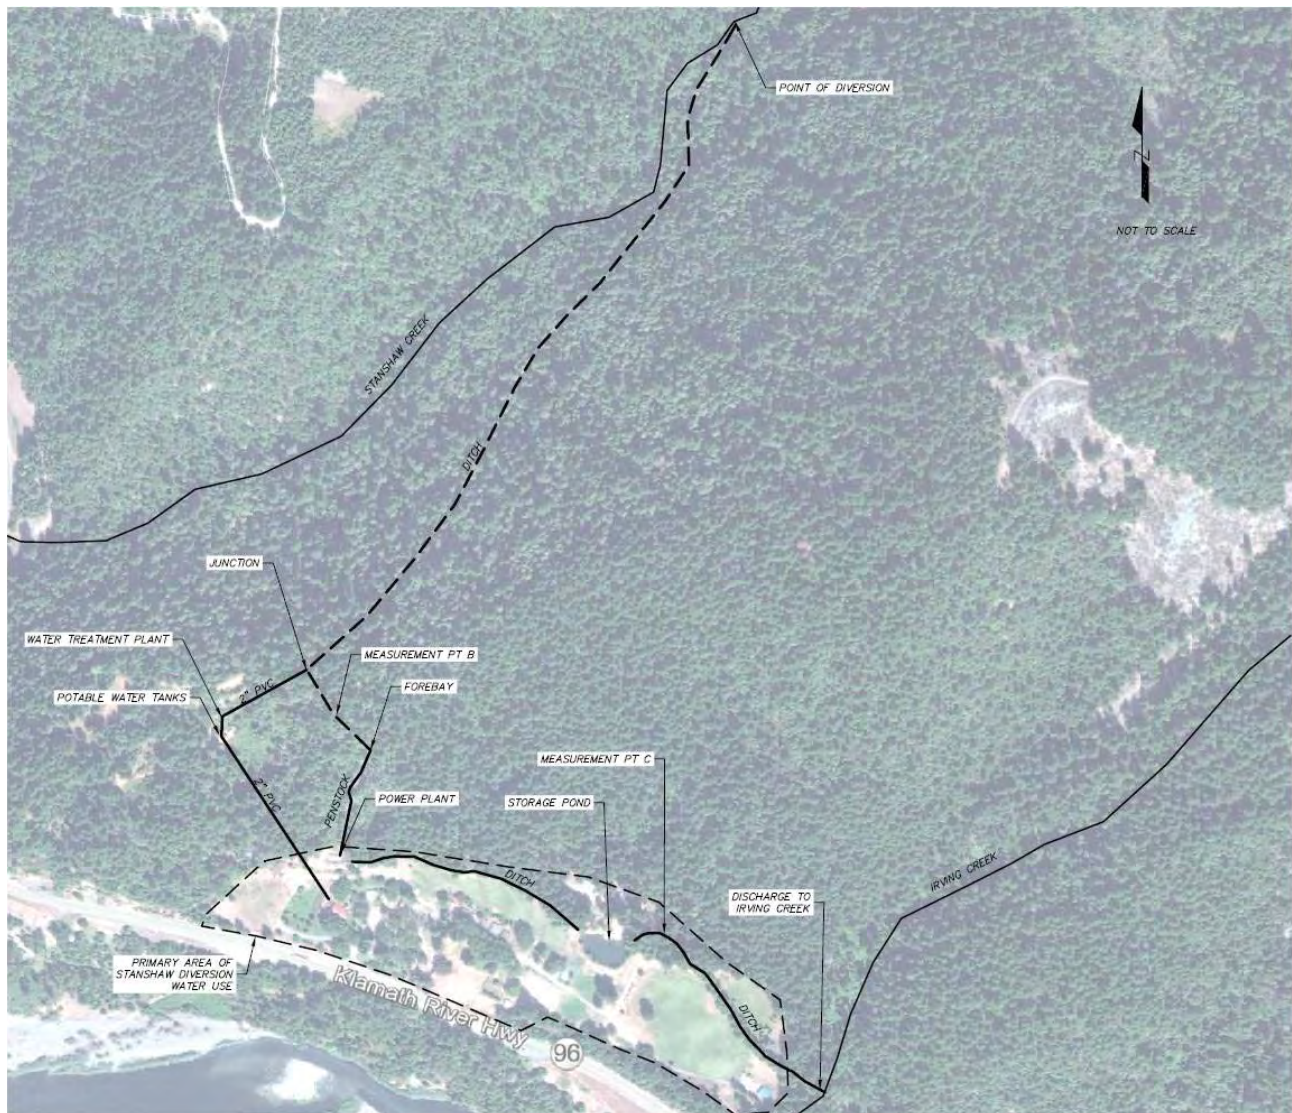
Figure 2. Water Conveyance Map

The point of diversion is located on Stanshaw Creek about 0.68 miles upstream of the Highway 96 crossing. A channel spanning gravel and cobble push-up dam diverts water that does not seep through the dam into a diversion ditch. The amount diverted typically varies with available stream flow, independent of demand. Under typical late spring, summer, and fall flow conditions (less than about 3 to 4 cfs), the majority of creek flow is diverted into the ditch. Conveyance from the point of diversion to the ranch is gravity driven. Flows are conveyed from the point of diversion about 0.5 miles to a junction where flows can be conveyed to a water treatment plant to the southwest, and to a forebay and penstock to the southeast that services the power generation facility and the pressurized irrigation system. The conveyance structures between the point of diversion and the junction consists of unlined and lined reaches of ditch. The lined reaches are lined with culvert pipe cut to form half round pipe sections. These semi-circular pipe sections include corrugated HDPE pipe with smooth interior walls and corrugated metal pipe. One section of pipe was measured to be 30 inches in diameter. The other sections appeared to be the same diameter.

Water conveyed to the forebay travels along lined and unlined ditches to the forebay tank where the water is screened for debris and enters the pressurized conveyance system. Water is conveyed a horizontal distance of about 430 feet and a vertical distance of about 200 feet through 13.5 inch interior diameter smooth walled plastic pipe and 14 inch steel pipe to a junction immediately upstream of the power plant. The power plant consists of a Pelton wheel driven by two pressurized jets. Discharge from the power plant is conveyed in a ditch to a pond. The pond is used for recreation and water storage for fire prevention. Flows from the pond are conveyed in a ditch to the south across the ranch, and then drops off a headcut, down a ravine and into Irving Creek. Excess diversion leaving the pond and flowing towards Irving Creek were measured on one occasion to be about 1 cfs. The water used for power generation is not re-used for irrigation or domestic purposes.

Mr. Cole monitors diversion flow at a location in the canal downstream of the junction point that provides water to the water treatment plant. Water levels are monitored in a half section of corrugated metal pipe. He has marked the inner diameter of a 30 inch diameter corrugated metal pipe to create water level gage that he refers to as the Stanshaw Gage and the units as Stanshaw Units. At flows below 13.3 Stanshaw Units¹, there is insufficient water to generate hydropower to meet demand. The Ranch's power system is currently configured to accept power from one generation source: the hydropower generator or diesel generator. When Stanshaw Creek diversions are insufficient to meet all demands, the Ranch relies on a diesel generator for power and water is generally consumed for irrigation and guest needs. Diversion flows are not reduced when hydropower generation ceases. During these times, flows in excess of the flow required for irrigation and domestic use are conveyed to Irving Creek.

In addition to these reported measurements, in June of 2013, Doug Cole established three measurement locations to quantify flow through his diversion system. These locations are shown in Figure 1. They consist of rectangular metal boxes 1.57 feet deep by 2.5 feet wide. Mr. Cole measures velocity and flow depth at 0.417 feet (5 inches), 1.25 feet (15 inches), and 2.083 feet (25 inches) from the interior box edge to compute a flow rate. Measurement location A is near the point of diversion, B is located between the treated water and power/irrigation flow junction, and C is located near the outlet of the pond.

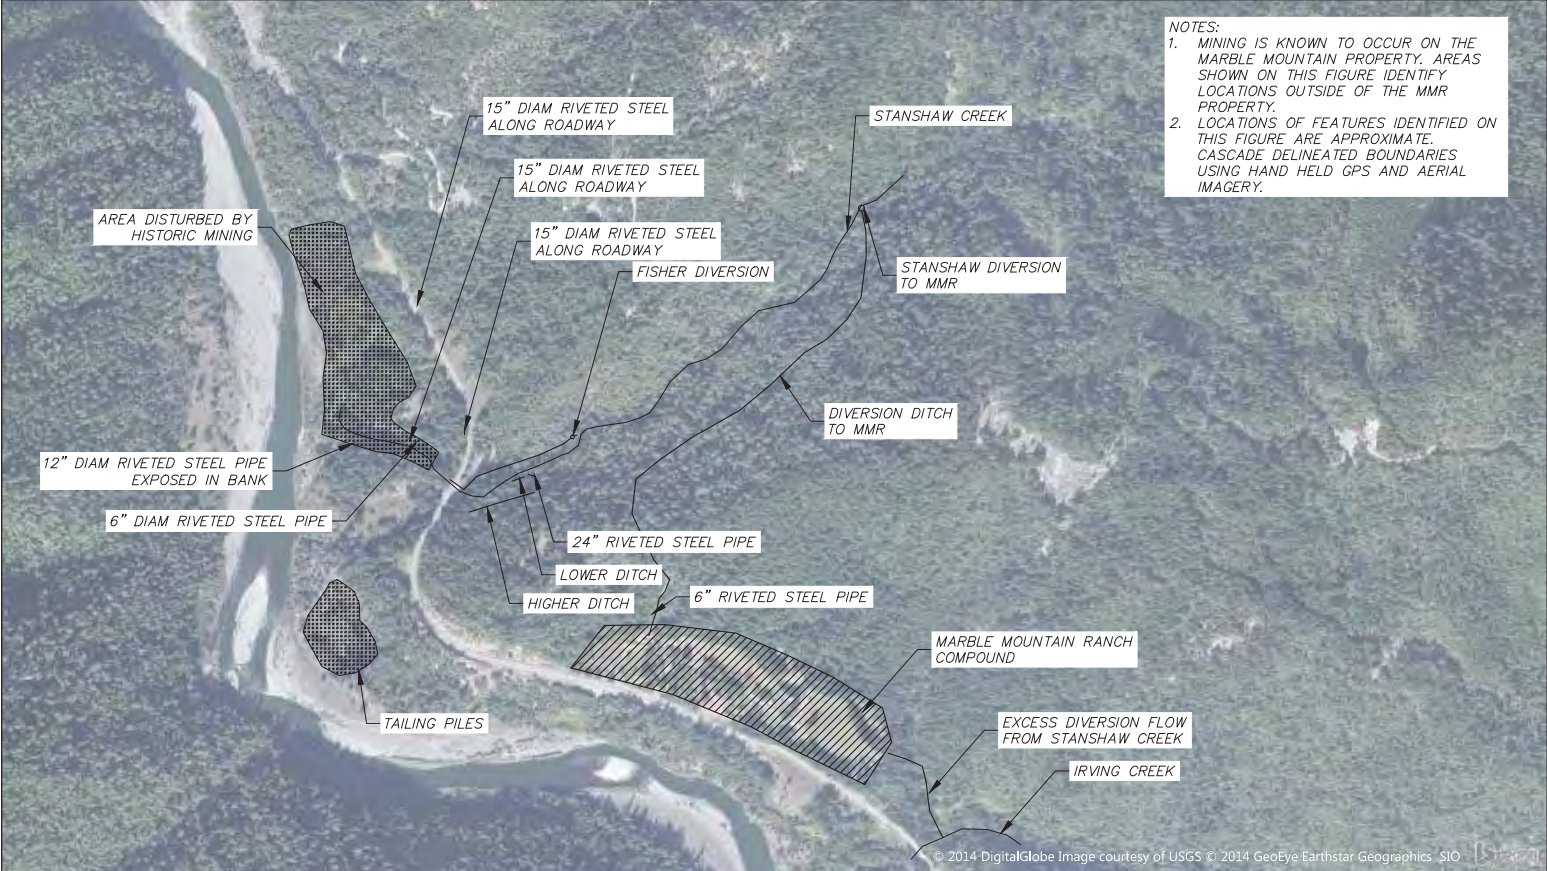
Marble Mountain Ranch
Water Rights Investigation
 Figure 3. Location Map of Historical Mining
 Artifacts and Areas of Disturbance

The original water right claim was for 15 cfs. Cascade does not have documentation of how much water was actually used for hydraulic mining. The land area upon which mining could have occurred was much larger than the current area of MMR. Stanshaw Creek flow may have been higher in historic times than it is today. However, it is not likely that Stanshaw Creek flowed at a rate sufficient to allow diversions of 15 cfs except possibly during very high flow periods. In any event, during the late 1800's and early 1900's, the majority of the water used was probably for mining, with smaller amounts devoted to domestic and irrigation purposes. This pattern probably persisted from the 1860's to the time hydraulic mining activities decreased and then ceased. From about 1920's or early 1930's to the early or mid-1950's, a period of approximately 15-30 years, seasonal irrigation appears to be the primary consumptive use with lesser amounts used for year round domestic purposes. Figure 3 shows locations outside of the Marble Mountain Ranch Property where mining related activities likely occurred.

NOTES:
 1. MINING IS KNOWN TO OCCUR ON THE MARBLE MOUNTAIN PROPERTY. AREAS SHOWN ON THIS FIGURE IDENTIFY LOCATIONS OUTSIDE OF THE MMR PROPERTY.
 2. LOCATIONS OF FEATURES IDENTIFIED ON THIS FIGURE ARE APPROXIMATE. CASCADE DELINEATED BOUNDARIES USING HAND HELD GPS AND AERIAL IMAGERY.

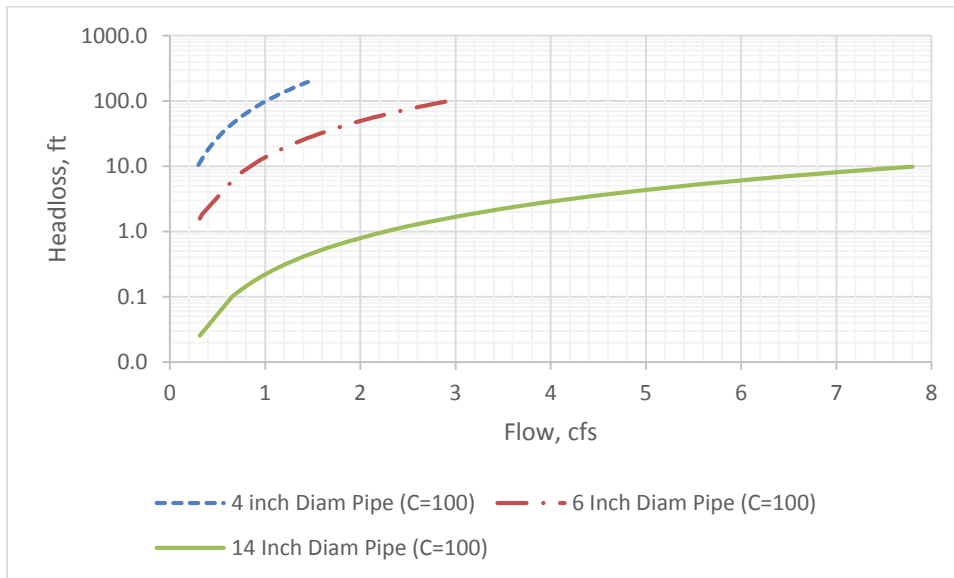
Figure 4. Pipe Headlosses

The flow rate required to generate power is a function of the total static head minus the headlosses referred to herein as net head. Headlosses include losses due to pipe friction and minor losses such as at the inlet, bends, reducers, and outlet. For the purposes of this investigation, minor losses were considered to be small compared to friction losses in the pipe. Because we don't know the true pipe size used to convey water from the ditch to the power plant at the time Lue Hayes purchased the property, Cascade modeled headloss and potential power generation from a 4 inch and 6 inch diameter pipe as well as the 14 inch pipe that currently conveys water down the hillslope, a vertical distance of about 200 feet. As illustrated in Figure 2, the pipe diameter can significantly influence headloss. The headloss curves shown in Figure 2 were computed assuming a pipe length of 500 feet, the estimated

length of the pipe, using Hazen-Williams formula for headloss. The loss coefficient was assumed to be 100, which is often used for “old unlined or tar-dipped cast-iron pipes in good condition” (Roberson et al. 1998). Figure 3 shows the change in net head with flow at the Pelton wheel for three different pipe sizes: a 4 inch diameter pipe, the pipe diameter Hayes stated conveyed water to the Pelton wheel prior to his purchase of the property; a 6 inch diameter pipe, the diameter of pipe that currently is abandoned near the existing 14 inch pipe; and a 14 inch pipe, which currently exists. Assuming a static head of 200 feet, the net head decreases dramatically with flow in a 4 inch diameter pipe and is relatively constant in a 14 inch pipe as shown in Figure 3.

Equation 3. Hazen-Williams Headloss Equation (Imperial Units)

$$h_L = \frac{4.73 * L * Q^{1.852}}{C^{1.852} * D^{4.87}}$$

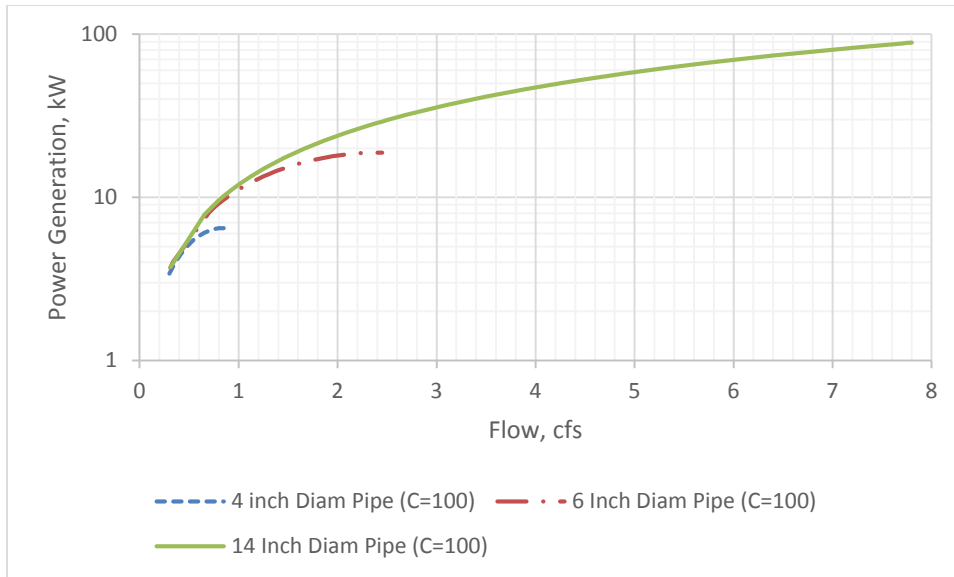
Figure 6. Power Generation Rating Curves

The change in power production is dramatically influenced by the pipe size as shown in Figure 4. Assuming an efficiency of 70 percent for the time prior to Cole’s power plant upgrades, peak power

generation of 6.47 kW occurs at a peak flow of 0.85 cfs for a 4 inch diameter pipe, 18.8 kW at a flow of 2.4 cfs for a 6 inch diameter, and 174 kW at a flow of 22 cfs for a 14 inch pipe (the current pipe size.) These estimates are based on a static head of 200 feet, Hazen-Williams coefficient of 100, and pipe length of 500 feet and were calculated using Equation 1.

Cascade developed power flow rating curves to estimate power production using readily available information and standard engineering equations. Energy production from a Pelton wheel can be characterized as a function of the fluid density (ρ), acceleration due to gravity (g), flow rate (Q), total dynamic head (ΔH), and the efficiency of the Pelton wheel and electrical system (μ) as shown in Equation 1. In this case, the fluid is water and assumed to have a constant density of 1000 kg/m³ (62.4 lbs/ft³). Computations are based on a gravitational acceleration of 9.81 m/s² (32.2 ft/s²). Total dynamic head was computed by subtracting the static head by the headloss through the pipe. Headlosses through the pipe was computed using the Hazen-Williams equation. The formula is presented in Equation 2. Power generation efficiency was assumed to be 70 percent prior to Douglas Coles acquisition of the property and 80 percent after his acquisition.

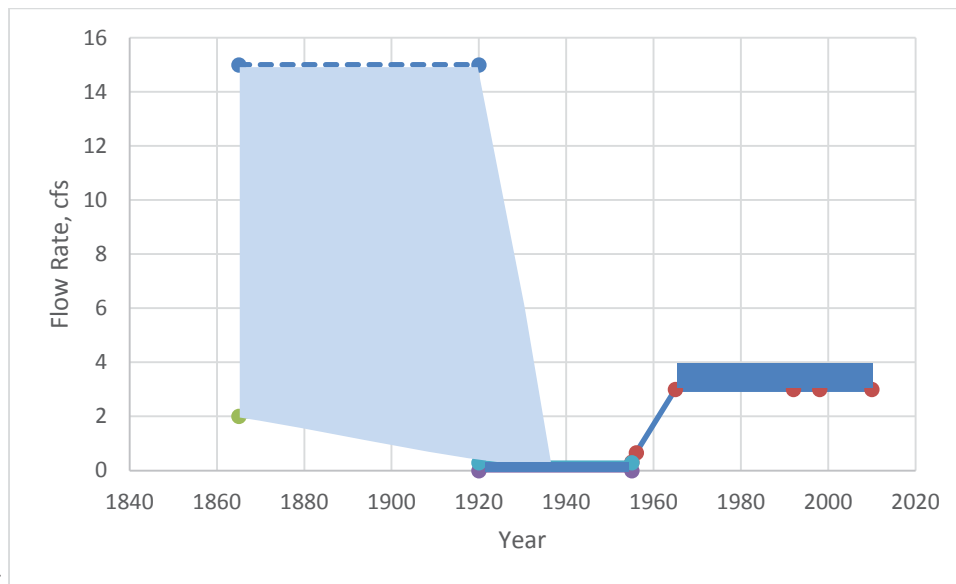
Figure 7. Water Use for Mining and Hydropower Generation

Cascade used the power generation estimates and statements provided by Hayes and Cole as well as readily available information to estimate water use over time. During the active mining period from 1865 to 1920's/1930's, the shaded area in Figure 5 shows the amount of the water right Stanshaw acquired (approximately 15 cfs), and the average summer base flow for Stanshaw Creek (approximately 2 cfs). Diversion rates likely varied seasonally between these ranges, although an analysis of Stanshaw Creek average flows by season (Miller, 2000) showed that even average winter flows are well below 15 cfs. Uses from 1920's/1930's until 1955 when Lue Hayes purchased the property for based on available evidence, was between 0 and 0.36 cfs. Figure 2 illustrates how water use for mining and hydropower has changed over time.

Date	Mining, cfs	Hydropower, cfs
1860's- 1920's or 1930's	up to 15	0-0.36 ³
Pre-1955 ¹	0.00	0.00 to 0.36 ^{2,3}
1955 ¹	0.00	0.36 ^{2,3}
1960 ¹	0.00	0.66 ^{2,4}
1965 ¹	0.00	3 ²
1998 ²	0.00	3
2010 ²	0.00	3 to 3.5

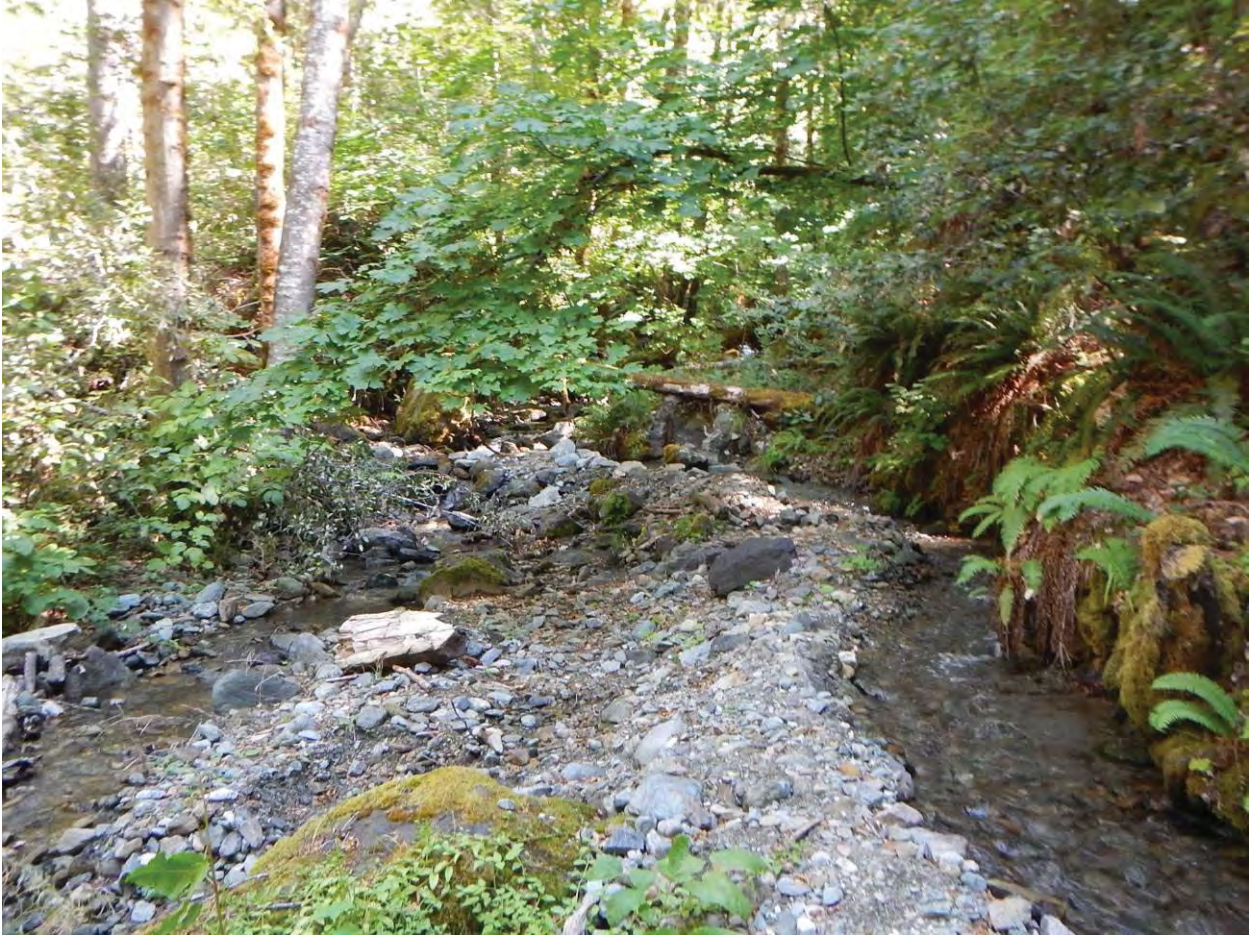
Photograph 1. Point of Diversion on Stanshaw Creek

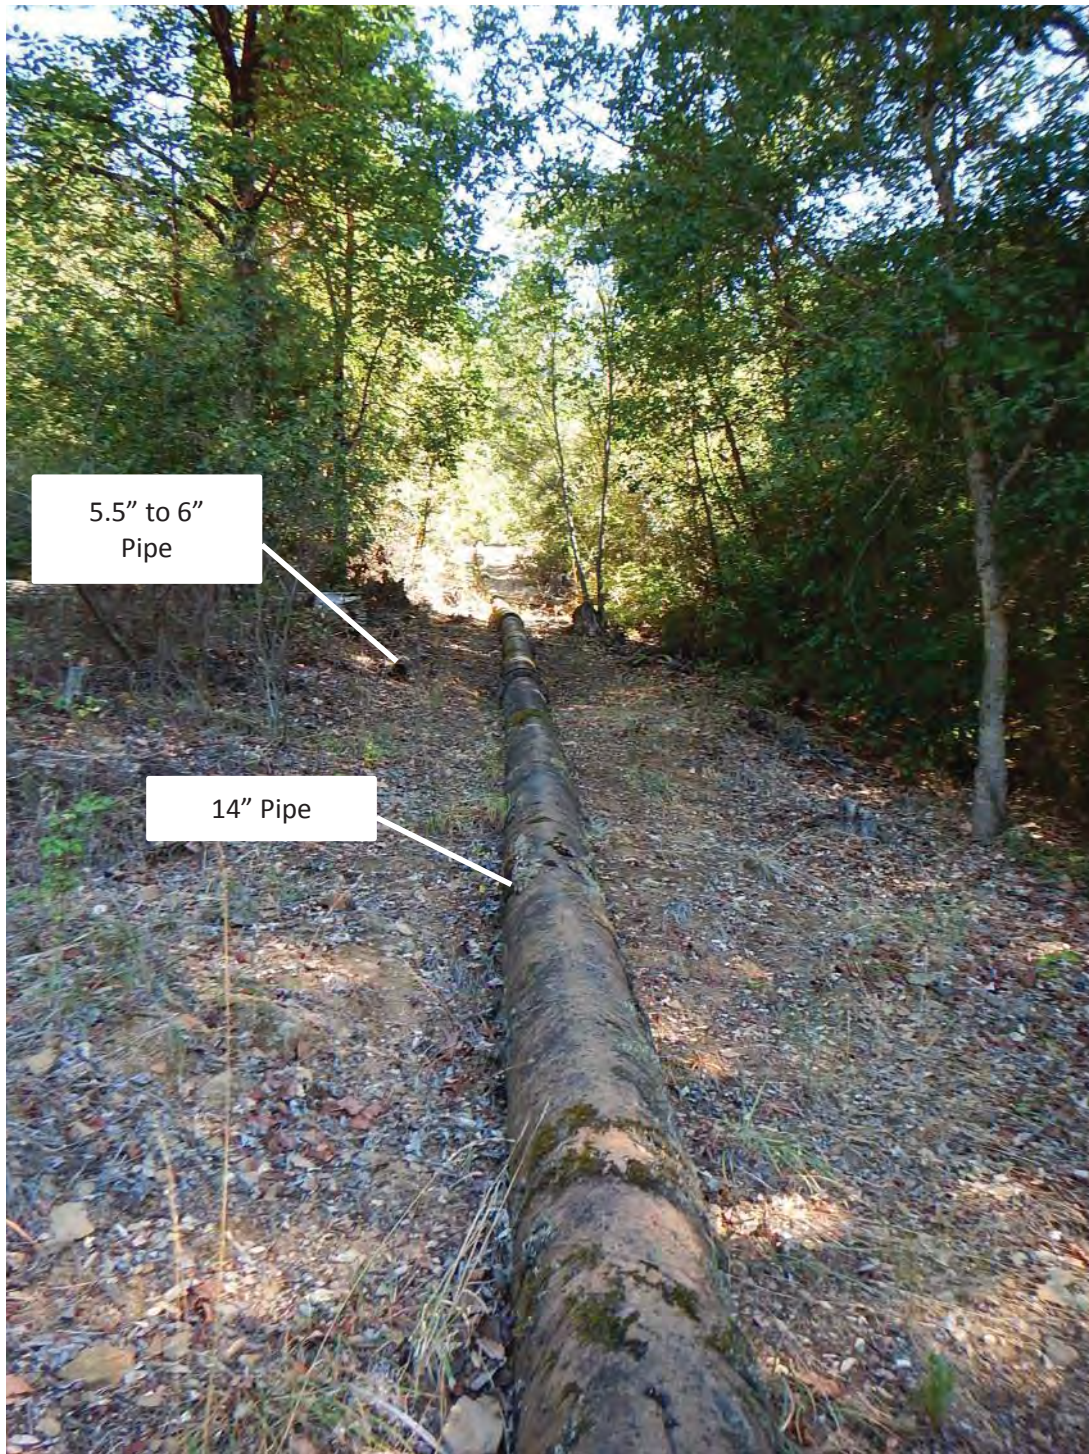
Photograph 2. 14" Diameter Penstock installed by Lue Hayes after he purchased the property in 1955.

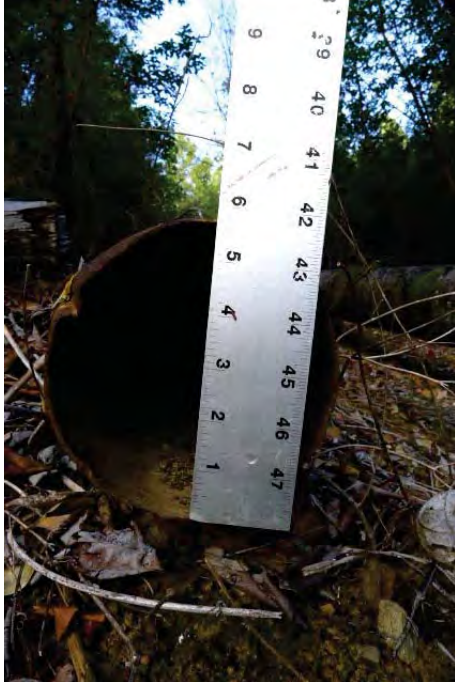
Photograph 3. Pipe adjacent to 14" Pipe. End of pipe was crimped making estimation of Interior diameter imprecise.

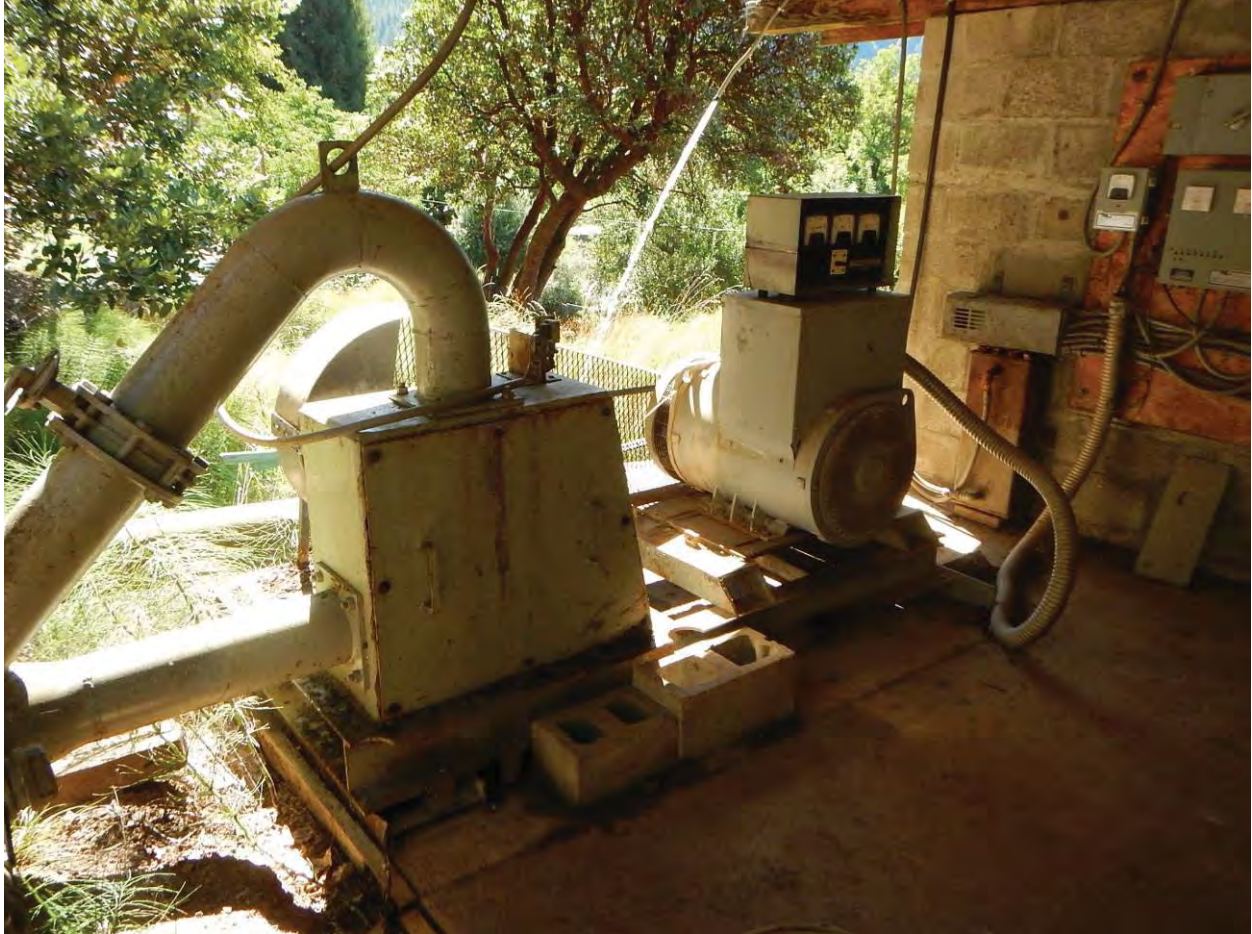
Photograph 4. Micro-hydro power plant diversion flows enter from the pipes on the left of the photograph. Heated effluent from the heat sink resistor is visible near the top of the photograph near the roof beam.

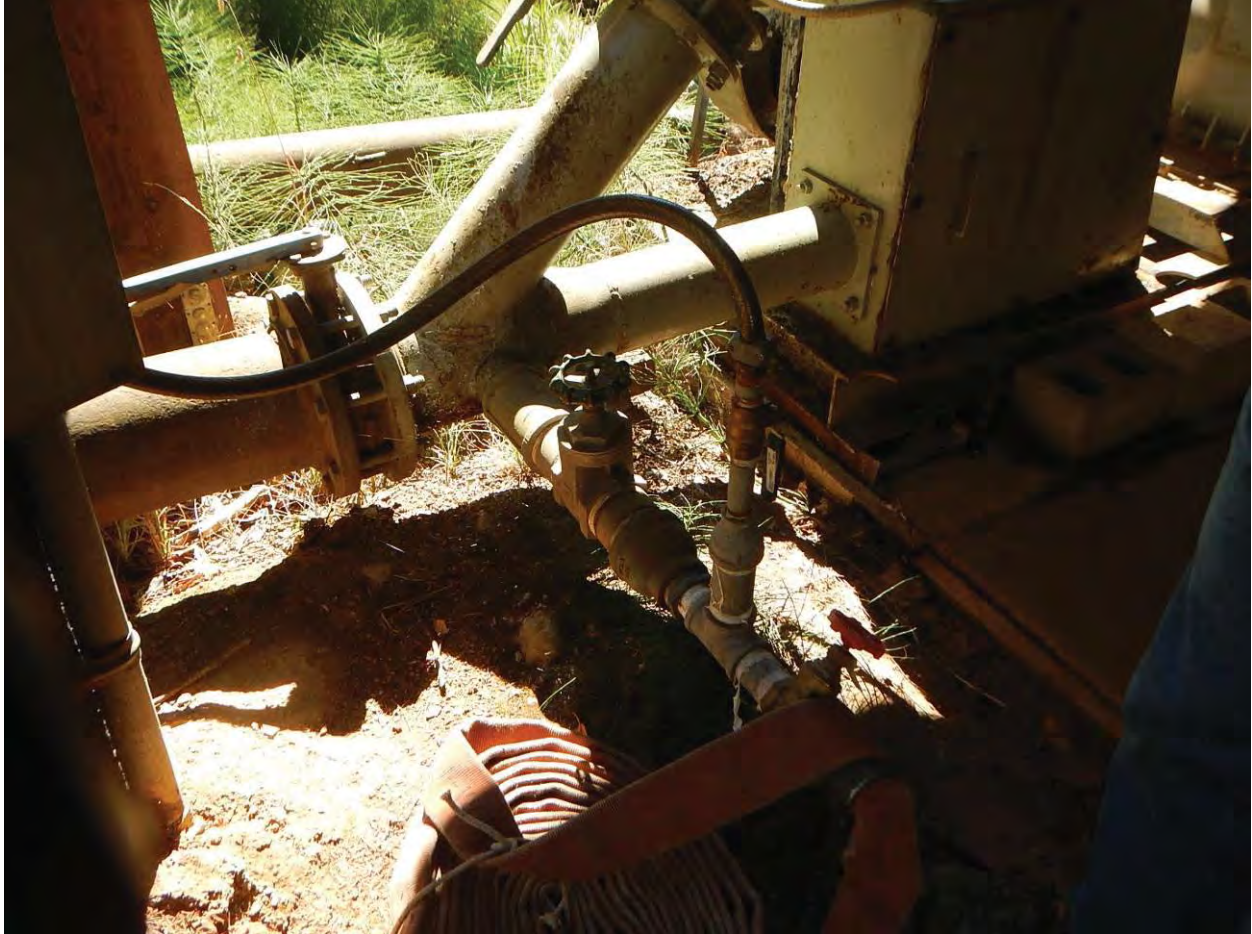
Photograph 5. Junction near hydro-power unit. Large diameter pipes convey water to Pelton wheel. Small diameter pipe that tees at a 90 degree angle conveys water to heat sink resistor and hose.

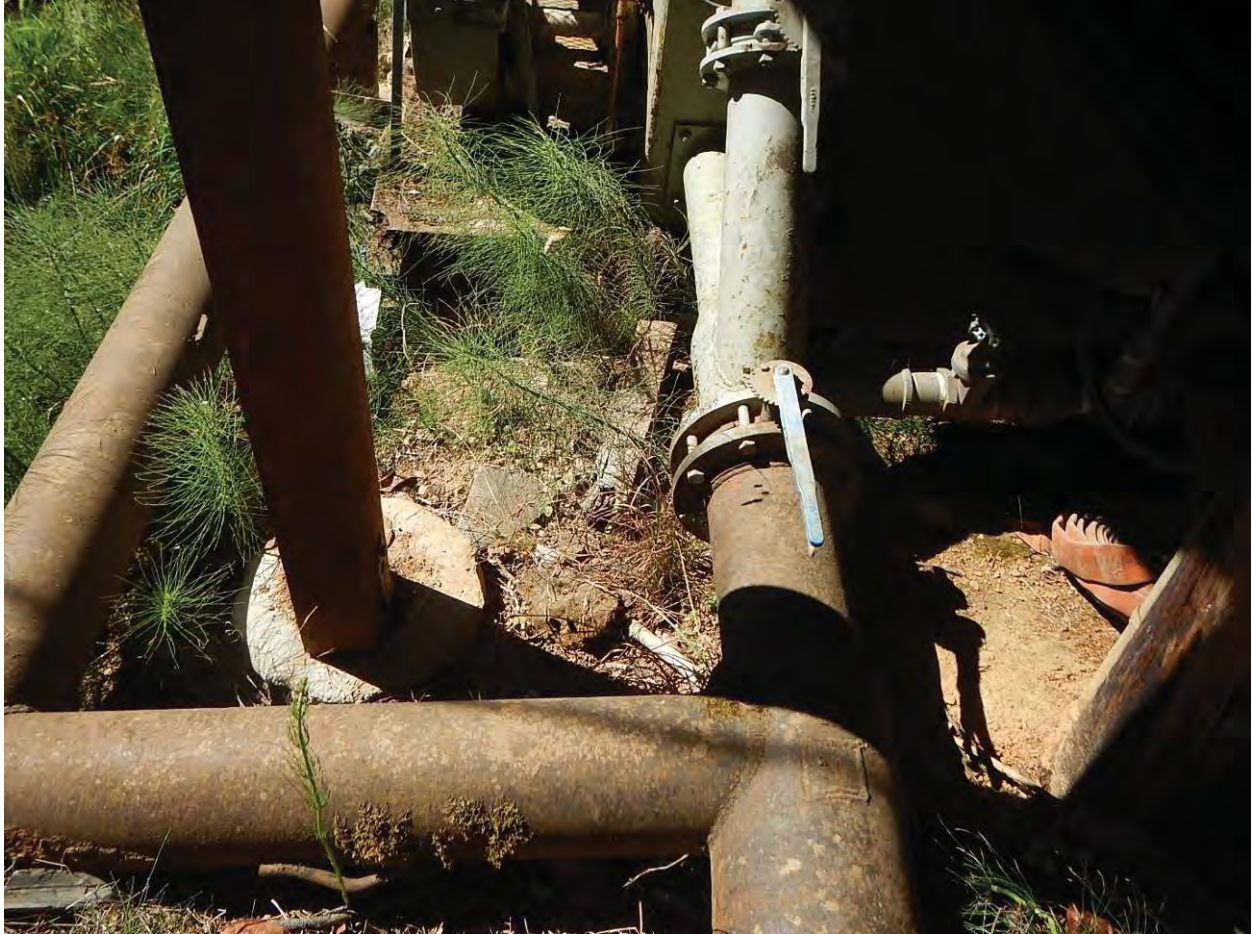
Photograph 6. Junctions near power plant. Tee near the bottom of the photograph serves as junction for flow to power plant and irrigation system. Flow conveyed into the pipe to the left of the photograph serves the irrigation system.

Irrigation and fire prevention flows are conveyed through a short run of nine inch diameter steel pipe to four inch diameter PVC pipe that extends from the junction at the power plant to sprinkler guns located in pastures and hose bibs and couplers located throughout the property.

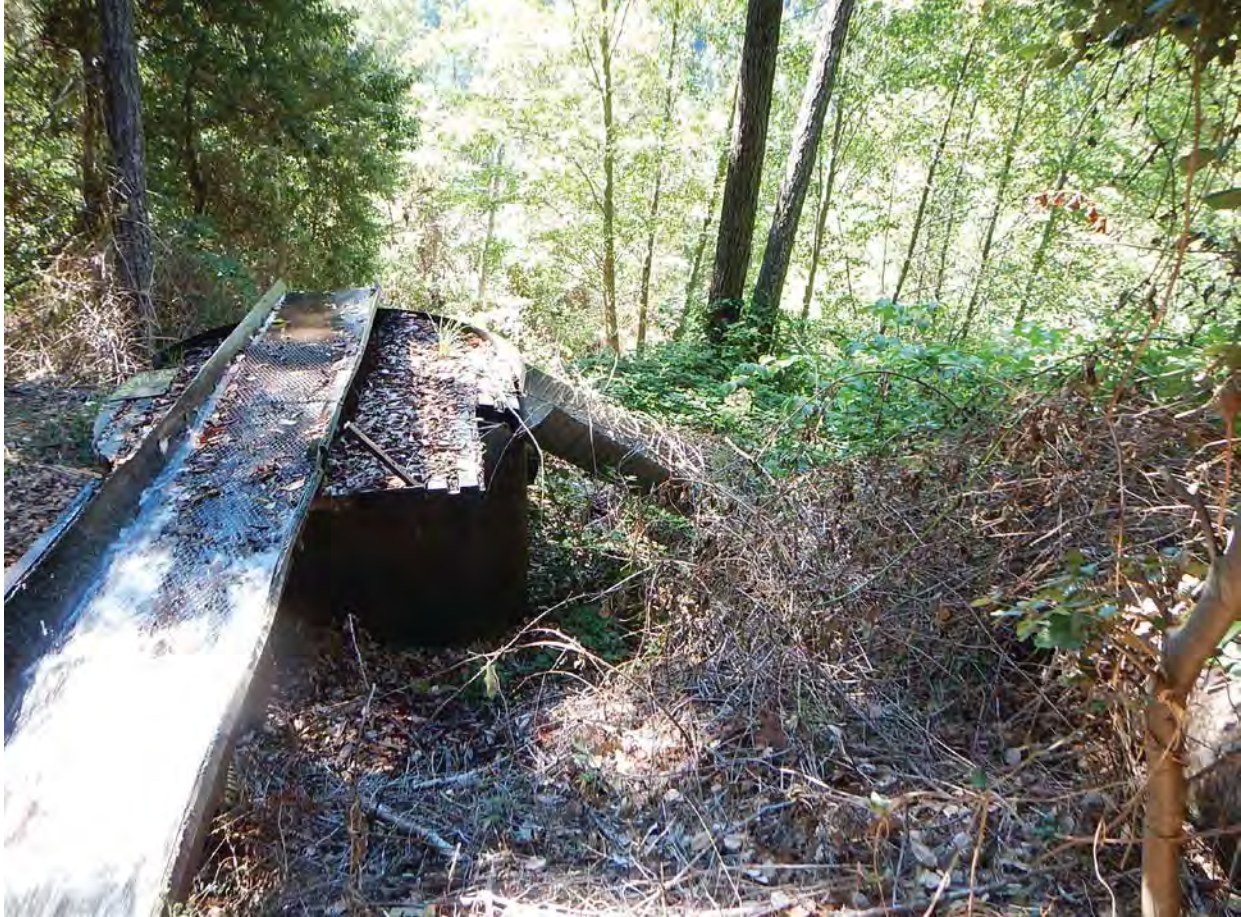
Photograph 7. Forebay to pressurized system. Flows enter system through the screen in the half pipe section.

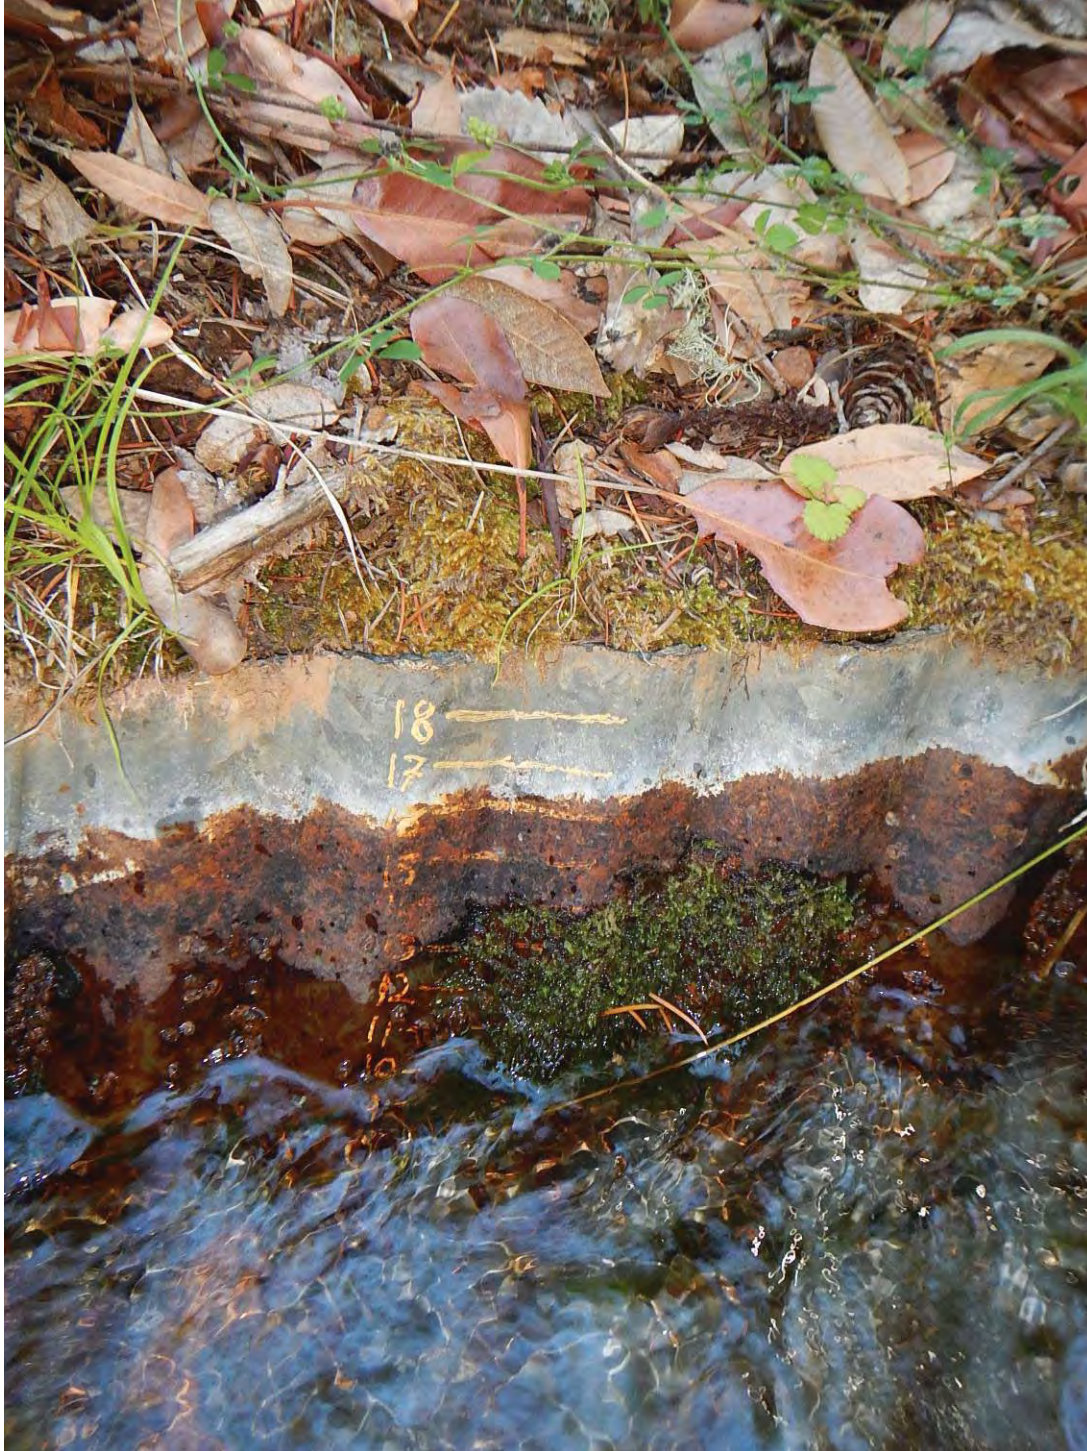
Photograph 8. Stanshaw Gage developed by Douglas Cole.

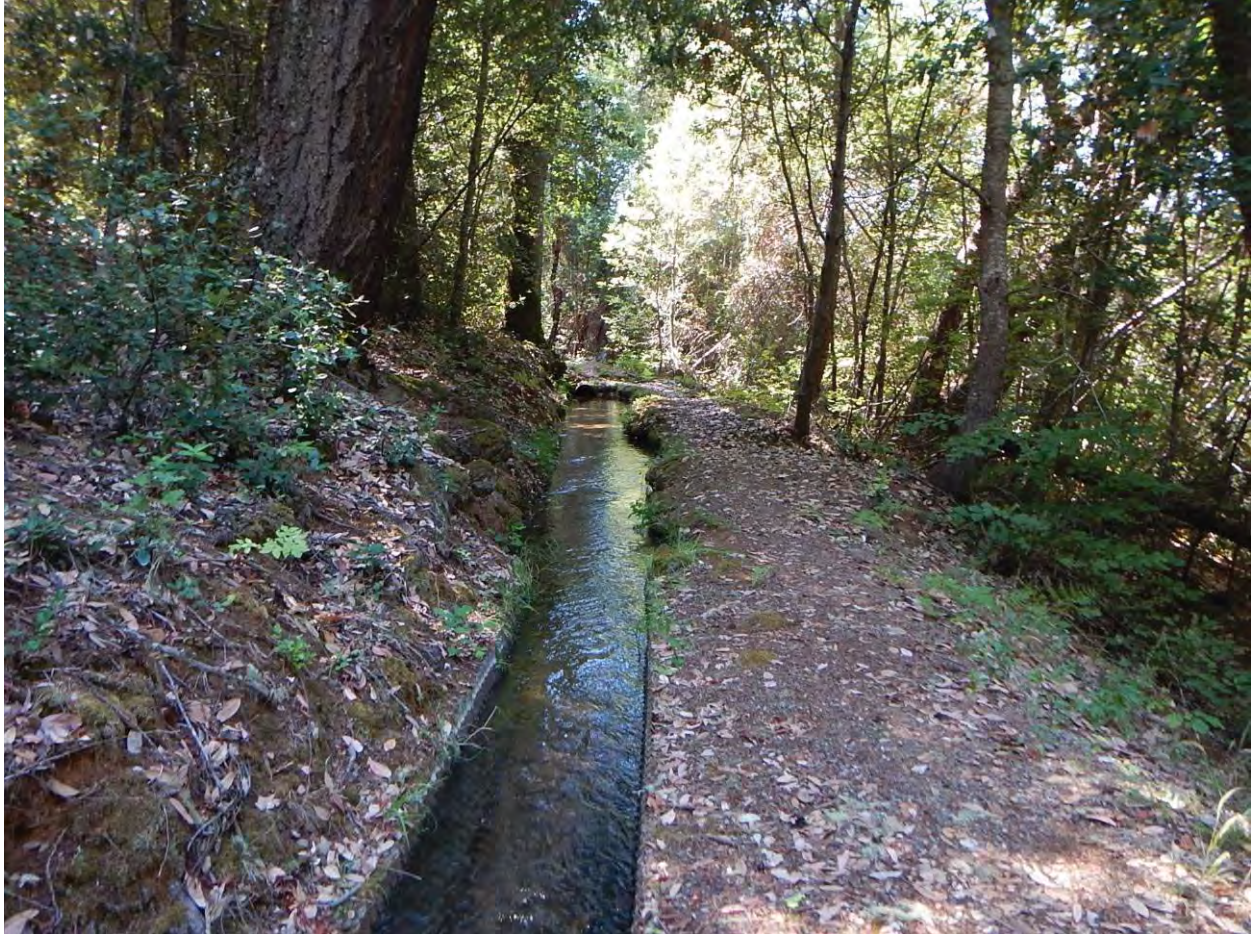
Photograph 9. HDPE pipe lining ditch.

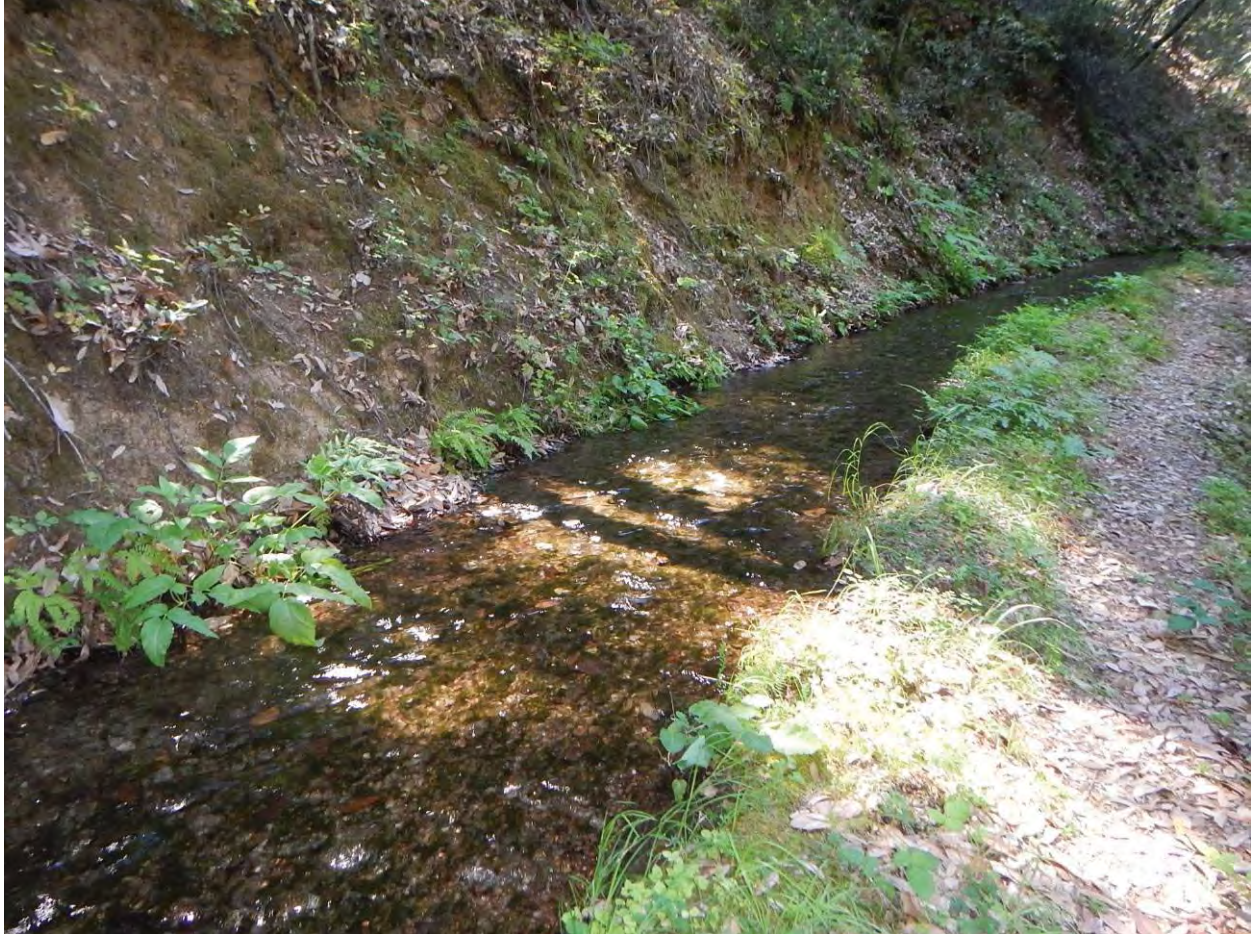
Photograph 10. Unlined ditch.

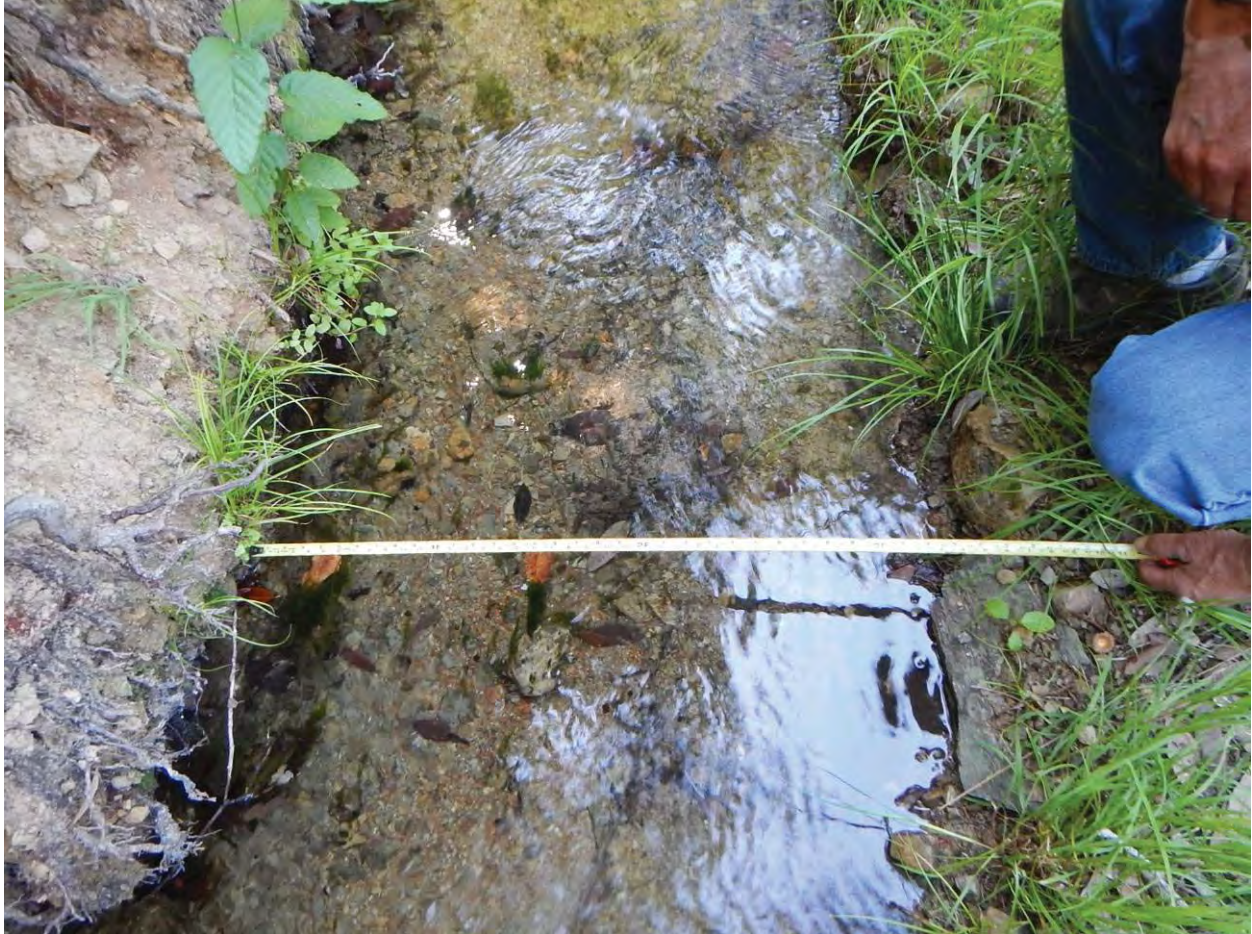
Photograph 11. Narrow location in canal, top width about 3.3 feet
