Marble Mountain Ranch Water Rights Investigation: Water Use Technical Memorandum

18 November 2014

Marble Mountain Ranch Water Rights Investigation

Water Use Technical Memorandum

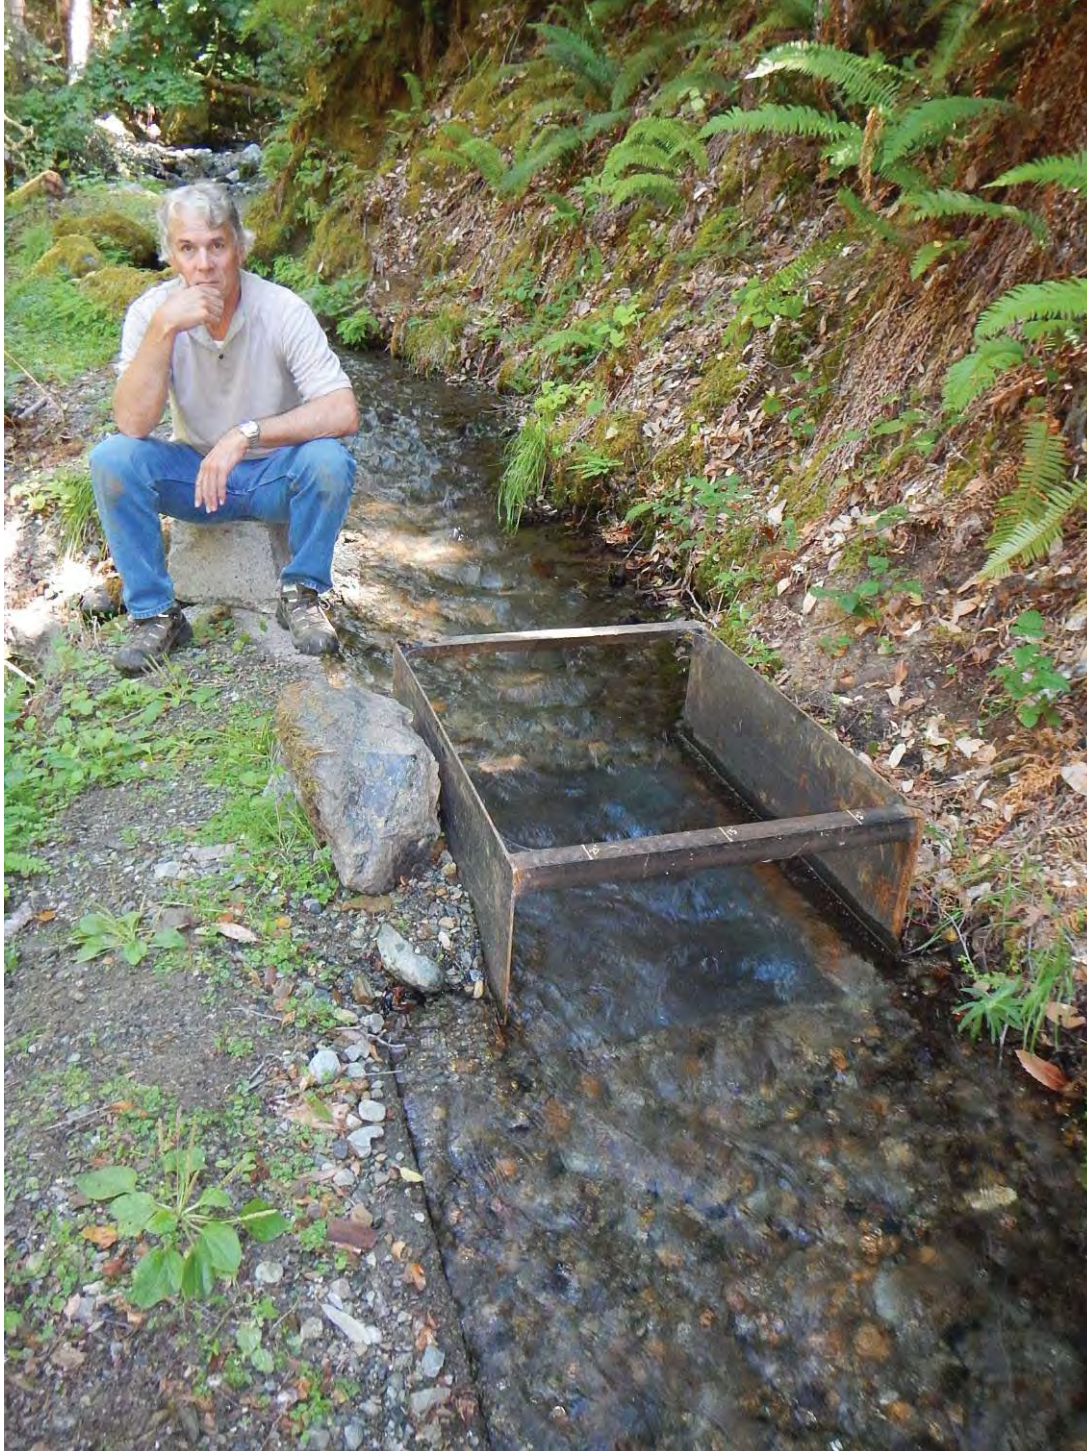
Photograph 12. Measurement Point A established by Douglas Cole near point of diversion.

In addition to these reported measurements, in June of 2013, Doug Cole established three measurement locations to quantify flow through his diversion system. These locations are shown in Figure 1. They consist of rectangular metal boxes 1.57 feet deep by 2.5 feet wide. Mr. Cole measures velocity and flow depth at 0.417 feet (5 inches), 1.25 feet (15 inches), and 2.083 feet (25 inches) from the interior box edge to compute a flow rate. Measurement location A is near the point of diversion, B is located between the treated water and power/irrigation flow junction, and C is located near the outlet of the pond.

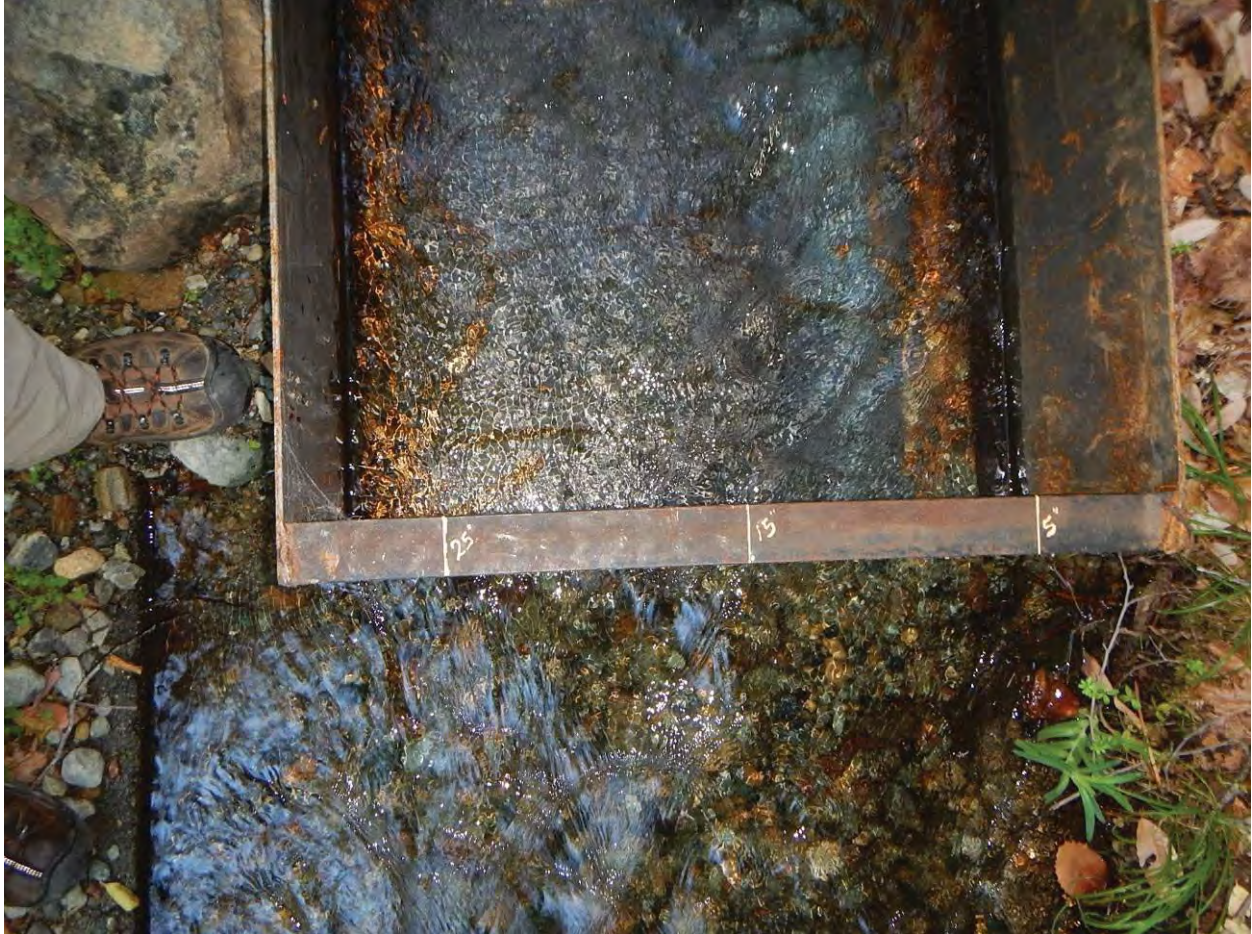
Photograph 13. Markings on metal bar indicate measurement locations.

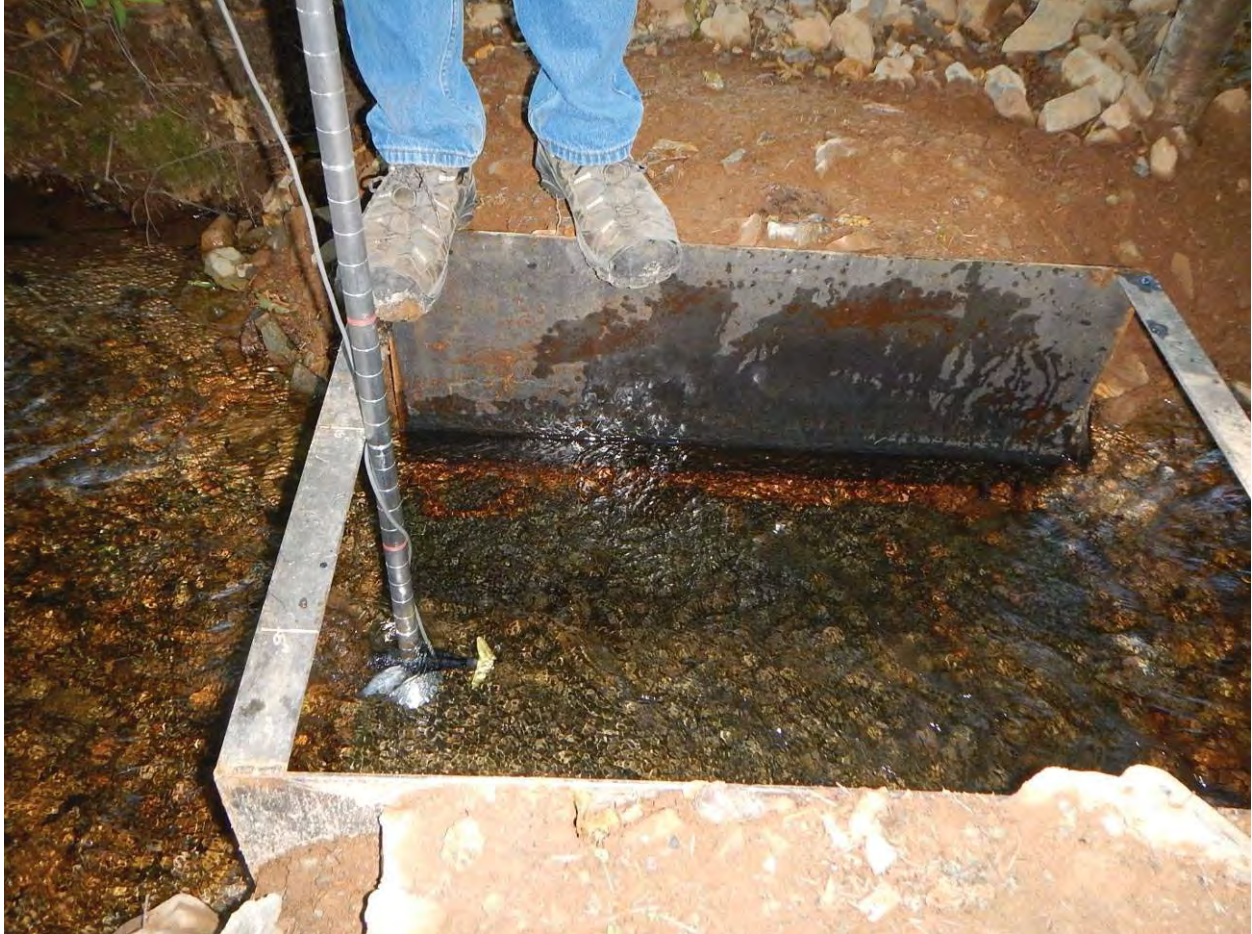
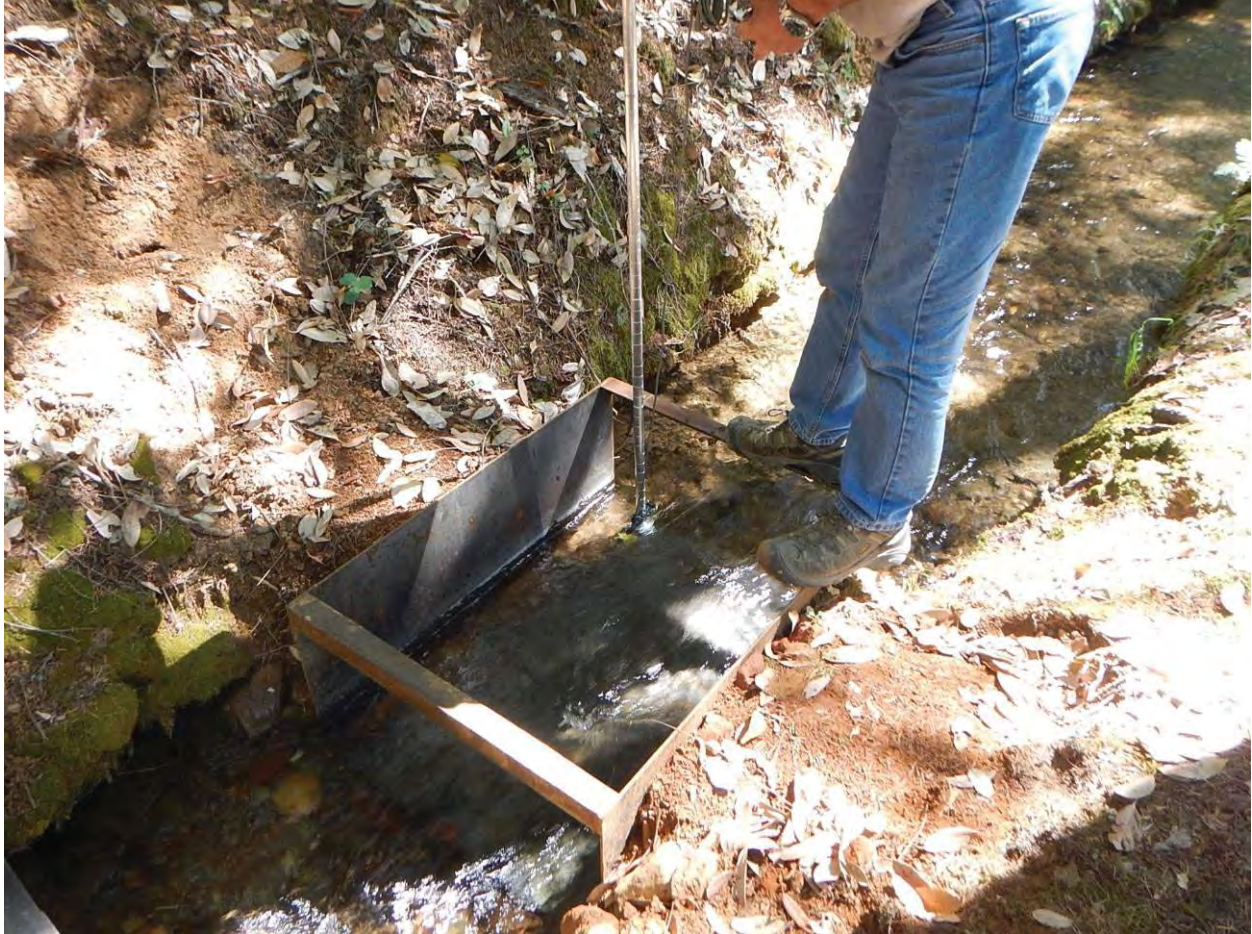
Photograph 14. Measurement conducted using Swiffer meter.

Photograph 15. Measurement conducted using Swiffer meter.

Cascade measured flows at flow measurement points A, B, and C on August 27, 2013. Measured flows are listed in Table 11. At the time of the measurements, 1.68 cfs was diverted into the ditch near the point of diversion. A combined amount of about 0.36 cfs was treated for use as potable water or infiltrated into the unlined ditch. About 1 cfs was discharged to Irving Creek. At the time of the measurement, the diesel generator was operating because diversion flows were insufficient for hydropower generation. As stated in Section 5.2, the electrical transmission system is currently setup to only accept power from one generation source: hydropower generator or diesel generator. At the time of these measurements, Cascade identified the maximum transmission loss was less than 0.36 cfs, the maximum consumptive use was 0.68 cfs, there was no hydropower generation, and flow discharged to Irving Creek was about 1 cfs.
