Marble Mountain Ranch Water Rights Investigation: Water Use Technical Memorandum

Water Use Technical Memorandum

August 18, 2014

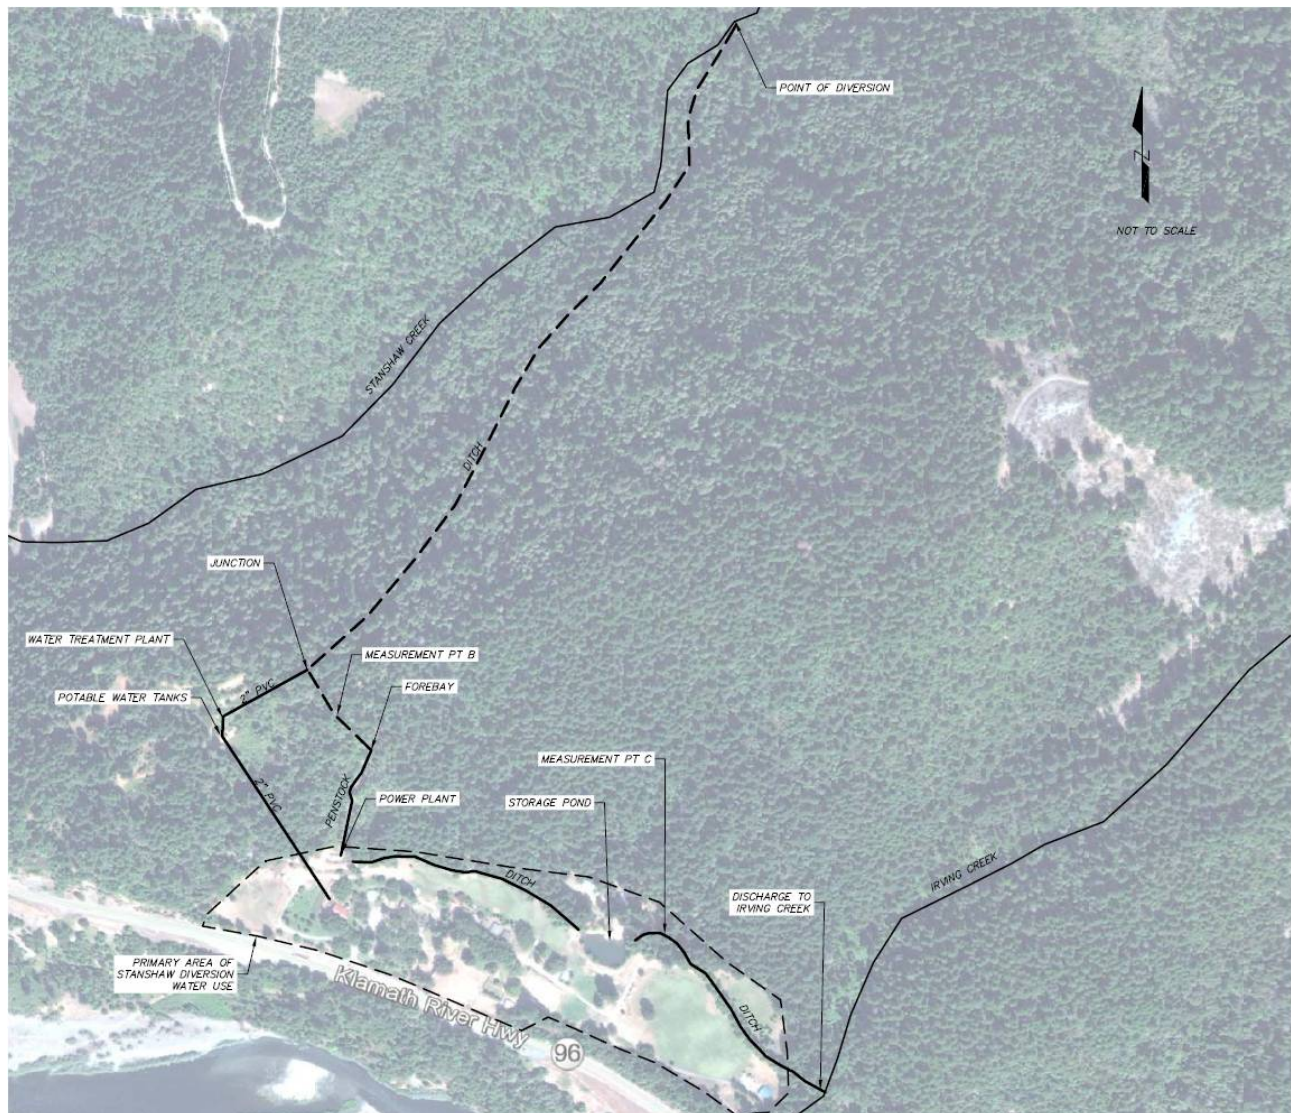
Figure 2. Water Conveyance Map

The point of diversion is located on Stanshaw Creek about 0.68 miles upstream of the Highway 96 crossing. A channel spanning gravel and cobble push-up dam diverts water that does not seep through the dam into a diversion ditch. The amount diverted typically varies with available stream flow, independent of demand. Under typical late spring, summer, and fall flow conditions (less than about 3 to 4 cfs), the majority of creek flow is diverted into the ditch. Conveyance from the point of diversion to the ranch is gravity driven. Flows are conveyed from the point of diversion about 0.5 miles to a junction where flows can be conveyed to a water treatment plant to the southwest, and to a forebay and penstock to the southeast that services the power generation facility and the pressurized irrigation system. The conveyance structures between the point of diversion and the junction consists of unlined and lined reaches of ditch. The lined reaches are lined with culvert pipe cut to form half round pipe sections. These semi-circular pipe sections include corrugated HDPE pipe with smooth interior walls and corrugated metal pipe. One section of pipe was measured to be 30 inches in diameter. The other sections appeared to be the same diameter.

Water conveyed to the forebay travels along lined and unlined ditches to the forebay tank where the water is screened for debris and enters the pressurized conveyance system. Water is conveyed a horizontal distance of about 430 feet and a vertical distance of about 200 feet through 13.5 inch interior diameter smooth walled plastic pipe and 14 inch steel pipe to a junction immediately upstream of the power plant. The power plant consists of a Pelton wheel driven by two pressurized jets. Discharge from the power plant is conveyed in a ditch to a pond. The pond is used for recreation and water storage for fire prevention. Flows from the pond are conveyed in a ditch to the south across the ranch, and then drops off a headcut, down a ravine and into Irving Creek. Excess diversion leaving the pond and flowing towards Irving Creek were measured on one occasion to be about 1 cfs. The water used for power generation is not re-used for irrigation or domestic purposes.

Irrigation and fire prevention flows are conveyed through a short run of nine inch diameter steel pipe to four inch diameter PVC pipe that extends from the junction at the power plant to sprinkler guns located in pastures and hose bibs and couplers located throughout the property.

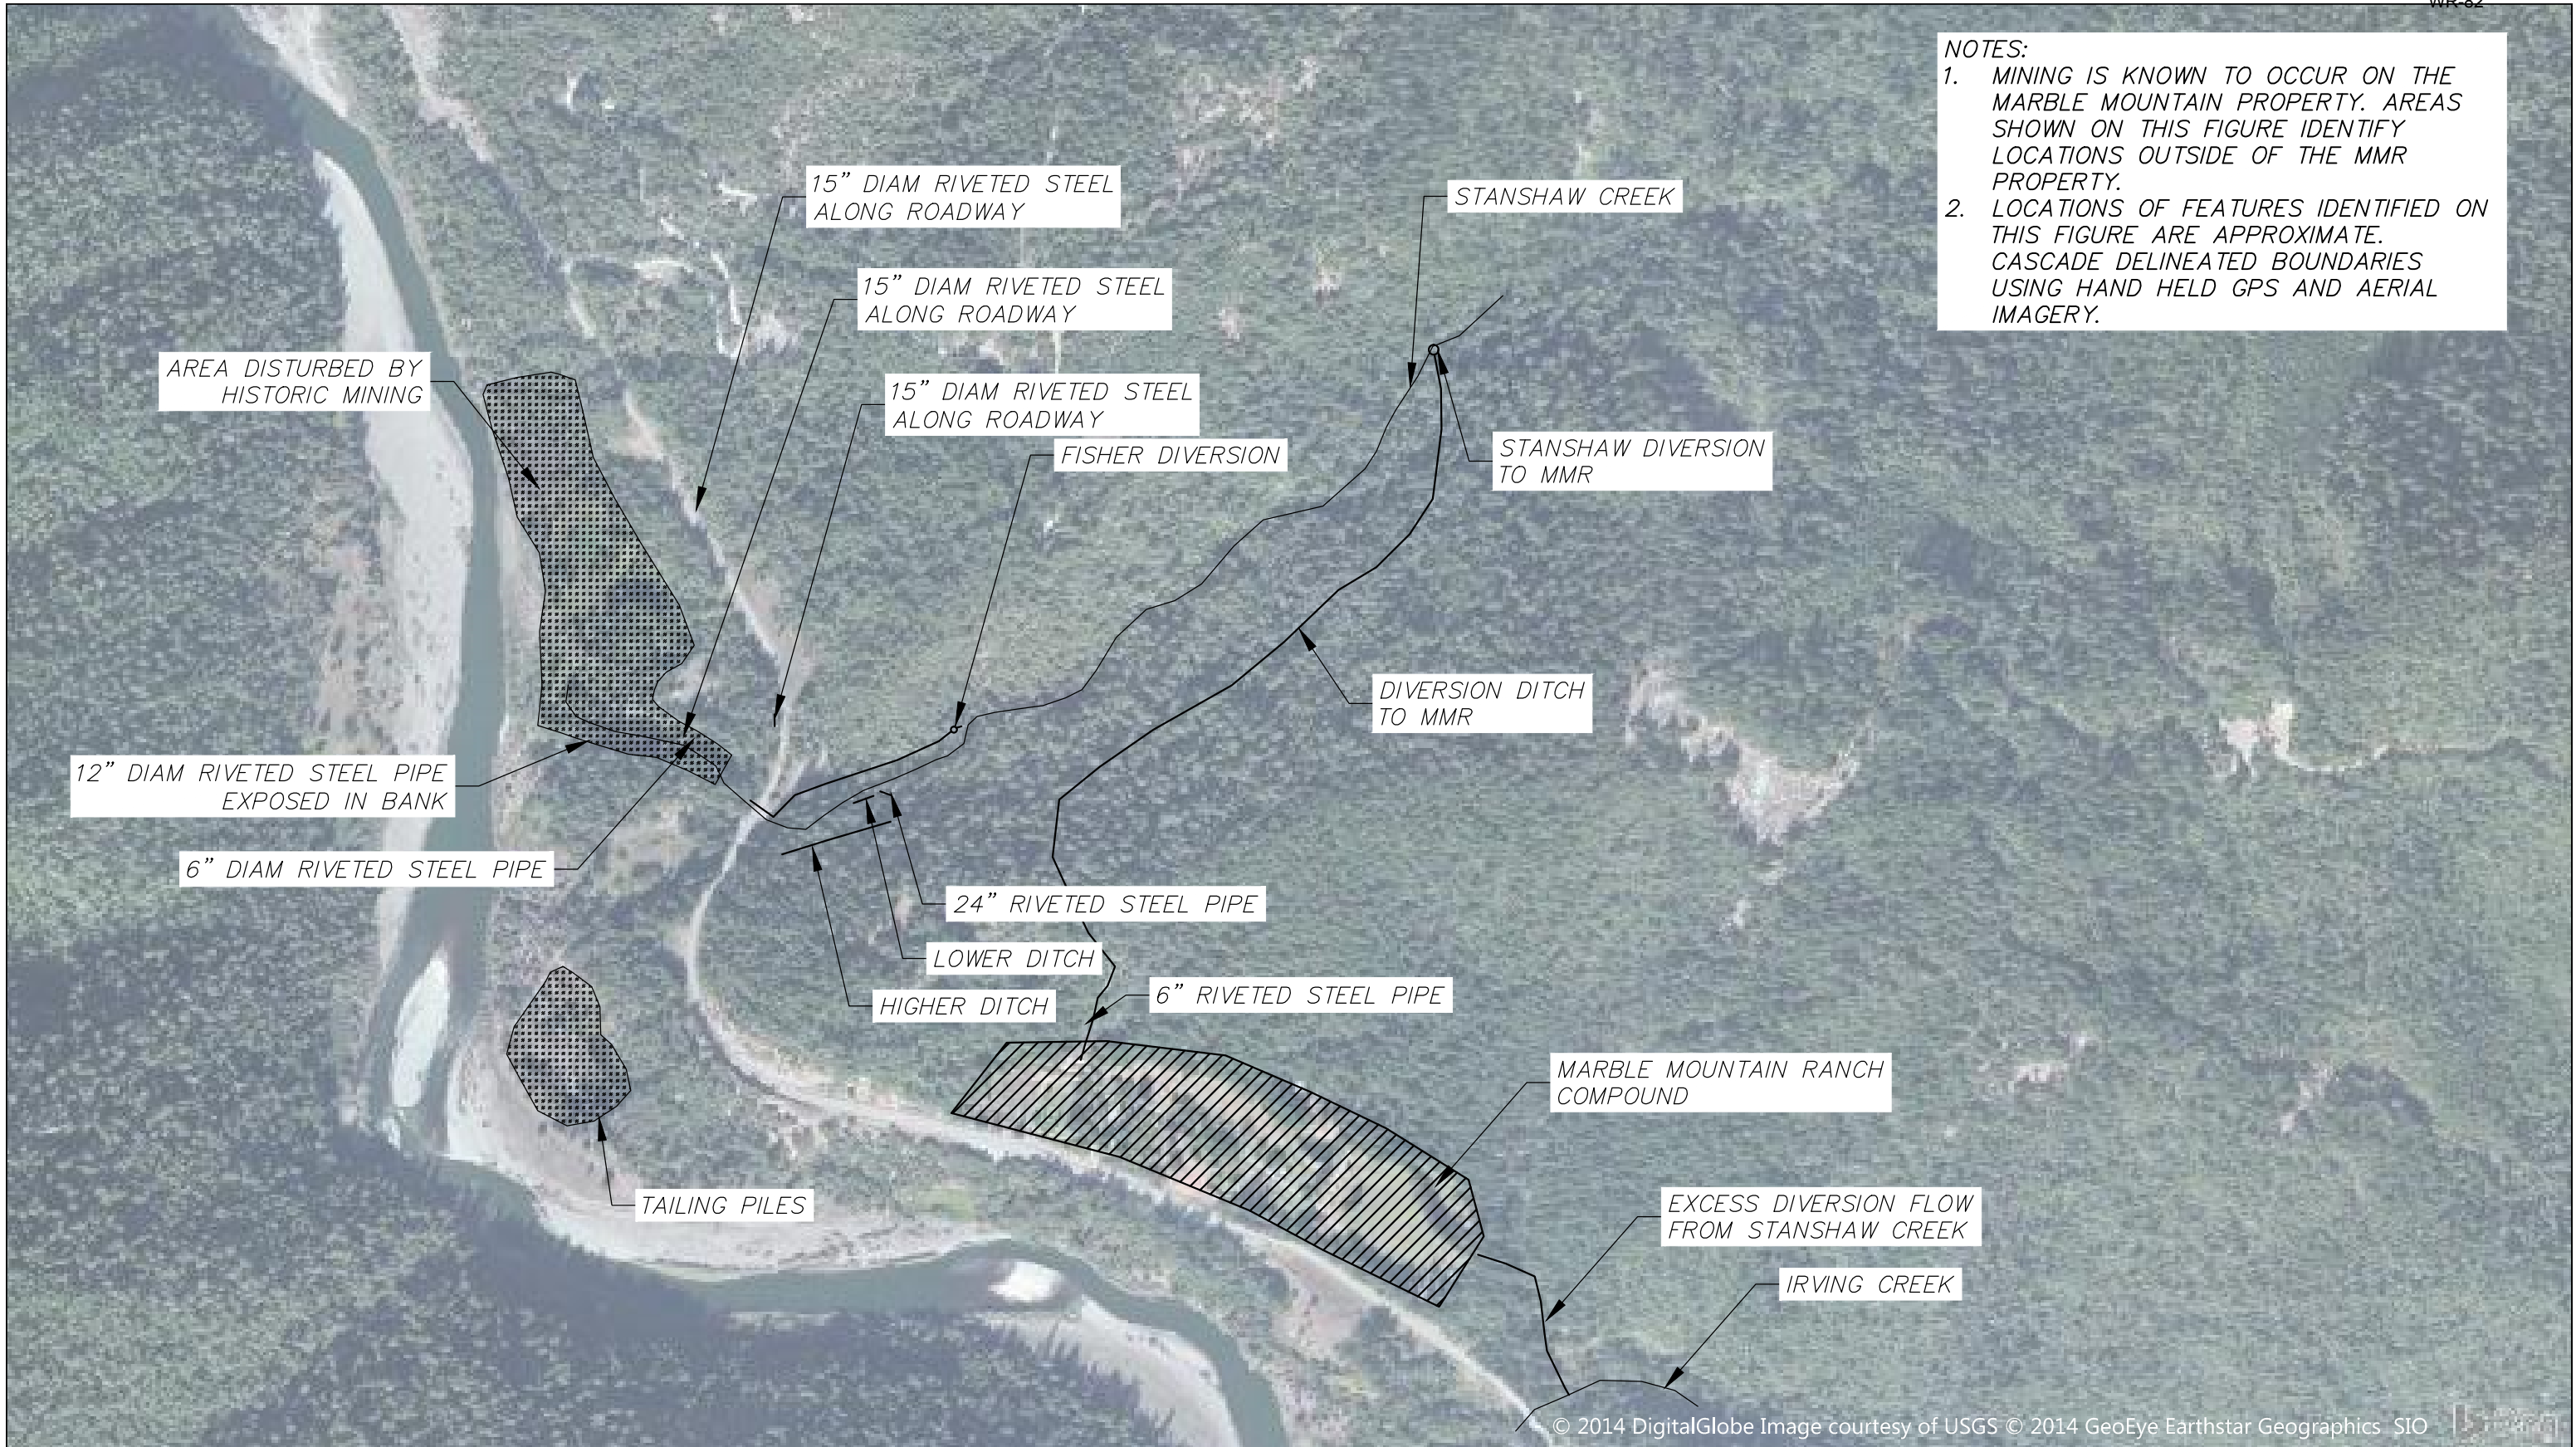
Marble Mountain Ranch
Water Rights Investigation
 Figure 3. Location Map of Historical Mining
 Artifacts and Areas of Disturbance

NOTES:
 1. MINING IS KNOWN TO OCCUR ON THE MARBLE MOUNTAIN PROPERTY. AREAS SHOWN ON THIS FIGURE IDENTIFY LOCATIONS OUTSIDE OF THE MMR PROPERTY.
 2. LOCATIONS OF FEATURES IDENTIFIED ON THIS FIGURE ARE APPROXIMATE. CASCADE DELINEATED BOUNDARIES USING HAND HELD GPS AND AERIAL IMAGERY.

The original water right claim was for 15 cfs. Cascade does not have documentation of how much water was actually used for hydraulic mining. The land area upon which mining could have occurred was much larger than the current area of MMR. Stanshaw Creek flow may have been higher in historic times than it is today. However, it is not likely that Stanshaw Creek flowed at a rate sufficient to allow diversions of 15 cfs except possibly during very high flow periods. In any event, during the late 1800's and early 1900's, the majority of the water used was probably for mining, with smaller amounts devoted to domestic and irrigation purposes. This pattern probably persisted from the 1860's to the time hydraulic mining activities decreased and then ceased. From about 1920's or early 1930's to the early or mid-1950's, a period of approximately 15-30 years, seasonal irrigation appears to be the primary consumptive use with lesser amounts used for year round domestic purposes. Figure 3 shows locations outside of the Marble Mountain Ranch Property where mining related activities likely occurred.

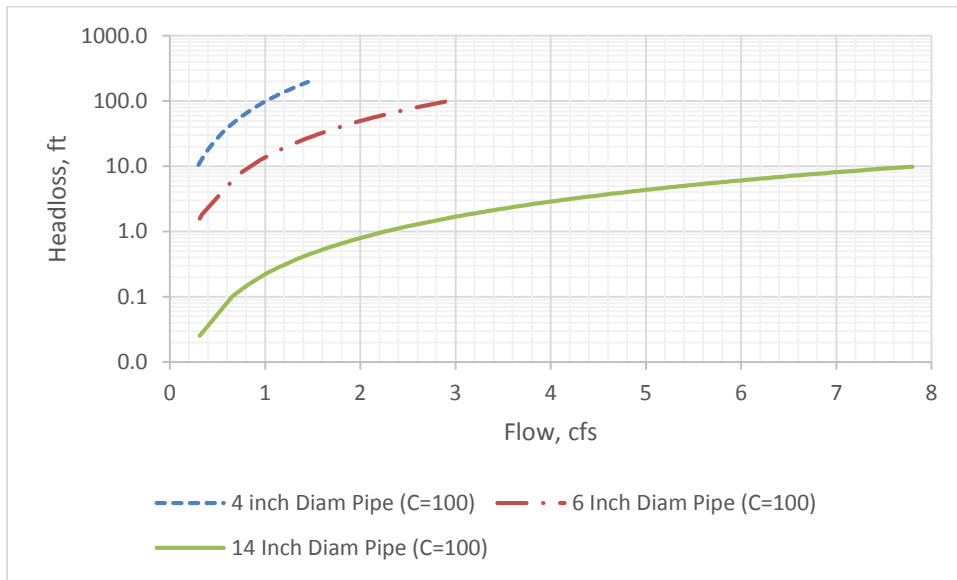
Figure 4. Pipe Headlosses

The flow rate required to generate power is a function of the total static head minus the headlosses referred to herein as net head. Headlosses include losses due to pipe friction and minor losses such as at the inlet, bends, reducers, and outlet. For the purposes of this investigation, minor losses were considered to be small compared to friction losses in the pipe. Because we don't know the true pipe size used to convey water from the ditch to the power plant at the time Lue Hayes purchased the property, Cascade modeled headloss and potential power generation from a 4 inch and 6 inch diameter pipe as well as the 14 inch pipe that currently conveys water down the hillslope, a vertical distance of about 200 feet. As illustrated in Figure 2, the pipe diameter can significantly influence headloss. The headloss curves shown in Figure 2 were computed assuming a pipe length of 500 feet, the estimated

length of the pipe, using Hazen-Williams formula for headloss. The loss coefficient was assumed to be 100, which is often used for “old unlined or tar-dipped cast-iron pipes in good condition” (Roberson et al. 1998). Figure 3 shows the change in net head with flow at the Pelton wheel for three different pipe sizes: a 4 inch diameter pipe, the pipe diameter Hayes stated conveyed water to the Pelton wheel prior to his purchase of the property; a 6 inch diameter pipe, the diameter of pipe that currently is abandoned near the existing 14 inch pipe; and a 14 inch pipe, which currently exists. Assuming a static head of 200 feet, the net head decreases dramatically with flow in a 4 inch diameter pipe and is relatively constant in a 14 inch pipe as shown in Figure 3.

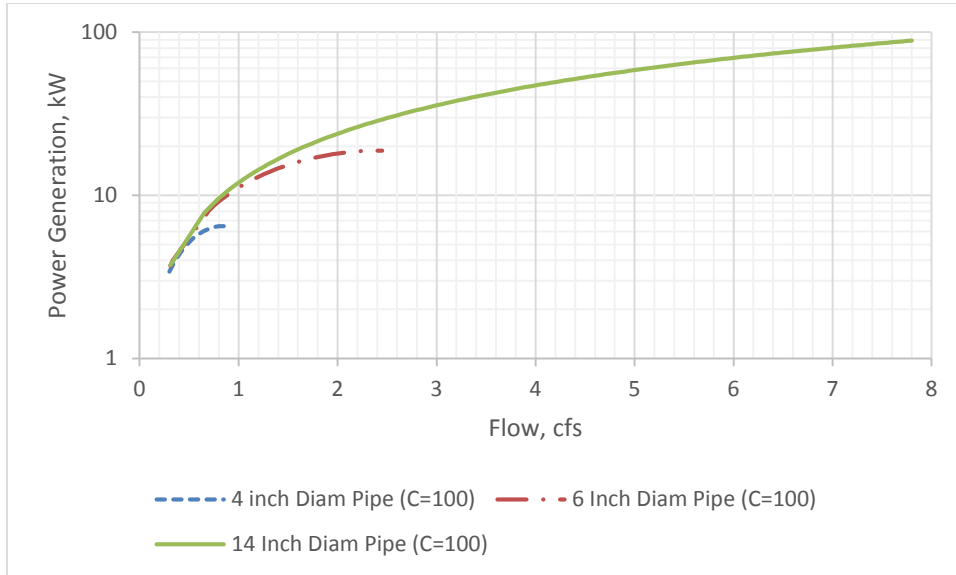
Figure 6. Power Generation Rating Curves

The change in power production is dramatically influenced by the pipe size as shown in Figure 4. Assuming an efficiency of 70 percent for the time prior to Cole’s power plant upgrades, peak power

generation of 6.47 kW occurs at a peak flow of 0.85 cfs for a 4 inch diameter pipe, 18.8 kW at a flow of 2.4 cfs for a 6 inch diameter, and 174 kW at a flow of 22 cfs for a 14 inch pipe (the current pipe size.) These estimates are based on a static head of 200 feet, Hazen-Williams coefficient of 100, and pipe length of 500 feet and were calculated using Equation 1.

Cascade developed power flow rating curves to estimate power production using readily available information and standard engineering equations. Energy production from a Pelton wheel can be characterized as a function of the fluid density (ρ), acceleration due to gravity (g), flow rate (Q), total dynamic head (ΔH), and the efficiency of the Pelton wheel and electrical system (μ) as shown in Equation 1. In this case, the fluid is water and assumed to have a constant density of 1000 kg/m³ (62.4 lbs/ft³). Computations are based on a gravitational acceleration of 9.81 m/s² (32.2 ft/s²). Total dynamic head was computed by subtracting the static head by the headloss through the pipe. Headlosses through the pipe was computed using the Hazen-Williams equation. The formula is presented in Equation 2. Power generation efficiency was assumed to be 70 percent prior to Douglas Coles acquisition of the property and 80 percent after his acquisition.

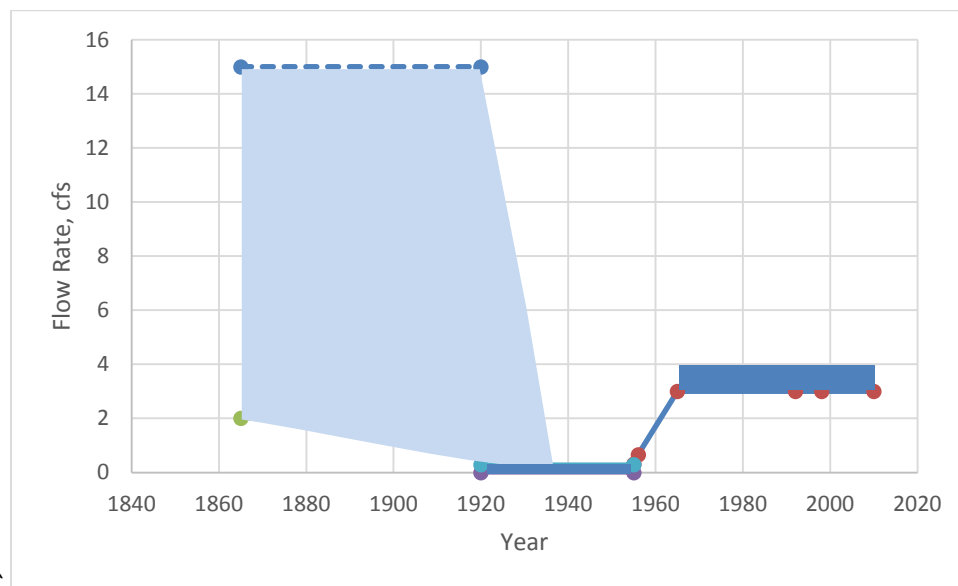
Figure 7. Water Use for Mining and Hydropower Generation

Cascade used the power generation estimates and statements provided by Hayes and Cole as well as readily available information to estimate water use over time. During the active mining period from 1865 to 1920's/1930's, the shaded area in Figure 5 shows the amount of the water right Stanshaw acquired (approximately 15 cfs), and the average summer base flow for Stanshaw Creek (approximately 2 cfs). Diversion rates likely varied seasonally between these ranges, although an analysis of Stanshaw Creek average flows by season (Miller, 2000) showed that even average winter flows are well below 15 cfs. Uses from 1920's/1930's until 1955 when Lue Hayes purchased the property for based on available evidence, was between 0 and 0.36 cfs. Figure 2 illustrates how water use for mining and hydropower has changed over time.

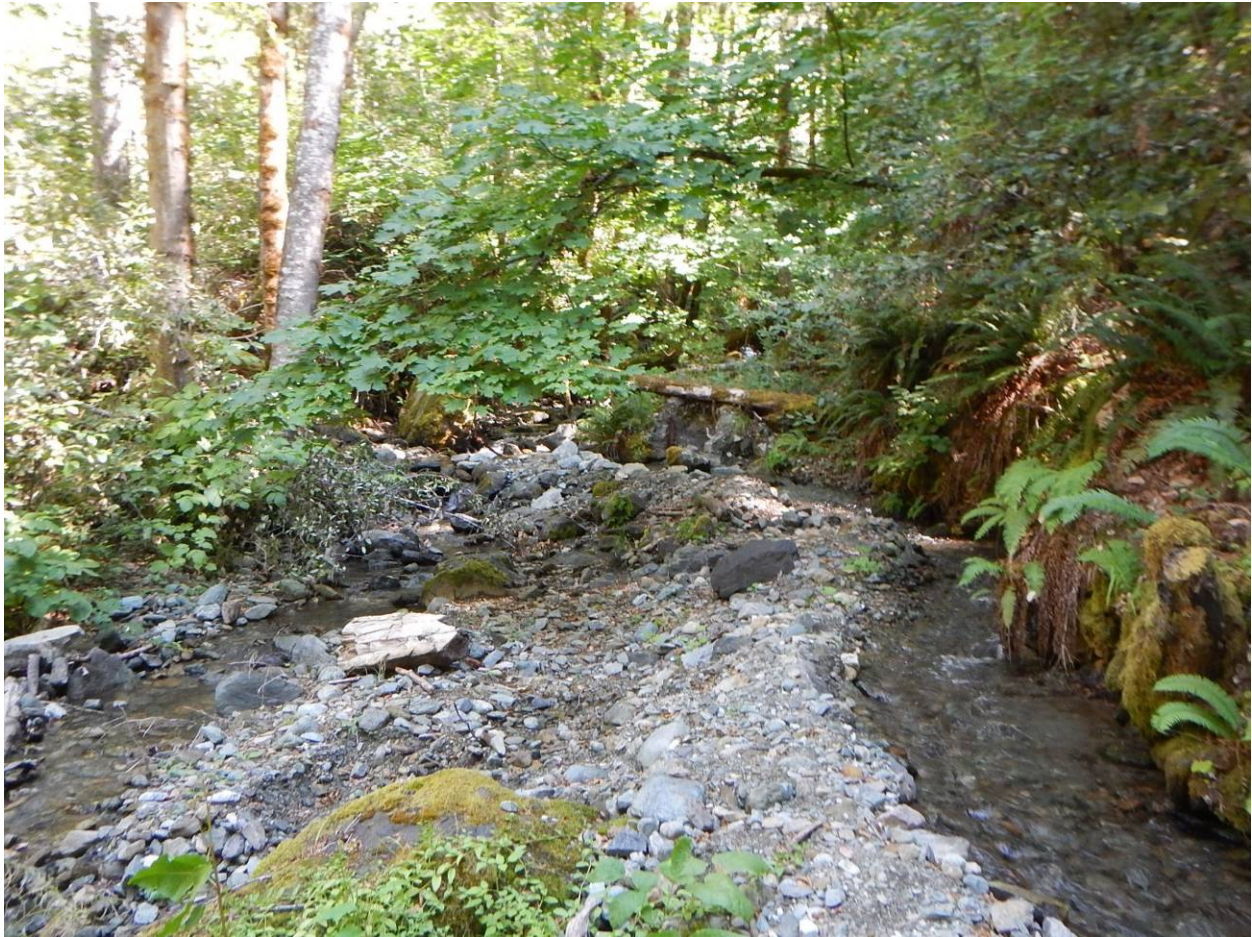
Photograph 1. Point of Diversion on Stanshaw Creek

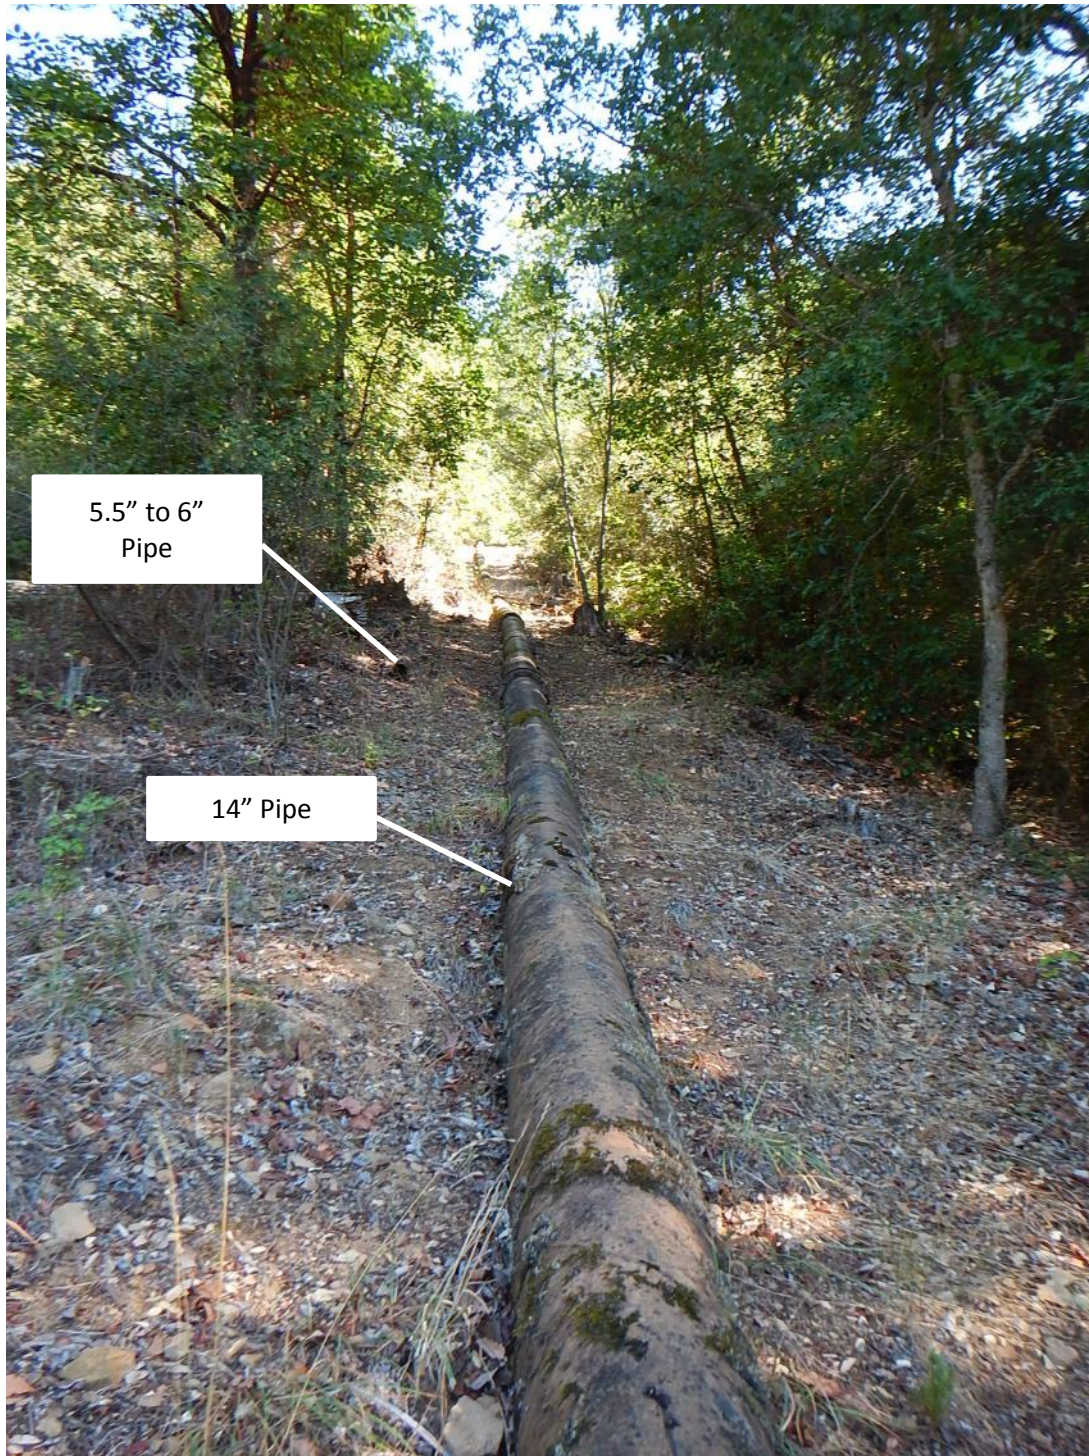
Photograph 2. 14" Diameter Penstock installed by Lue Hayes after he purchased the property in 1955.

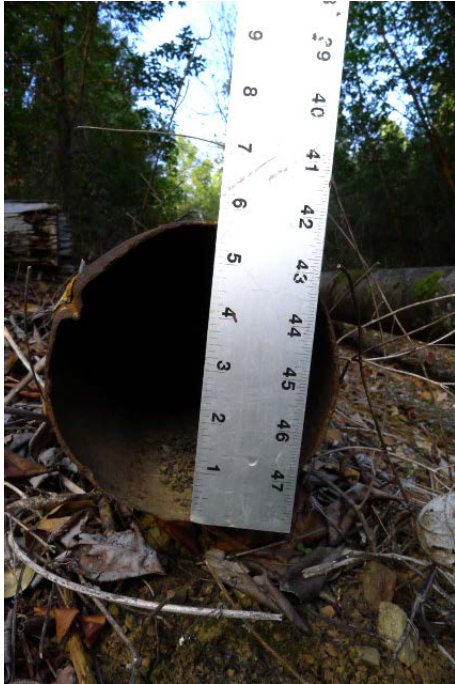
Photograph 3. Pipe adjacent to 14" Pipe. End of pipe was crimped making estimation of Interior diameter imprecise.

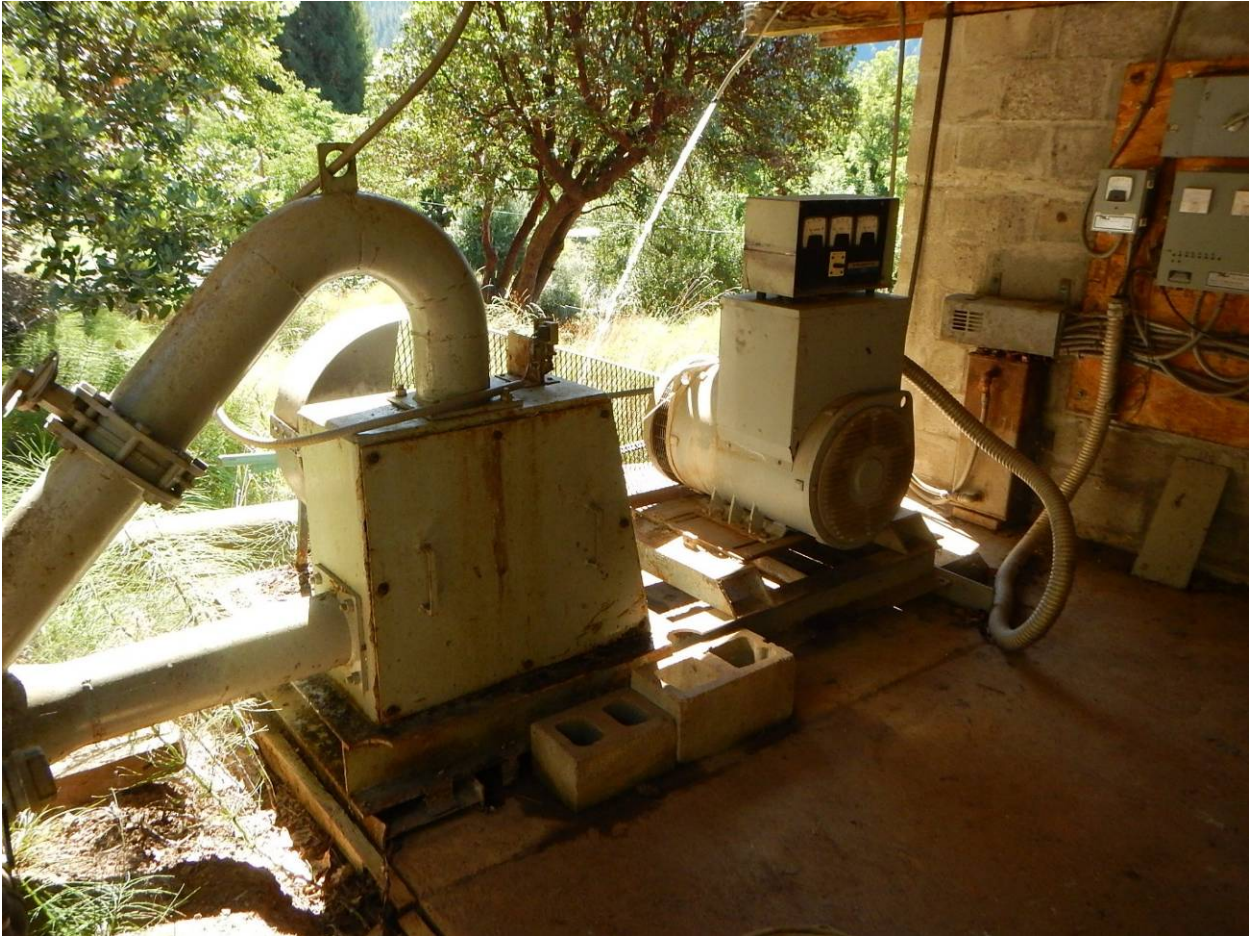
Photograph 4. Micro-hydro power plant diversion flows enter from the pipes on the left of the photograph. Heated effluent from the heat sink resistor is visible near the top of the photograph near the roof beam.

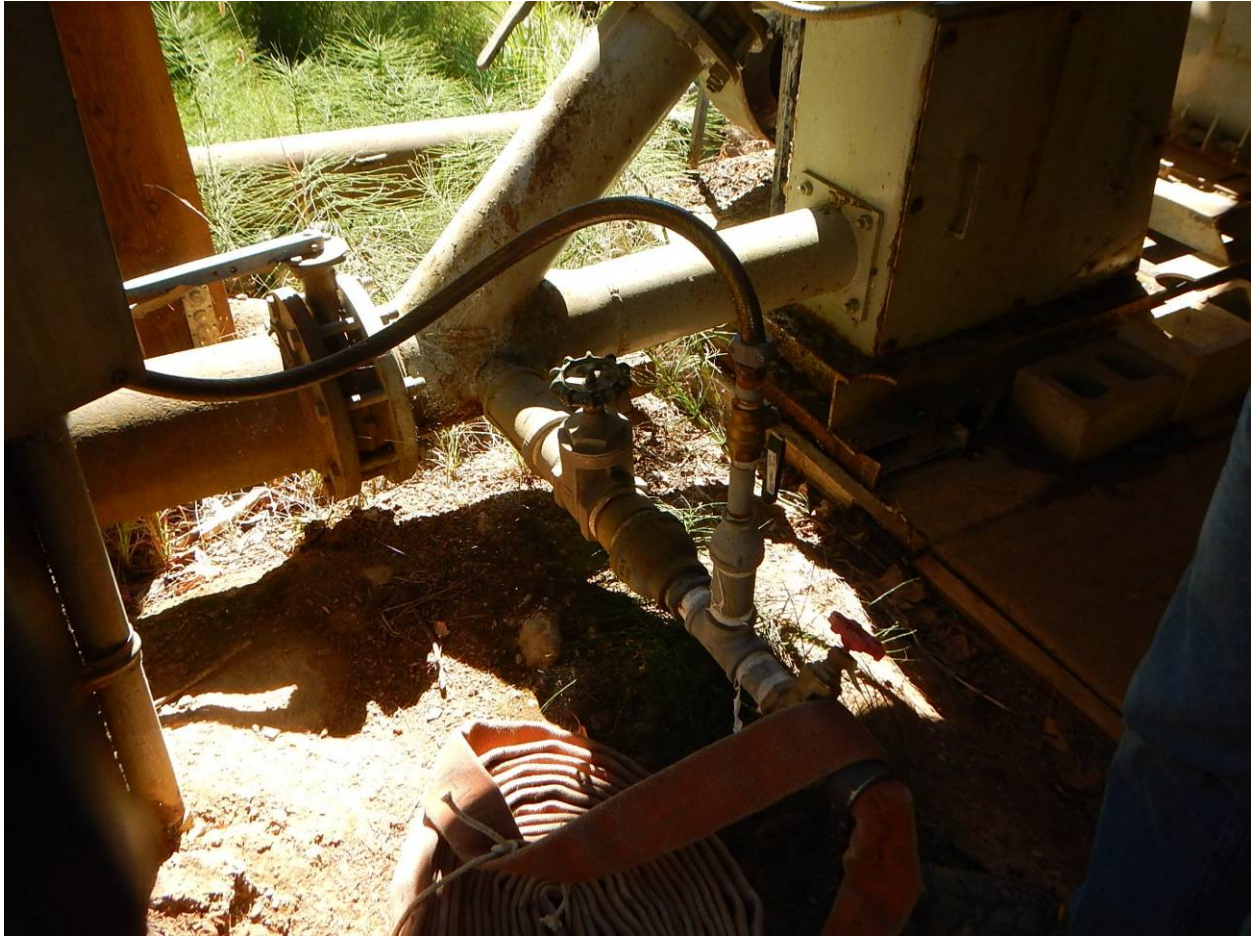
Photograph 5. Junction near hydro-power unit. Large diameter pipes convey water to Pelton wheel. Small diameter pipe that tees at a 90 degree angle conveys water to heat sink resistor and hose.

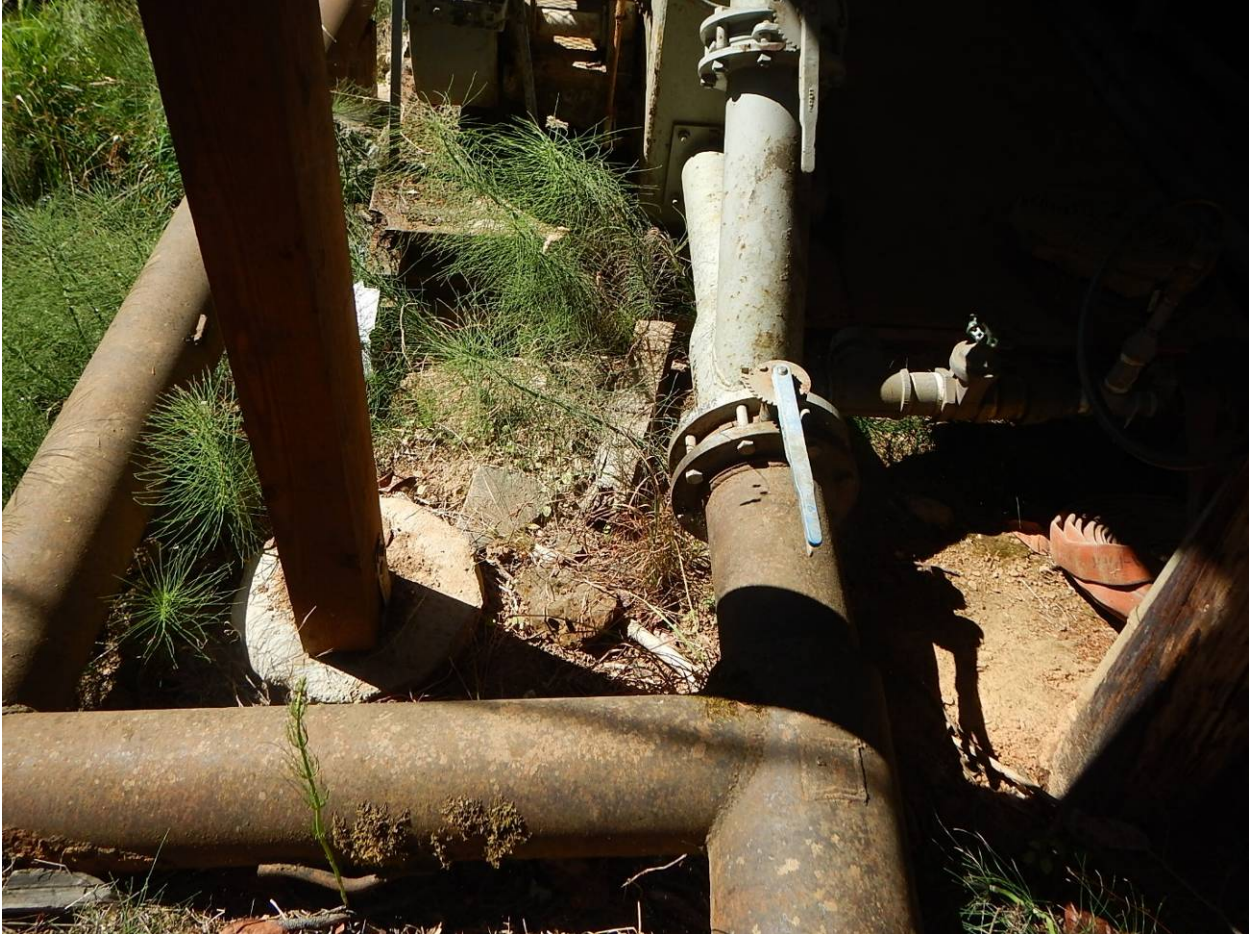
Photograph 6. Junctions near power plant. Tee near the bottom of the photograph serves as junction for flow to power plant and irrigation system. Flow conveyed into the pipe to the left of the photograph serves the irrigation system.

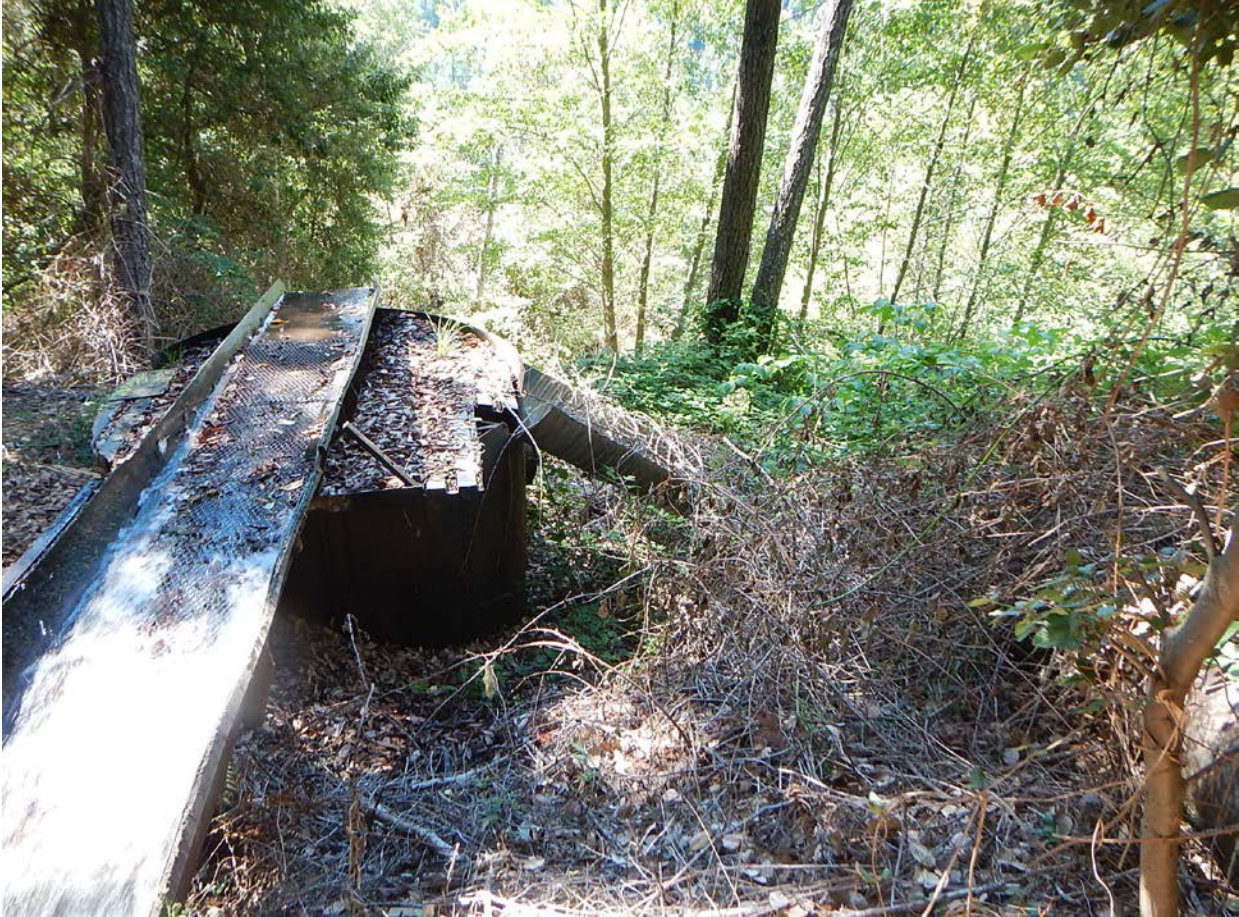
Photograph 7. Forebay to pressurized system. Flows enter system through the screen in the half pipe section.

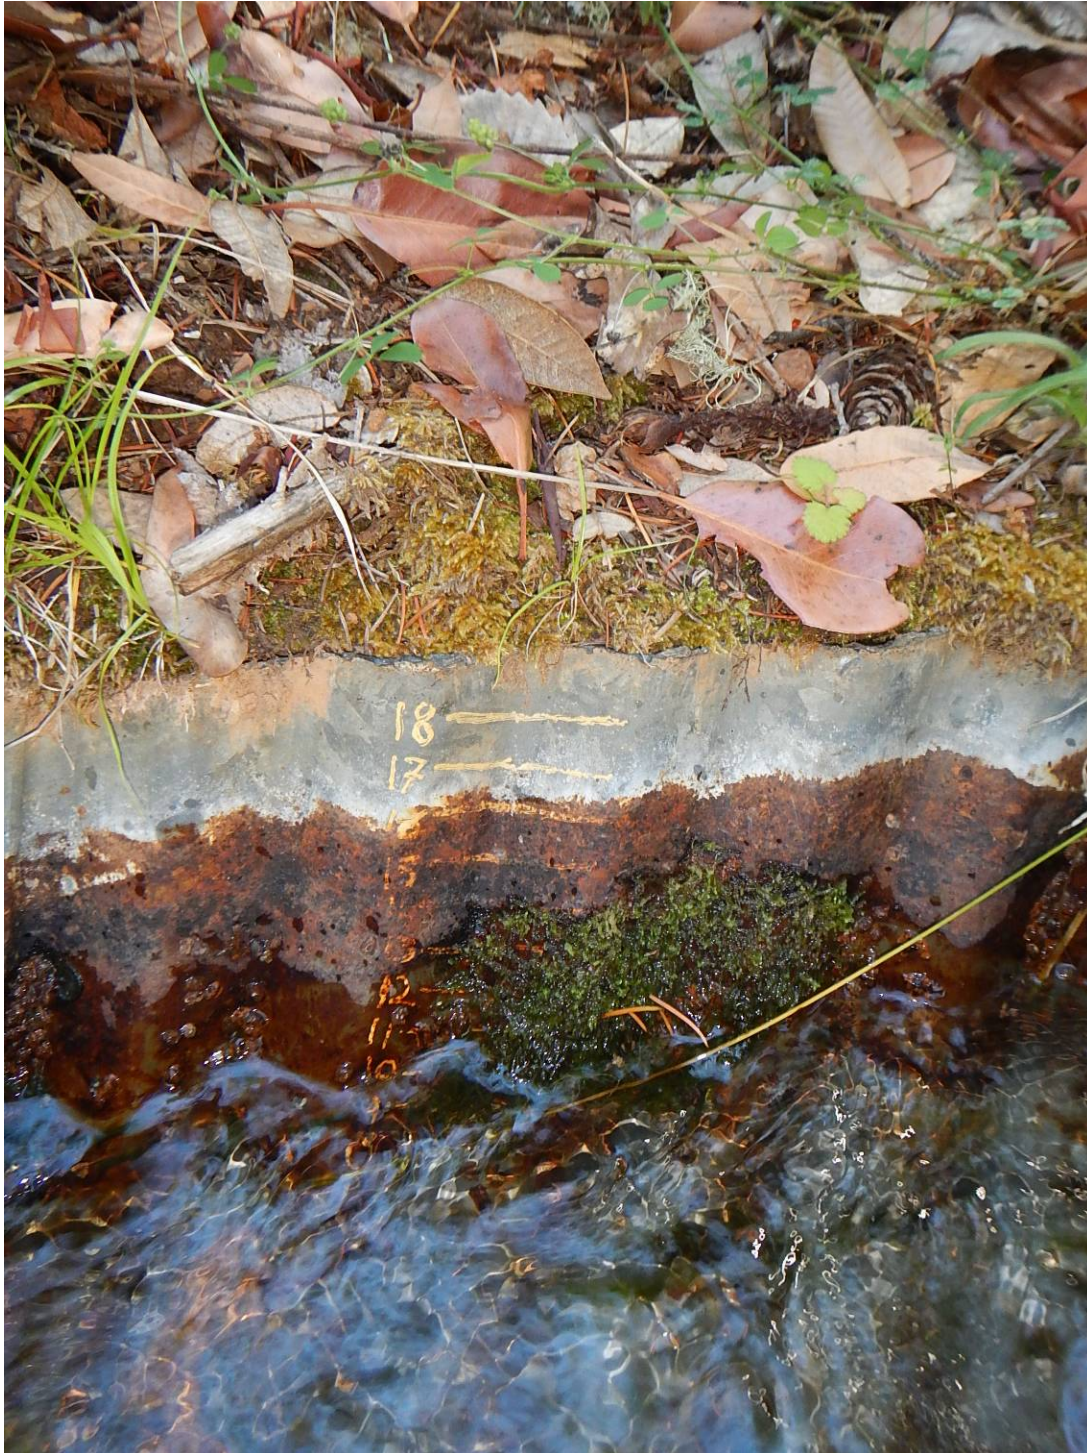
Photograph 8. Stanshaw Gage developed by Douglas Cole.

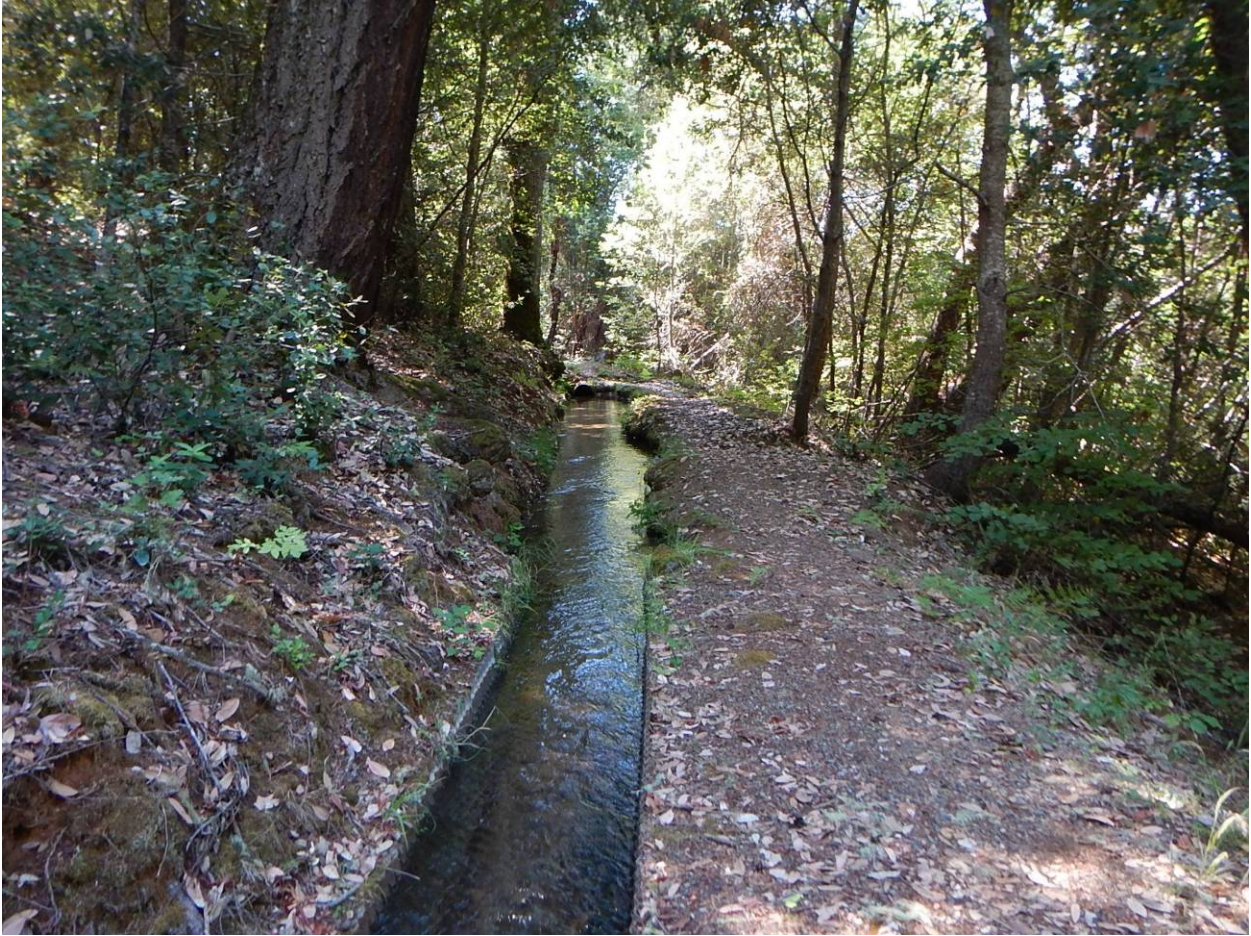
Photograph 9. HDPE pipe lining ditch.

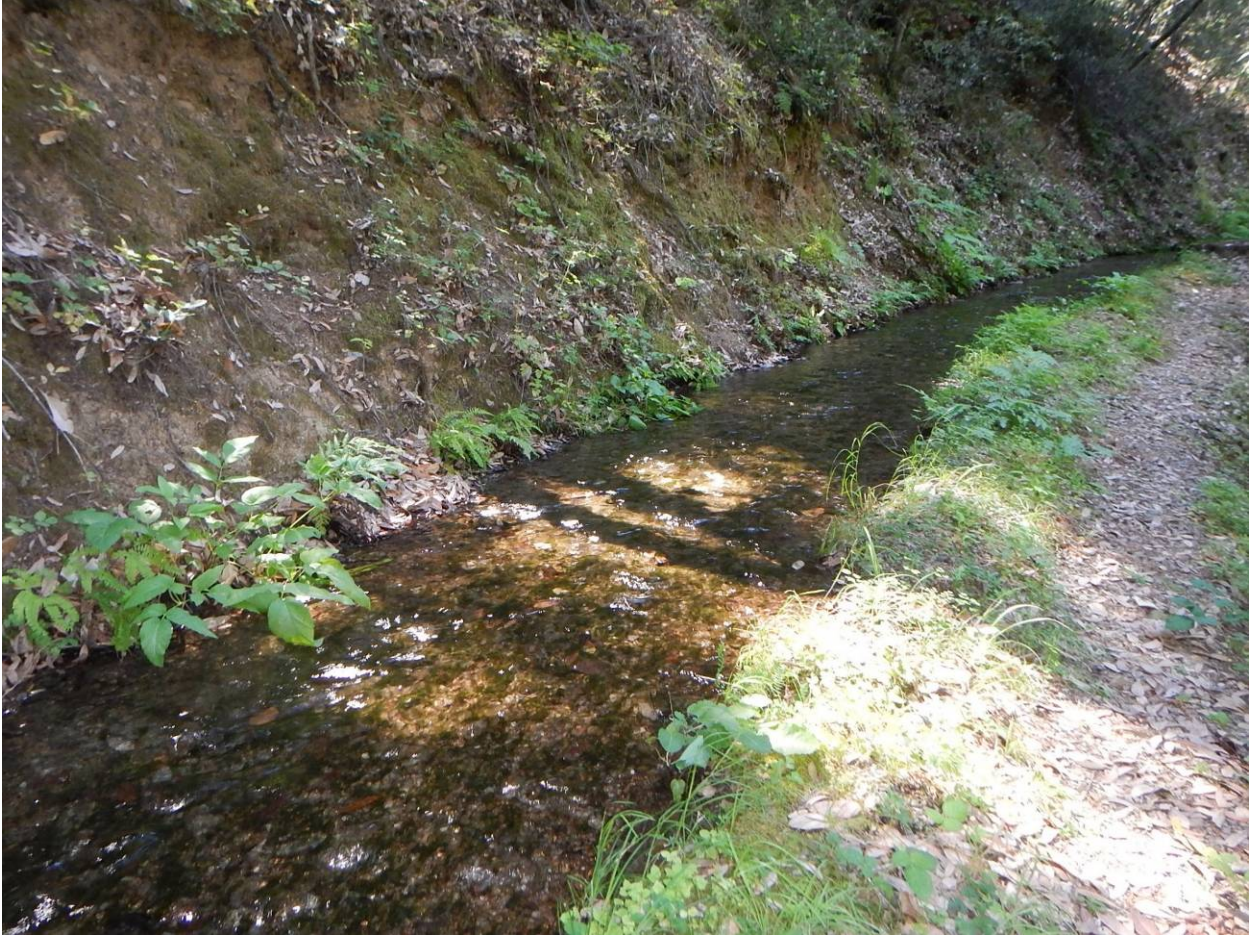
Photograph 10. Unlined ditch.

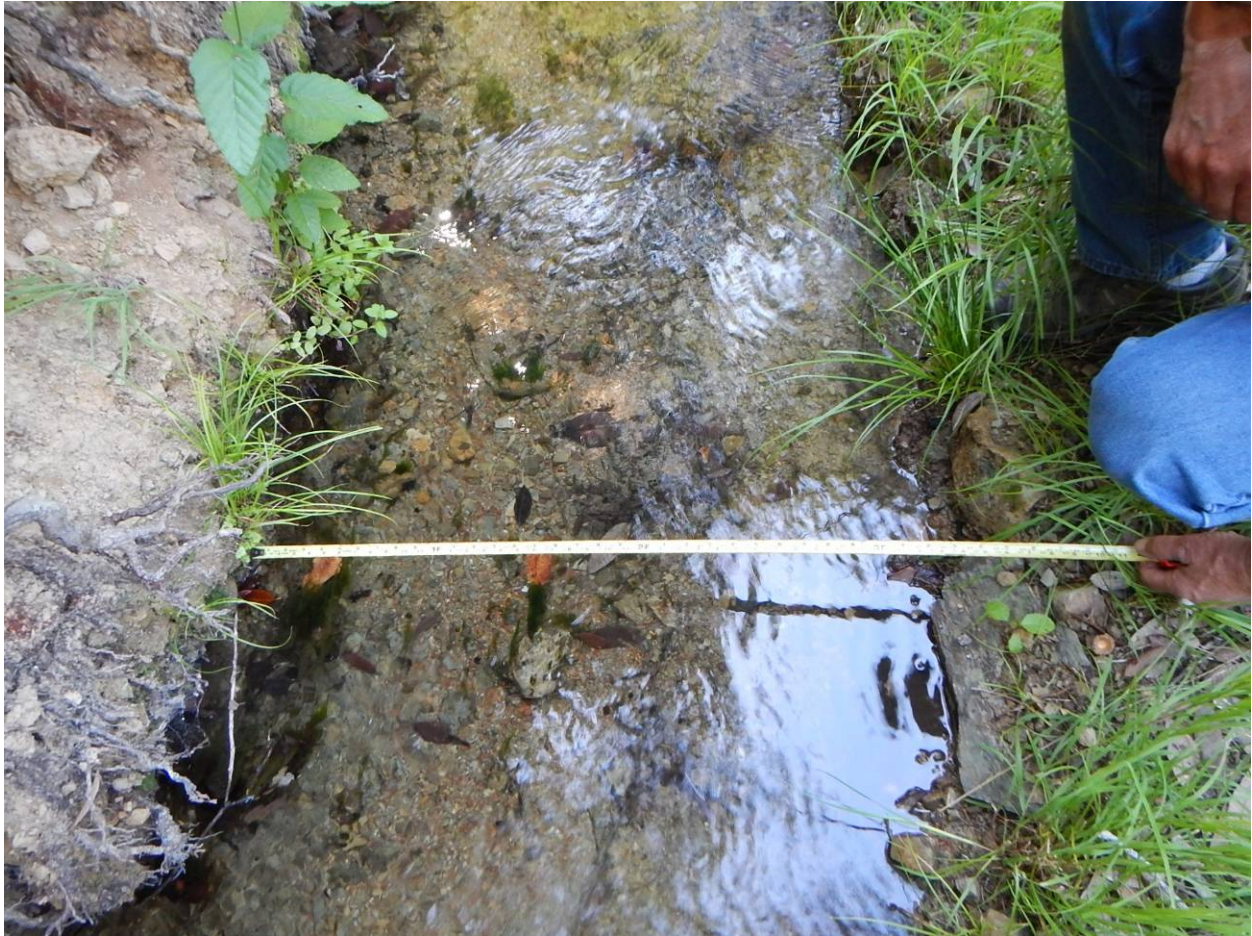
Photograph 11. Narrow location in canal, top width about 3.3 feet
