Marble Mountain Ranch Water Rights Investigation: Water Use Technical Memorandum

Water Use Technical Memorandum

August 18, 2014

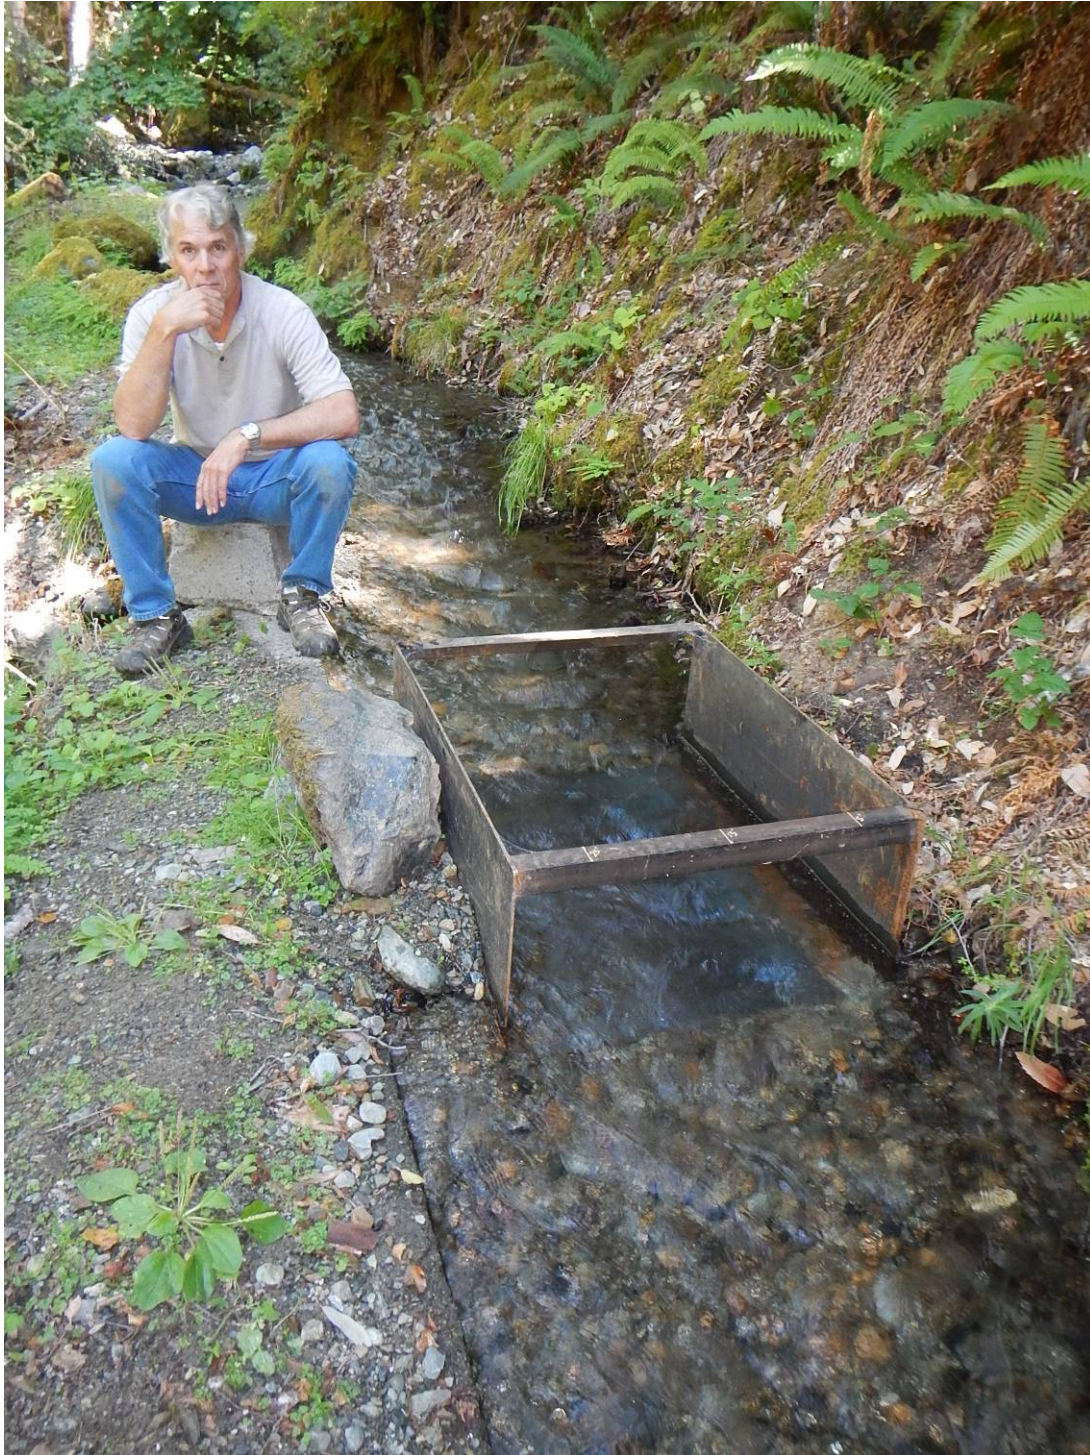
Photograph 12. Measurement Point A established by Douglas Cole near point of diversion.

In addition to these reported measurements, in June of 2013, Doug Cole established three measurement locations to quantify flow through his diversion system. These locations are shown in Figure 1. They consist of rectangular metal boxes 1.57 feet deep by 2.5 feet wide. Mr. Cole measures velocity and flow depth at 0.417 feet (5 inches), 1.25 feet (15 inches), and 2.083 feet (25 inches) from the interior box edge to compute a flow rate. Measurement location A is near the point of diversion, B is located between the treated water and power/irrigation flow junction, and C is located near the outlet of the pond.

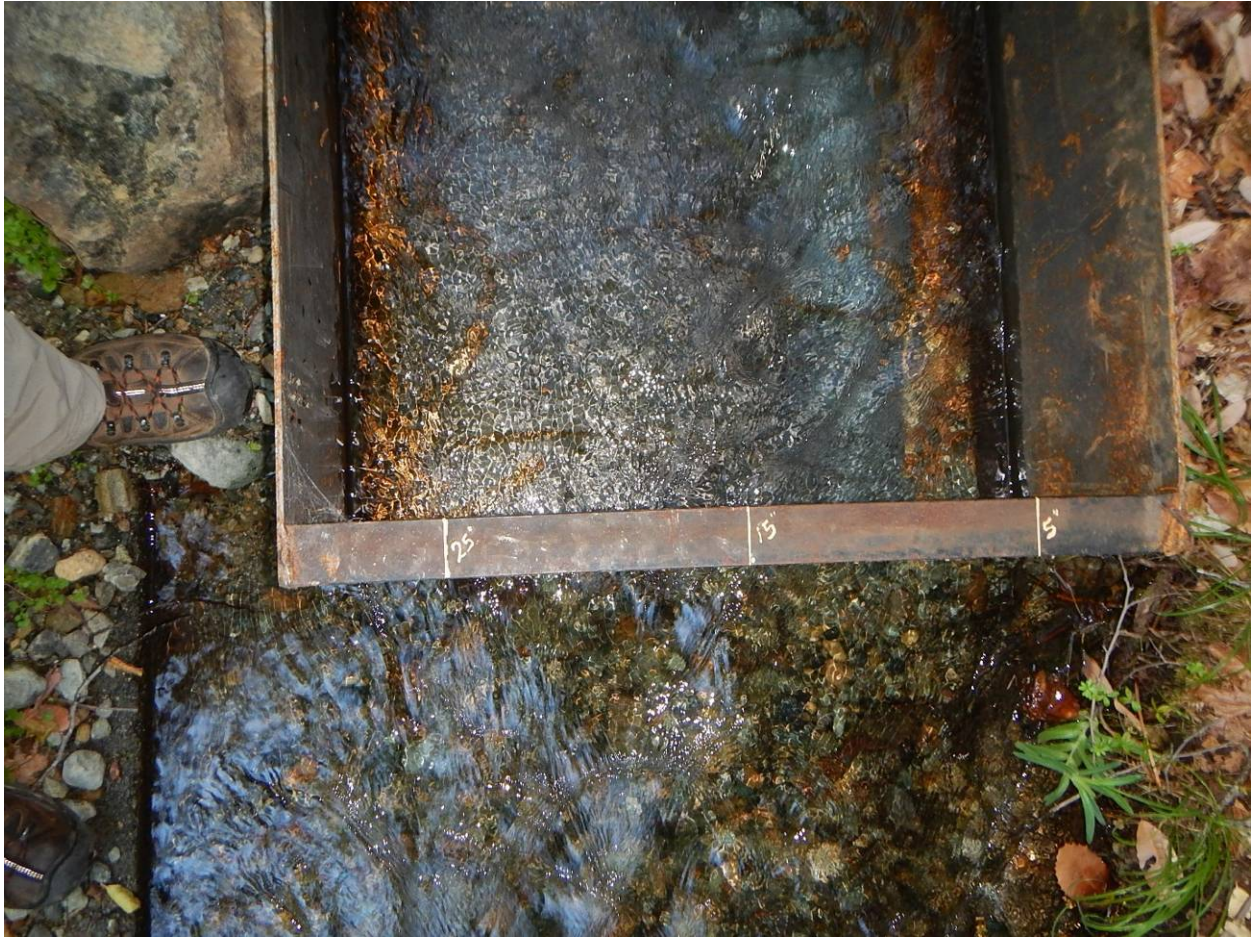
Photograph 13. Markings on metal bar indicate measurement locations.

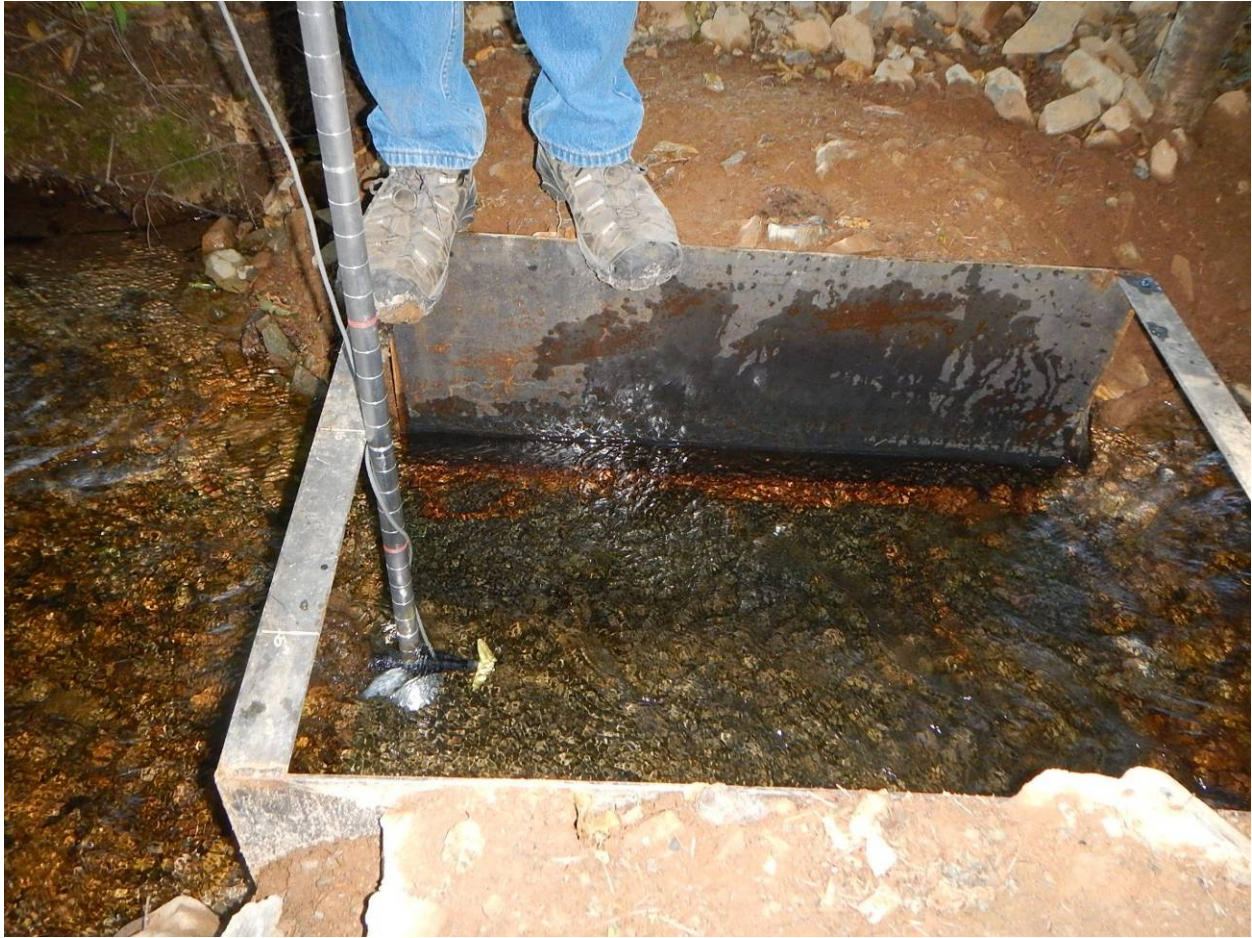
Photograph 14. Measurement conducted using Swiffer meter.

Cascade measured flows at flow measurement points A, B, and C on August 27, 2013. Measured flows are listed in Table 11. At the time of the measurements, 1.68 cfs was diverted into the ditch near the point of diversion. A combined amount of about 0.36 cfs was treated for use as potable water or infiltrated into the unlined ditch. About 1 cfs was discharged to Irving Creek. At the time of the measurement, the diesel generator was operating because diversion flows were insufficient for hydropower generation. As stated in Section 5.2, the electrical transmission system is currently setup to only accept power from one generation source: hydropower generator or diesel generator. At the time of these measurements, Cascade identified the maximum transmission loss was less than 0.36 cfs, the maximum consumptive use was 0.68 cfs, there was no hydropower generation, and flow discharged to Irving Creek was about 1 cfs.

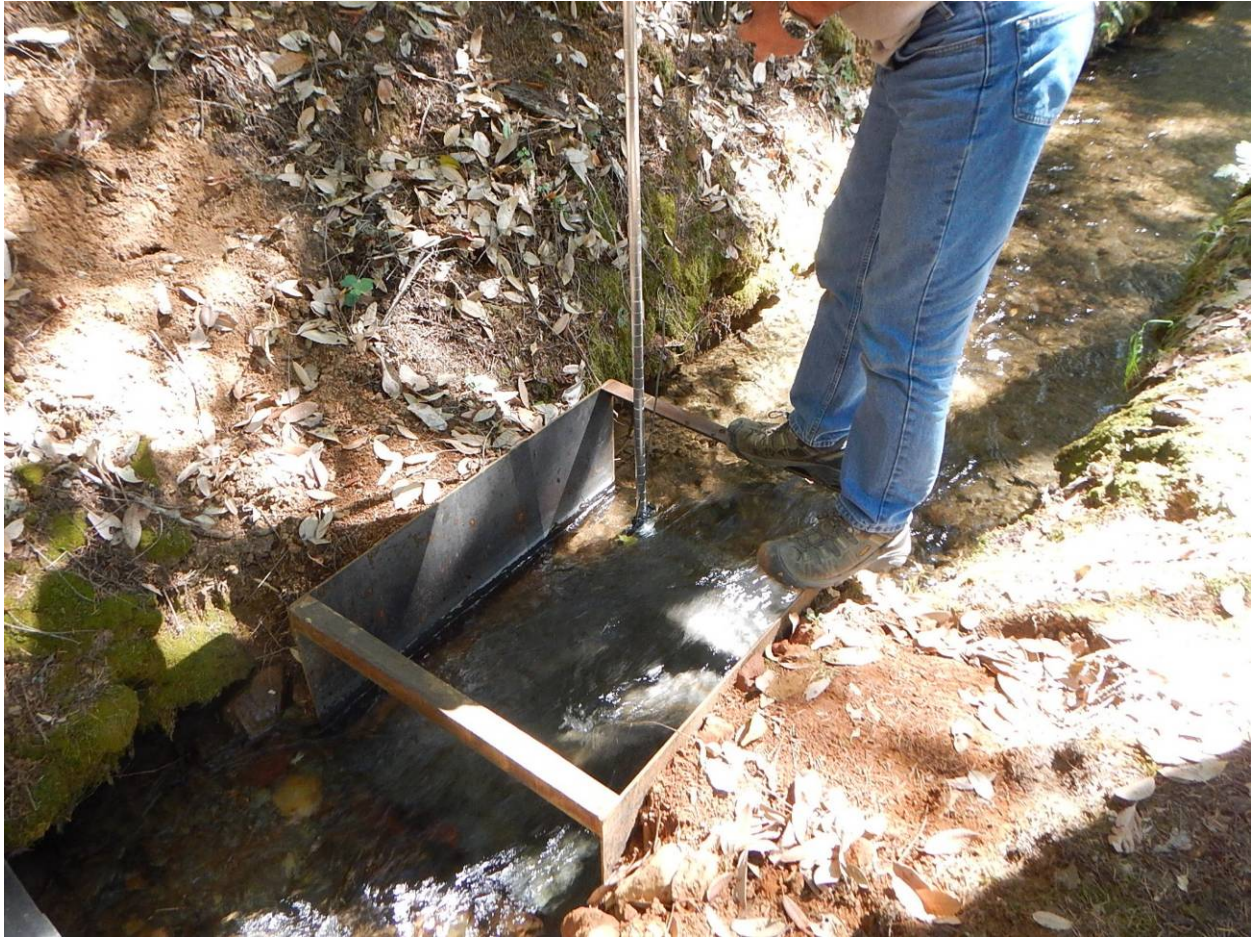
Photograph 15. Measurement conducted using Swiffer meter.
