**SACRAMENTO MUNICIPAL UTILITY DISTRICT
UPPER AMERICAN RIVER PROJECT
(FERC Project No. 2101)**

**PACIFIC GAS AND ELECTRIC COMPANY
CHILI BAR PROJECT
(FERC Project No. 2155)**

**CHANNEL MORPHOLOGY
TECHNICAL REPORT**

APRIL 2005

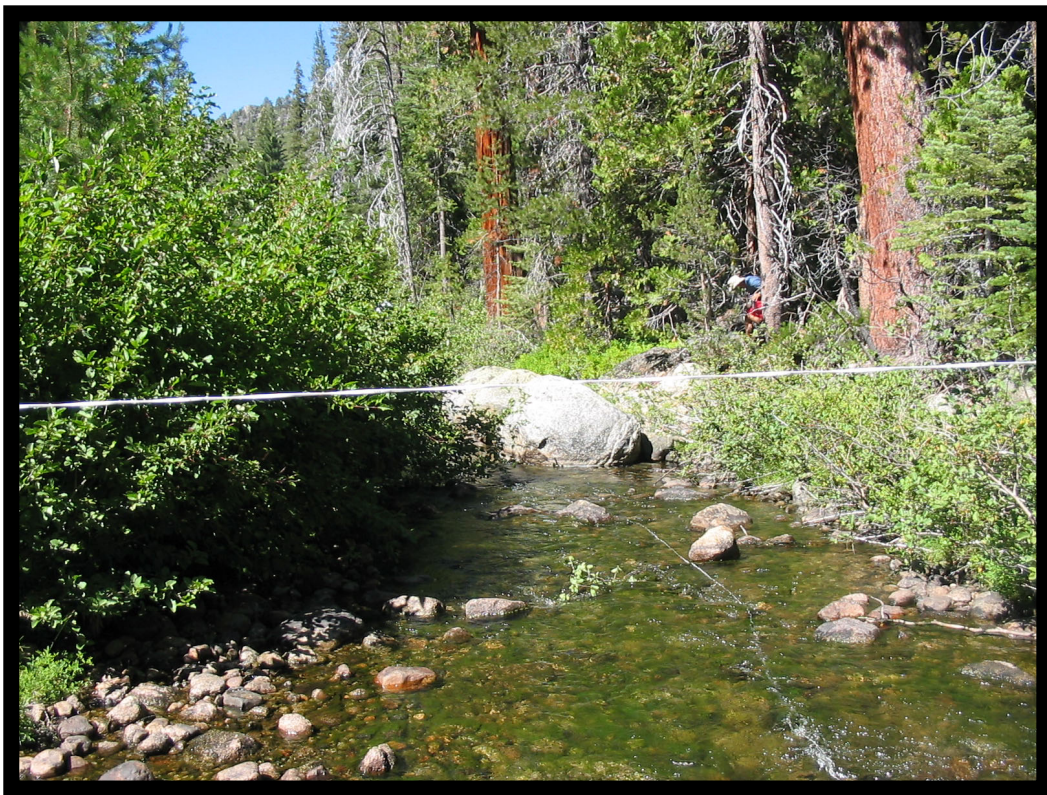
1 IMG_0662 RD-G1

E-1. Rubicon Dam Reach Site (RD-G1): Upper cross-section (1), looking downstream

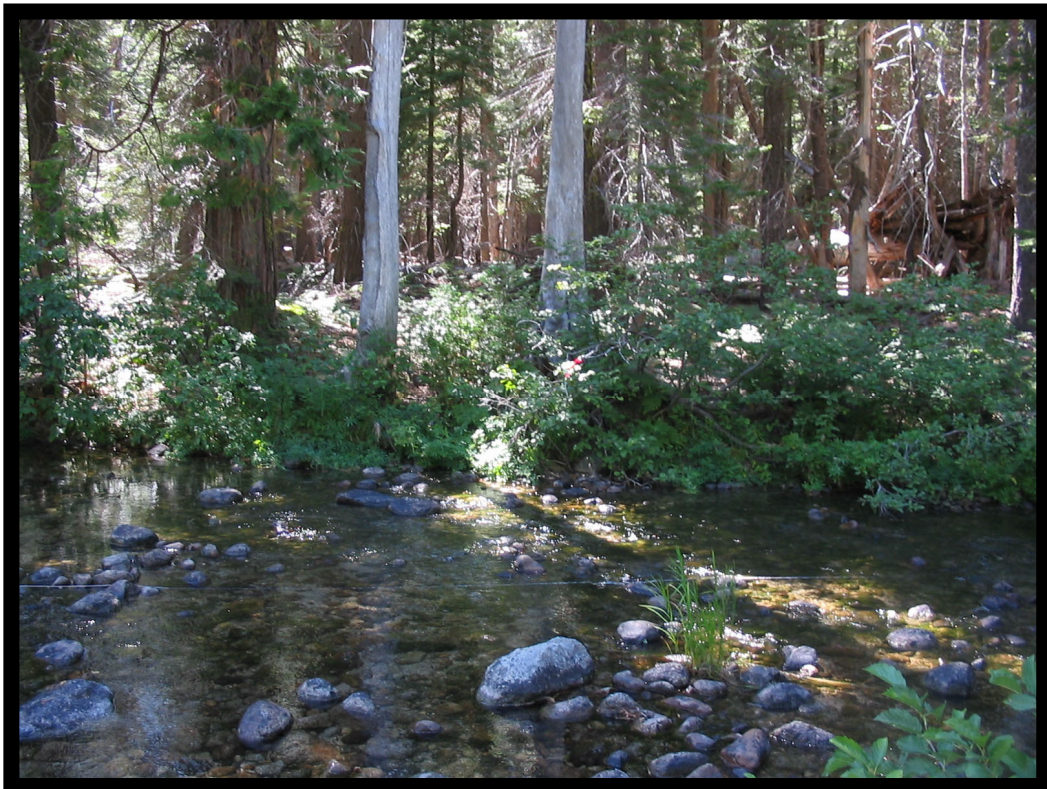
2 IMG_0651 RD-G1

E-2. Rubicon Dam Reach Site (RD-G1): Middle cross-section (2), looking at river-left bank from river-right bank

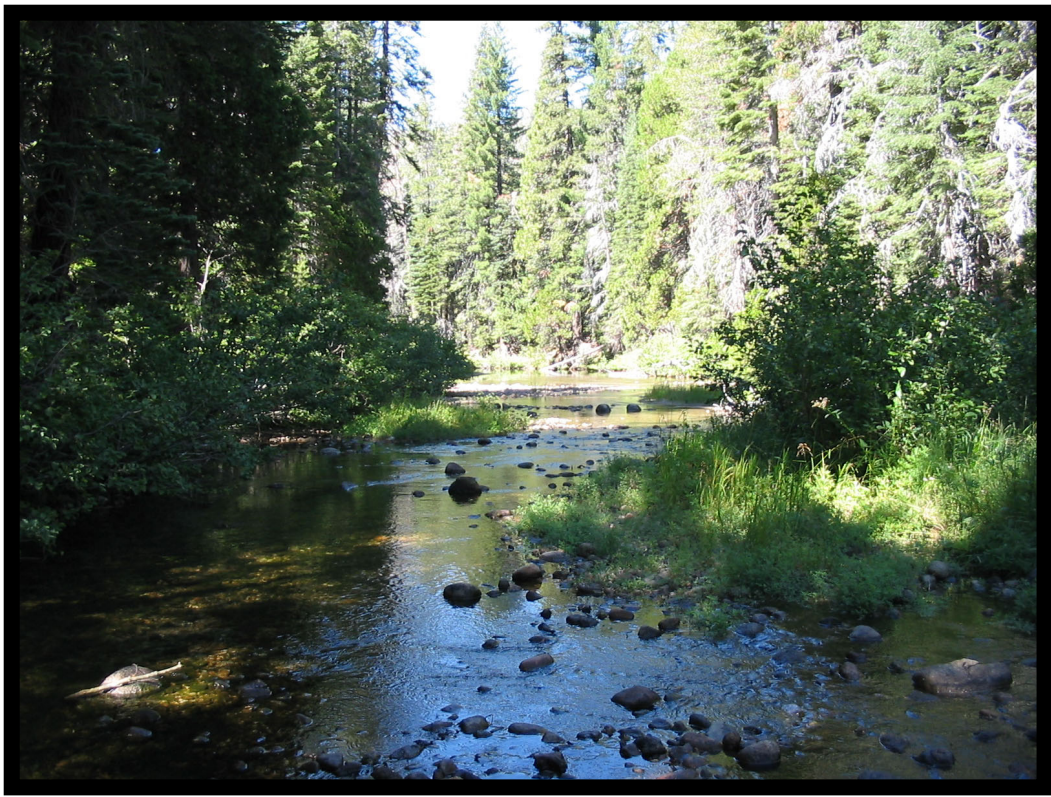
3 IMG_0658 RD-G1

E-3. Rubicon Dam Reach Site (RD-G1): Lower (3) cross-section, looking downstream.

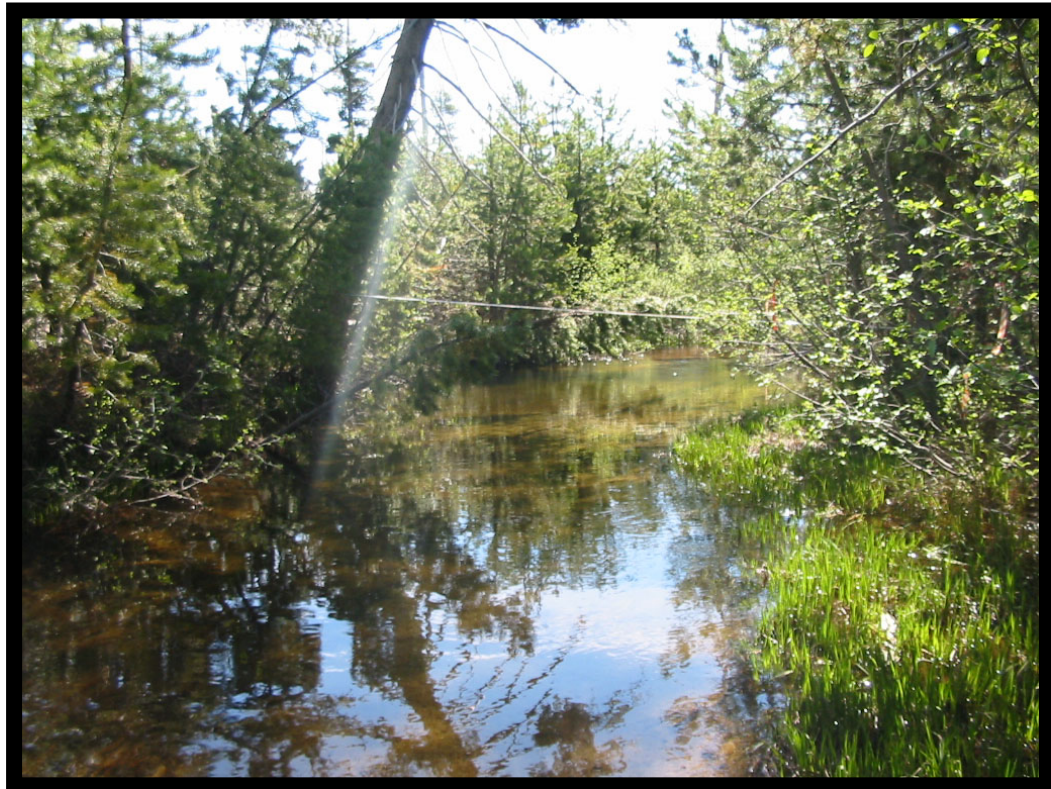
4 IMG_1331 LL-G1

E-4. Loon Lake Dam Reach Upper Site (LL-G1): Upper cross-section (1), looking upstream

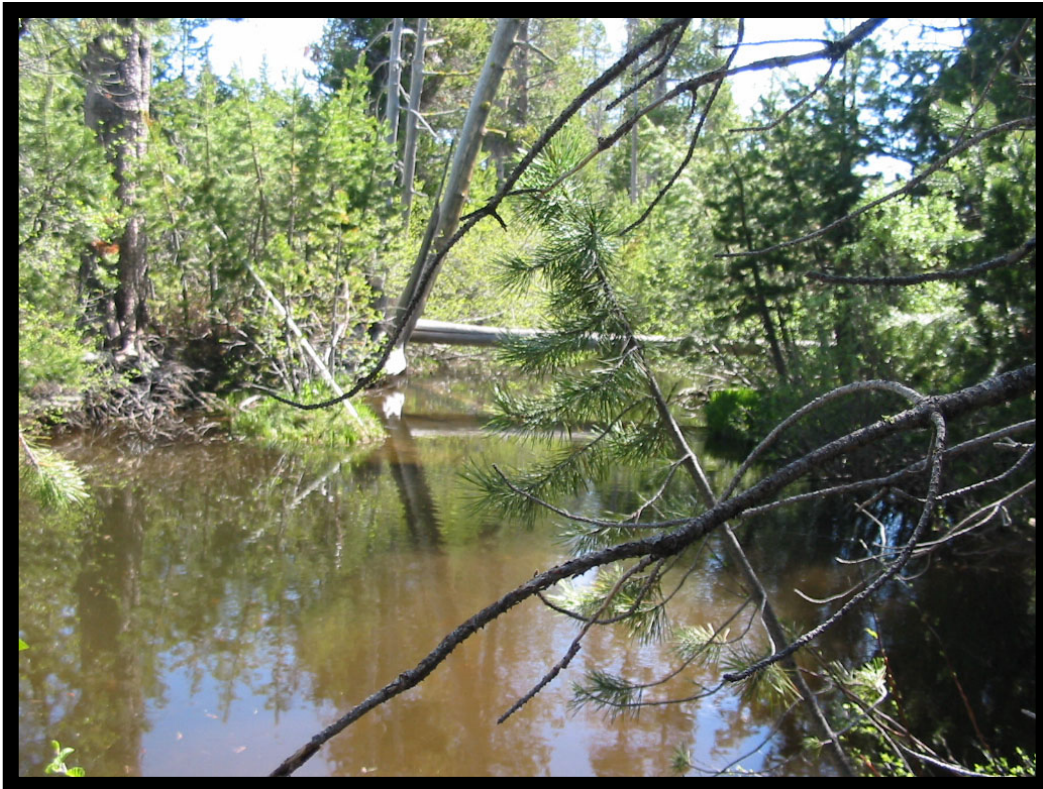
5 IMG_1328 LL-G1

E-5. Loon Lake Dam Reach Upper Site (LL-G1): Middle (2) cross-section, looking upstream.

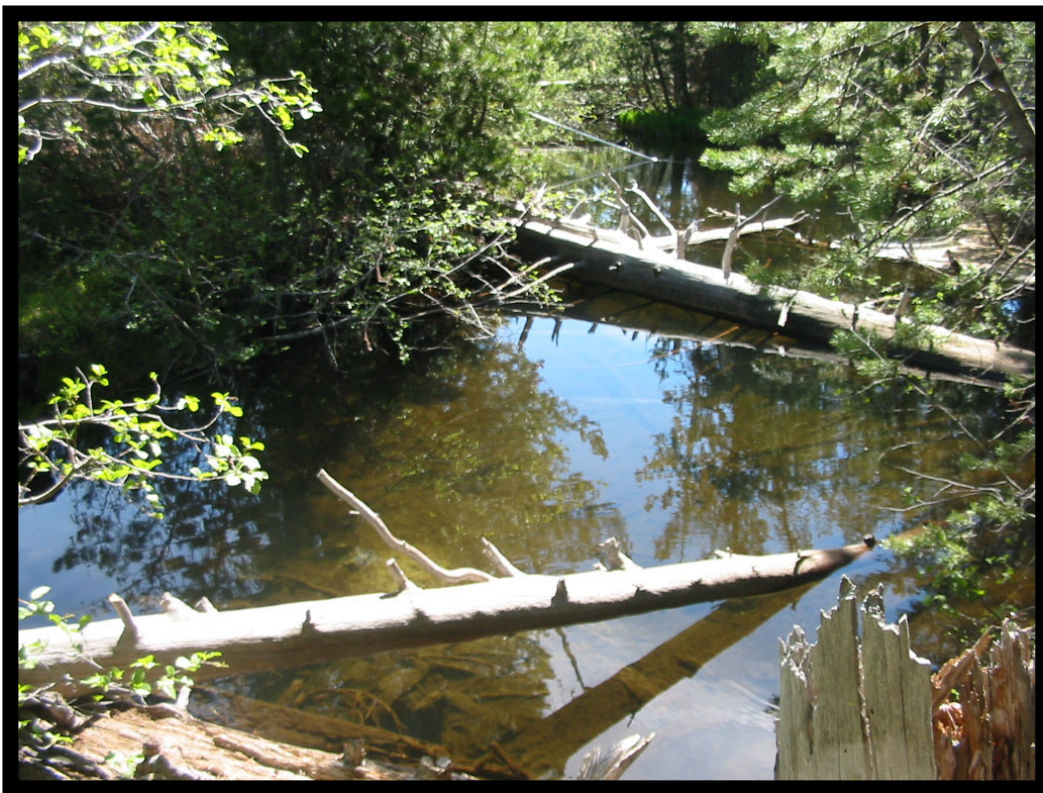
6 IMG_1323 LL-G1

E-6. Loon Lake Dam Reach Upper Site (LL-G1): Lower cross-section (3), looking downstream

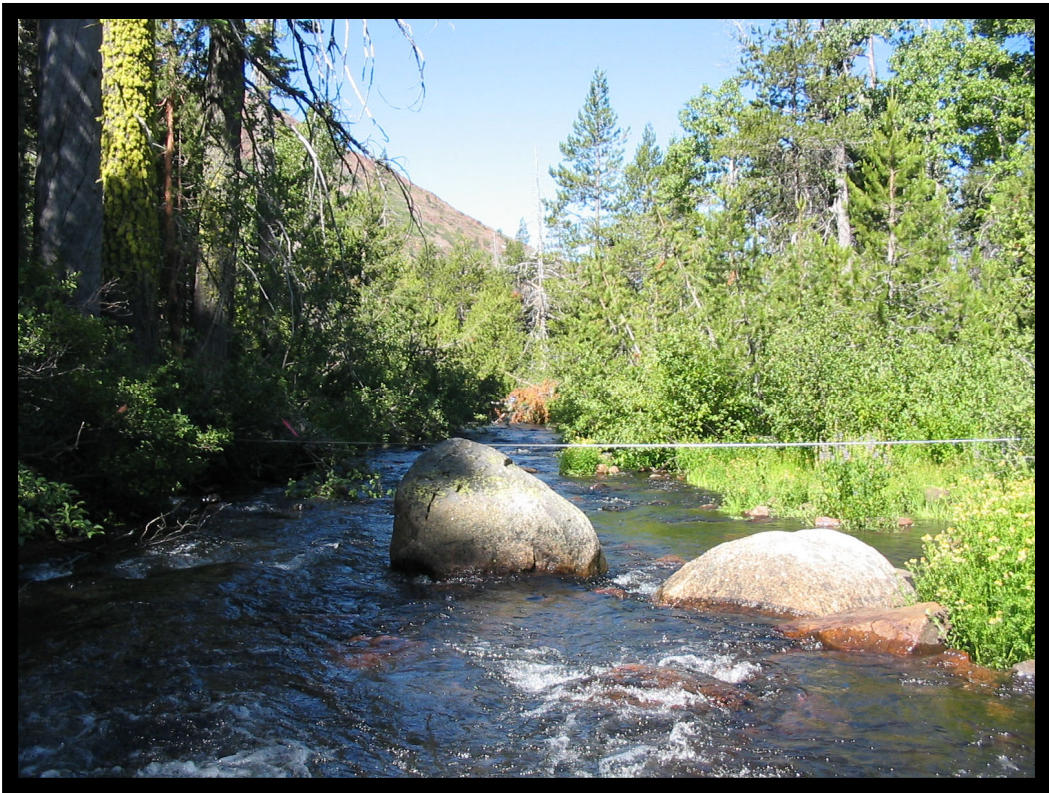
7 IMG_0499 LL-G2

Loon Lake Dam Reach Middle Site: While both the Loon Lake Dam Reach Middle Site and the Loon Lake Dam Reach Upper Site are located in meadow environments, the two sites are very different. The gradient at the middle site is about double the upper site, and sinuosity is markedly lower than the upstream site. Numerous lateral bars with bright surface grains indicate that sediment transport may occur regularly at moderate flows. In addition, many side channels were noted in the field, suggesting regular overbank flow and migration, or avulsion, of the main channel. Several debris jams and numerous key pieces of LWD created areas of scour and deposition in the channel (264 pieces/mile), suggesting that wood may affect channel morphology at this site.

E-7. Loon Lake Dam Reach Middle Site (LL-G2): Approximately 40 feet upstream of upper cross-section (1) looking downstream

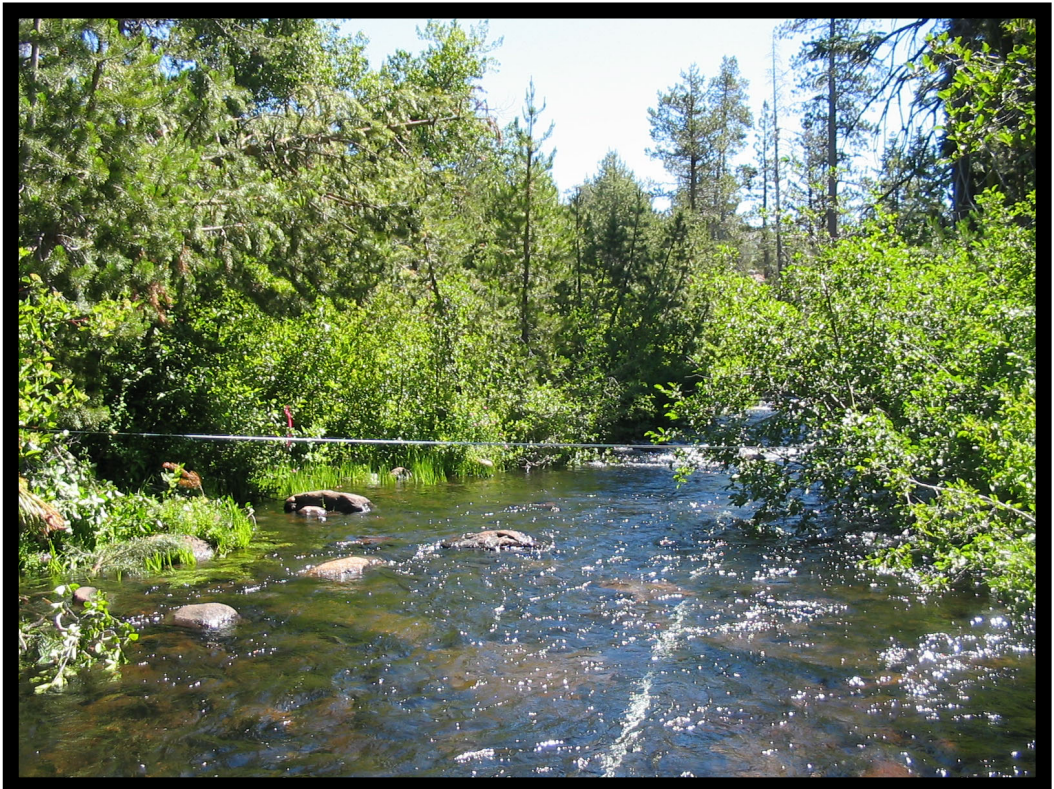
8 IMG_0504 LL-G2

E-8. Loon Lake Dam Reach Middle Site (LL-G2): Middle cross-section (2), from 40 feet downstream of middle cross-section (2) looking upstream

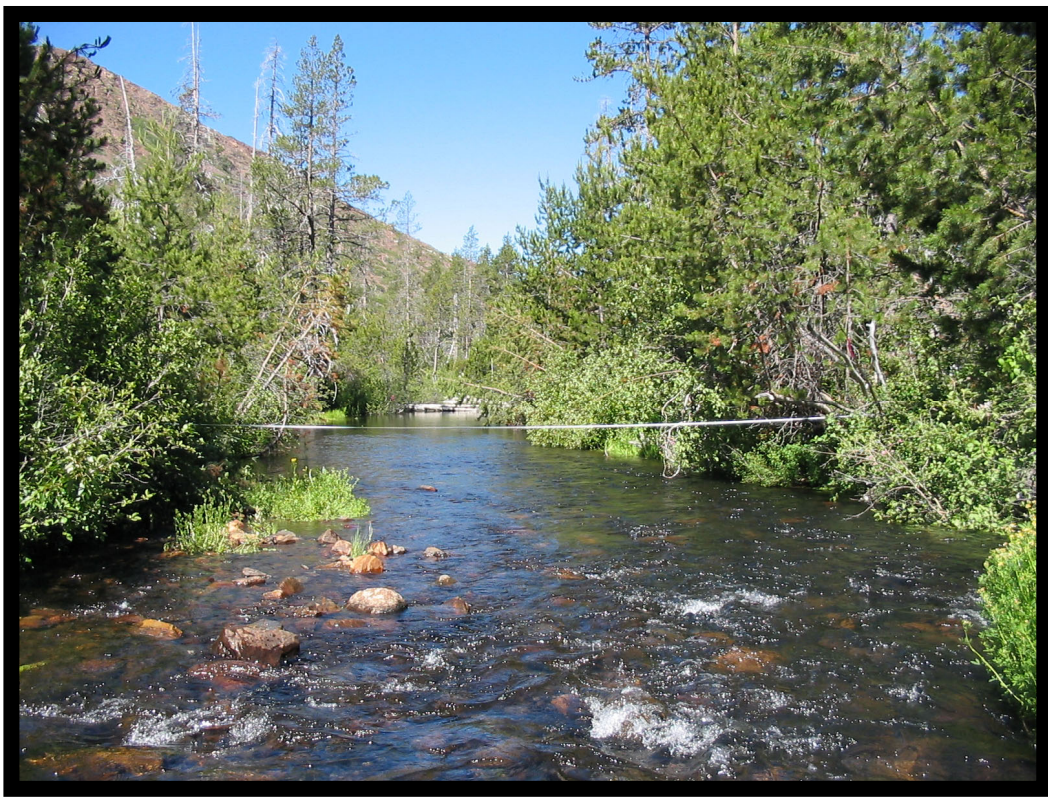
9 IMG_0517 LL-G2

E-9. Loon Lake Dam Reach Middle Site (LL-G2): Lower (3) cross-section, looking downstream; note transect tape.
